IMCA Safety Flash 12/11

October 2011

I Offshore Tank Container Rigging Failure

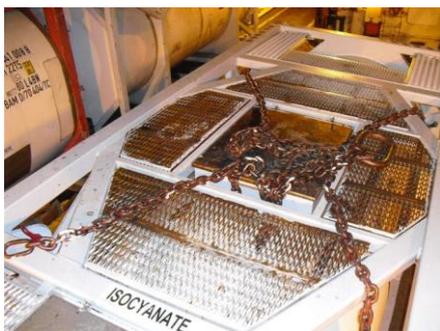
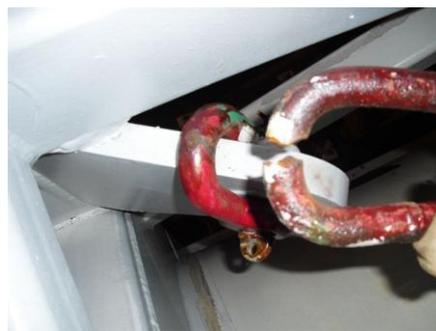
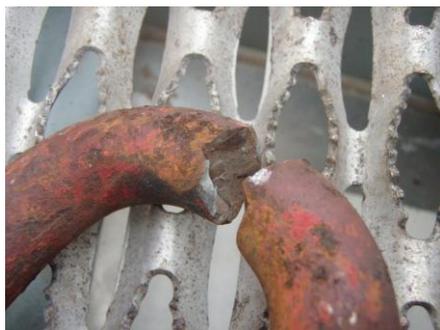
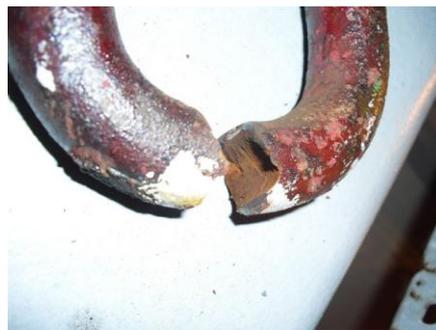
- ◆ Both containers were lifted in static conditions (deck to deck) in good weather conditions;
- ◆ Both containers were full at the time of lifting and the weight of the container did not exceed the safe working load;
- ◆ There was no deformation in the link or chain observed in either case; they were so-called cold fractures;
- ◆ In both cases it was the master link in a corner fitting of the container that failed.

Following the first incident, the chain link was sent to a laboratory to establish the cause of the failure. It was, at the time, concluded that the most likely scenario that caused the fast sudden fracture was a forging defect in the master link.

Following the second incident some seven months later, the similarities between the two incidents were apparent and it was established that both rigging sets were purchased from a single batch. With reference to similar incidents in the industry, hydrogen induced cracking or manufacturing process errors could not be ruled out. As this failure mechanism could not be determined by non-destructive examination methods, it was decided to replace all rigging sets from this batch (32 of) with new rigging sets.

Failed chain link

Laboratory results are awaited on these quarantined rigging sets and the broken link for further action as appropriate.

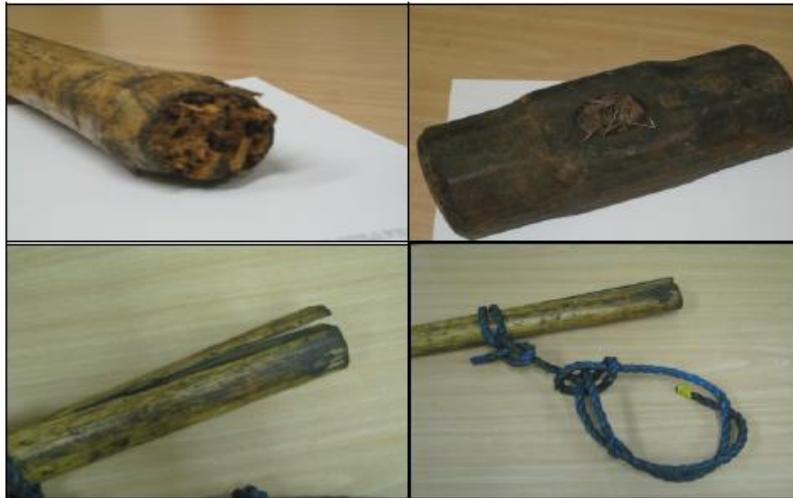
On closer inspection, it was noted that there were a number of small indentations around the head and along the shaft, two hairline cracks at the head end of the hammer and a large open split at the user end of the handle. It was also noted that the lanyard used to secure the handle was an inadequate solution for the retention of tools used at height.

Closer inspection of handle and hammer head

- ◆ The inspection for damage of all hand tools should always be carried out prior to use and before returning to storage location;
- ◆ Hammer heads should be checked for security prior to use, ensuring heads are securely fixed to handle;
- ◆ Defective tooling should be removed from service and quarantined;
- ◆ Appropriate tool retention methods should be used when working at height with tools; different methods may be appropriate for tools of different weight;
- ◆ The tool lanyard connection point should either be supplied with the hammer, recommended by the tool manufacturer or be a recommended and approved lanyard manufacturer's modification.

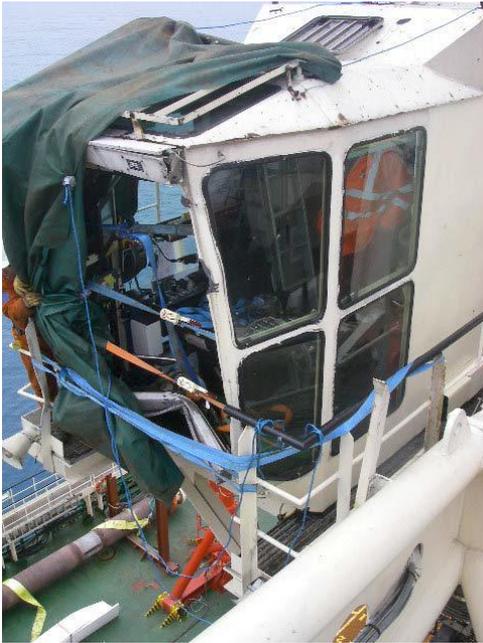
A member has reported an incident in which, owing to the sudden movement of the vessel, a crane winch wire hit the crane cab with the operator inside, causing damage to the cab structure. The operator was unharmed. The incident occurred after completing the wet storing of a spool using the single fall main block. The crane boom, complete with suspended spool lift rigging, was recovered to the main deck. Whilst the block was over the deck, the vessel pitched and rolled heavily thus causing the crane block to swing adversely. The crane operator attempted to recover the situation. As he attempted to recover the block, the wire immediately above the block hit the crane cab damaging the cab structure and breaking glass. The impact showered the crane operator with glass.

Crane cab showing damage

- ◆ A safe landing area on the main deck should be identified and clearly marked both on the deck itself and on the General Arrangement (GA) drawings;
- ◆ If it becomes necessary to use this area, a specific risk assessment should be required and an alternative, temporary safe landing area identified;
- ◆ Lift planning should cover crane operations from start to finish, including the initial movement of the crane and also recovery of rigging to deck.

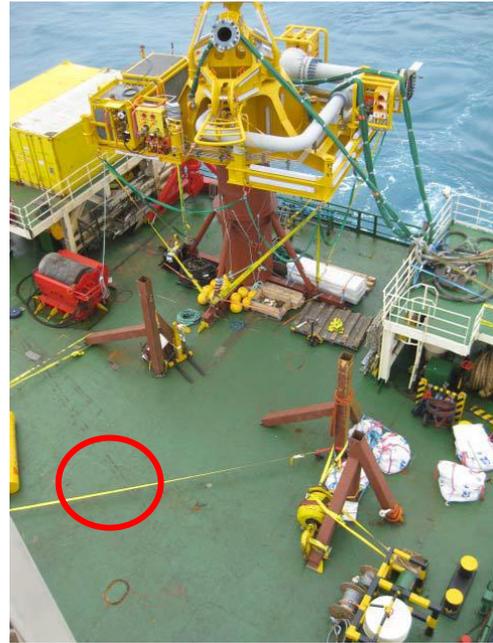
Landing area seen from above (circled)

- ◆ The landing area on the aft deck for the block and rigging was very restricted due to a tall subsea structure being in the same area;
- ◆ The crane boom position had to be at a 12m radius and the block had to be lifted high in order for the block and attached rigging to be lifted over the subsea structure. This position left the block at the same height as the crane cab.

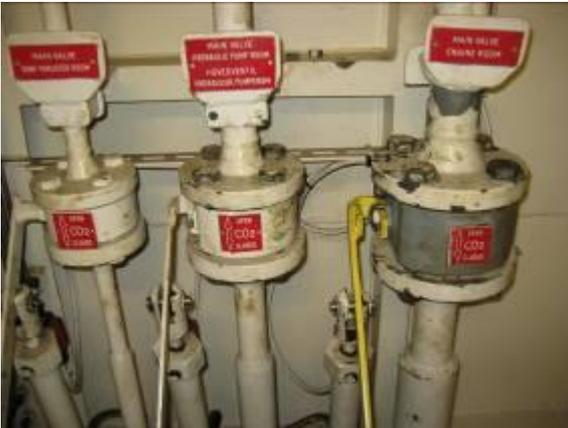
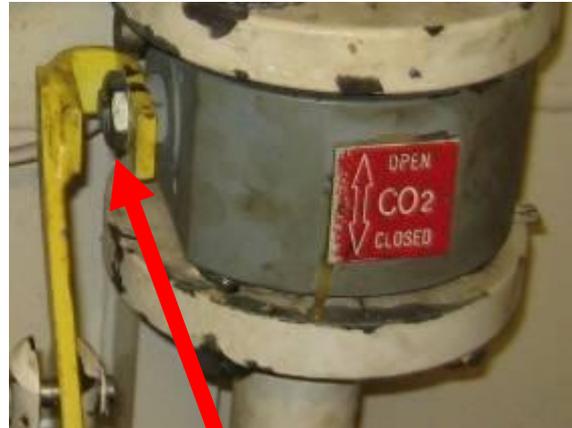
During routine inspection of a vessel's CO₂ fire fighting system it was noticed that the engine room CO₂ isolating valve remained in the closed position when the valve handle was manually operated. This was evident by the position of the valve spindle which remained in the closed position whilst the handle showed that the valve was open.

Spindle remained in the closed position whilst the handle was in the open

In the event of a fire and the need for CO₂ flooding, the isolating valve handle would have been forced to the open position, whilst the valve itself would have remained shut, thereby disabling CO₂ flooding.

The isolating valve was removed, freed up and the handle was repaired and tightened. During this repair process the safety pins for the CO₂ bottles were put in place and removed once the repair was completed.

All vessels must ensure that these CO₂ isolating valves open and that it is not just the handles turning on the valve spindles. All vessels are instructed to add a line of instruction to the TM job for checking that this valve is operating correctly when the inspection is done on the CO₂ system.

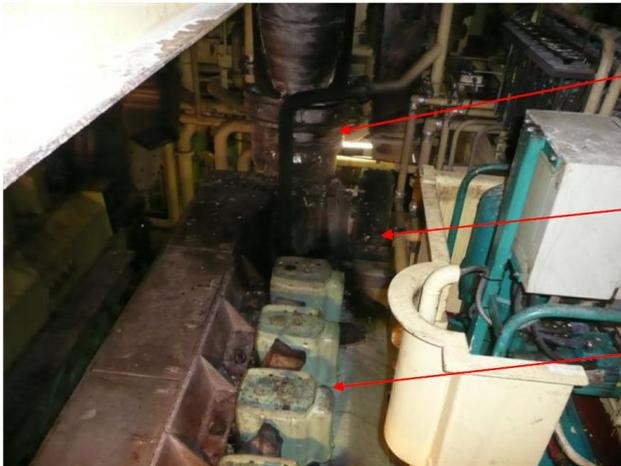
The source of the fire was subsequently identified as due to fuel oil leaking from the flange on a Fuel Injector Pump on main engine No.2. The fuel return line had come loose at the flange due to one of two securing bolts shearing and the other working loose. Fuel sprayed from the leaking flange and impinged upon the adjacent hot lagging of the main engine exhaust and turbo charger resulting in ignition and subsequent fire.

Source of Ignition- Hot Lagging on Exhaust and Turbo-charger-evidence of damage caused by fire

Overall View of Main Engine No.2 showing location of Fuel Pump and seat of Fire

- Include 3 monthly checks on fuel line flange bolts into contractor's Planned Maintenance System (PMS). This to include physical checks on the torque and condition of the fuel flange bolts as per Original Equipment Manufacturer (OEM) guidelines.
- Request information from engine manufacturer (MAK) on bolt composition and torquing requirements on securing bolts for the Fuel Injector Pump. Information to be disseminated to vessel operators and marine community via subsequent Information/Safety Flash

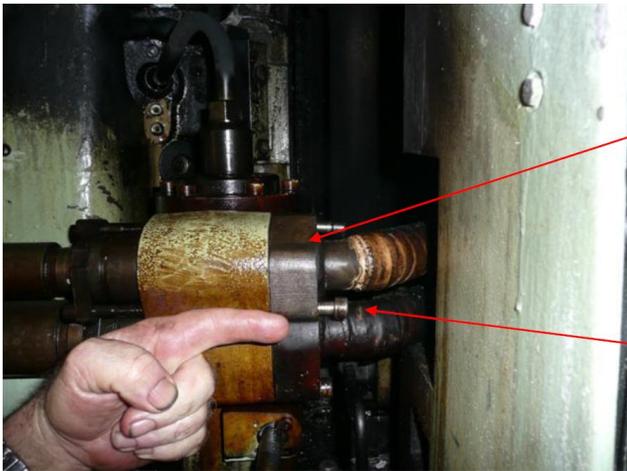
- Return Fuel line on the injector pump for main engine No.2 had come loose at the connection flange resulting in fuel spray to leak and impinge hot lagging on adjacent exhaust and turbocharger lagging. This subsequently resulted in ignition and fire
- The flange for the Fuel Injector Pump had only 2 securing bolts. One of which had sheared off and the other had worked loose which led to the fuel leak
- The Fuel Injector Pump was serviced every 15,000 running hours as per PMS. However no guidelines were available from the main engine manufacturer-MAK-on specific checks, torquing requirements and replacement programme for the securing bolts

Leaking Flange on Fuel Injector Pump Inlet Line

Flange Securing bolts that failed allowing oil leak to spray under pressure

Fuel Injection Pump Inlet Line showing 2 securing bolts holding flange face of Fuel Injector Pump

- Vessel operators to initiate checks on similar fittings on Fuel Injector Pumps and other high pressure pumps to check on condition and integrity of securing bolts. Checks and monitoring are especially critical after maintenance and reinstatement of high pressure lines to check for steady state operation

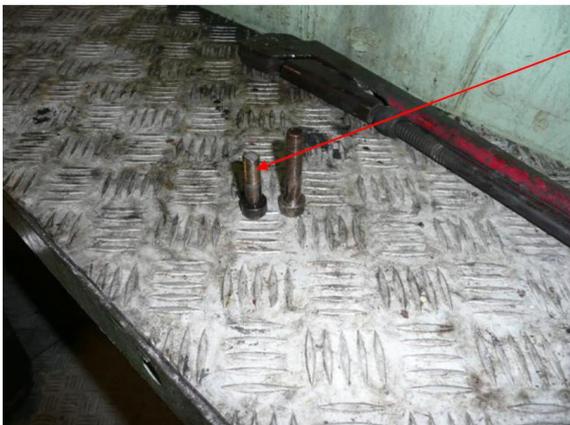
View of one of two Flange Securing Bolts that failed

Close View of Securing Bolts that failed holding flange face of Fuel Injector Pump
