## IMCA Safety Flash 12/12

November 2012

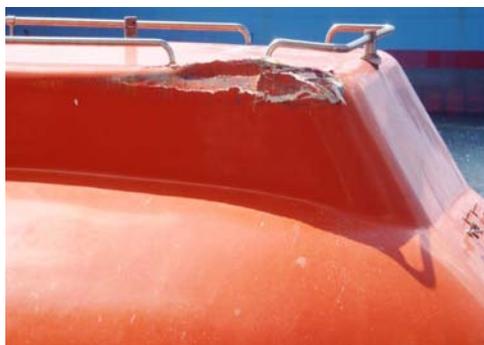
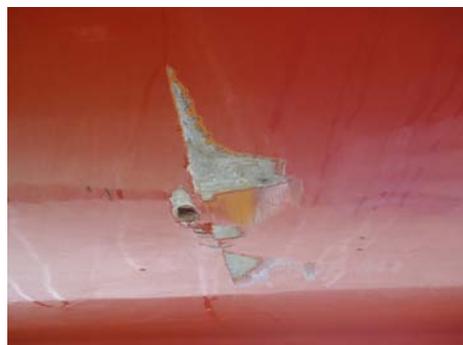
The lifeboat was moderately damaged, suffering a puncture hole in the starboard side bottom (approx. 5 x 5 cm), crushing damage to the fibre-glass on the starboard forward top (approx. 80 x 15 cm), and loss of some of the water sprinkler tubing, which came off when the lifeboat hit the side of the vessel. No one was in the lifeboat at the time and there were no injuries.

Figures showing damage to lifeboat

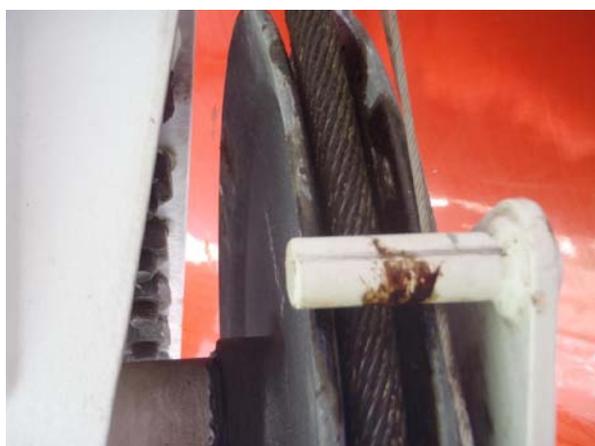
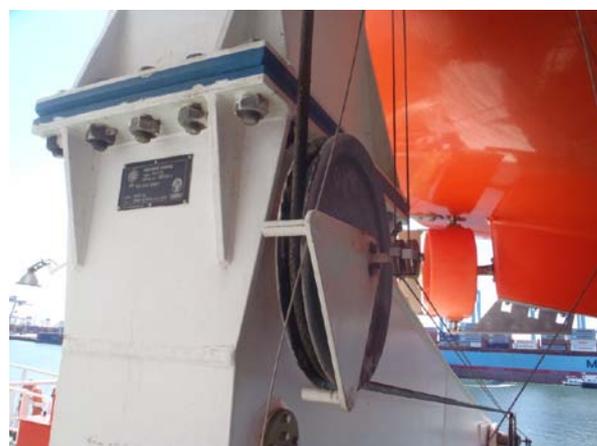
Whilst booming out, one of the remote control wires for lifting the brake got trapped behind a wire sheave arrangement. When the wire became taut, the remote control wire lifted the static brake and the lifeboat started lowering while it was still above the deck. The lifeboat got stuck on its protection fender, from which the stainless steel turnbuckle parted. The lifeboat then swung out sharply and was damaged in several locations when it swung back in, hitting the side of the vessel. The lifeboat then descended to the water on the centrifugal brake control. It was not possible to stop the process as the remote control wire remained stuck and taut, lifting the static brake.

Figures showing how remote wire got stuck behind a wire sheave arrangement

- ◆ It was unclear when the remote control wire had slipped in between the sheave and sheave guard. It was difficult to observe the many obstacles which could potentially foul this wire;
- ◆ If the remote wire had been kept under adequate tension this would have prevented the likelihood of it fouling;
- ◆ The fact that the lifeboat could be lowered while not yet fully boomed out could be considered a design error. The manufacturers have been asked to investigate this further;
- ◆ The likelihood that the remote wire could become fouled was not foreseen by the manufacturers, and there were no written procedures or instructions covering this.

- ◆ Persons involved with lifeboat lowering and recovery should ensure that the remote wires are constantly out of the sheave and not fouled with any other rigging.

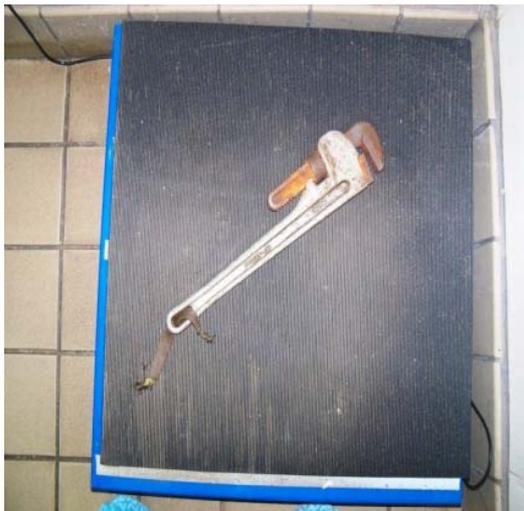
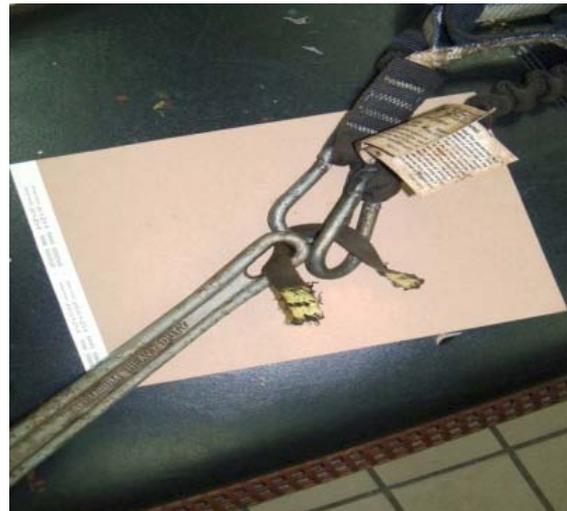
Figures: (L) pipe-wrench that fell (R) snapped single leg tether

- ◆ The crew had held a job safety analysis (JSA) meeting beforehand and identified and assembled the tools required for the job;
- ◆ The immediate cause of the incident was that the tool became caught during the lift, which caused the DROPS tether stitching to tear, allowing the pipe wrench to fall to the deck below.

- ◆ DROPS training plans should be continually emphasized;
- ◆ Care should be taken with the safe work load (SWL) of straps and tethers used for hoisting tools;
- ◆ Single leg tethers should not be used as lifting devices;
- ◆ Establish a pre-use inspection and regular inspection cycle for DROPS equipment;
- ◆ Carefully identify entanglement points on the lift route when hoisting tools aloft.

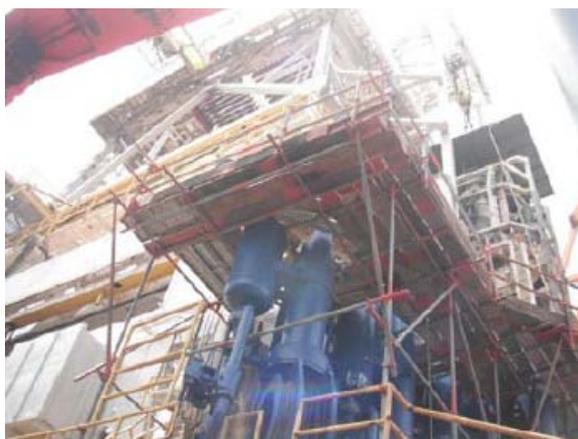
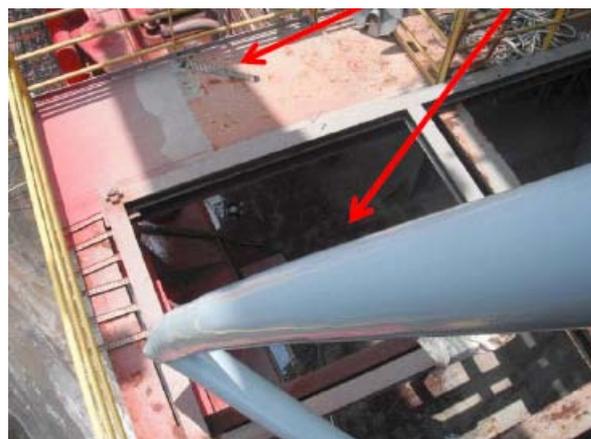
Figures: (L) Tensioner platform (R) showing where angle bar landed and bounced

- ◆ One of the workers doing the cutting was not qualified to do this task;
- ◆ The unqualified worker doing the cutting did not remove or secure the angle bar from the scaffold;
- ◆ There was no barricading tape found below the scaffold platform.

- ◆ All loose materials should be removed from all high level working platforms. If this is not possible, all materials must be relocated away from the edge of platform and should be properly secured;
- ◆ All areas underneath where work is taking place at height should be barriered off with hazard tape when overhead work is in progress, and should remain until after the overhead work is completed;
- ◆ A guard worker may be posted outside the danger zone to prevent access to the hazardous dropped object zone;
- ◆ Only properly trained and competent workers should be allowed to carry out the work;
- ◆ Before work at height starts when the vessel is in the shipyard, appropriate inspection of the worksite should take place by qualified shipyard personnel.

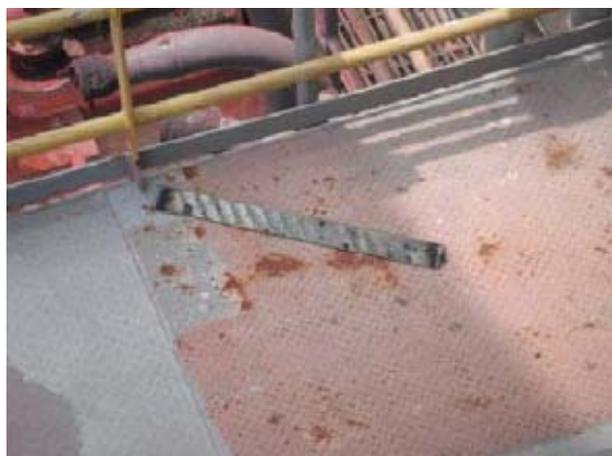
Figure showing piece of angle bar where it finally landed
