# IMCA Safety Flash 12/13

July 2013

## I Near Miss - Falling Transponder on Main Deck

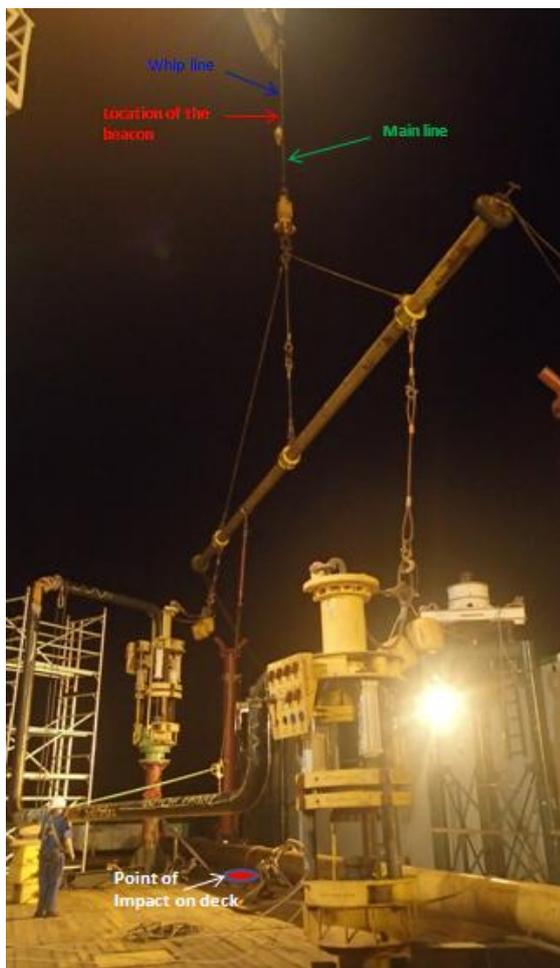
A member has reported an incident in which a transponder came into contact with the crane's sheave, causing the transponder to fall on deck. The incident occurred during lifting operations, which required overboarding a jumper and its spreader bar – both positioned on deck. The whole assembly was directly slung to the hook on the main line of the vessel's crane (see Figure 1). The main line and the whip line were both equipped with a transponder that was positioned right above the headache ball and directly secured to the wire rope with two jubilee clips.

Figure 1: Spreader bar assembly

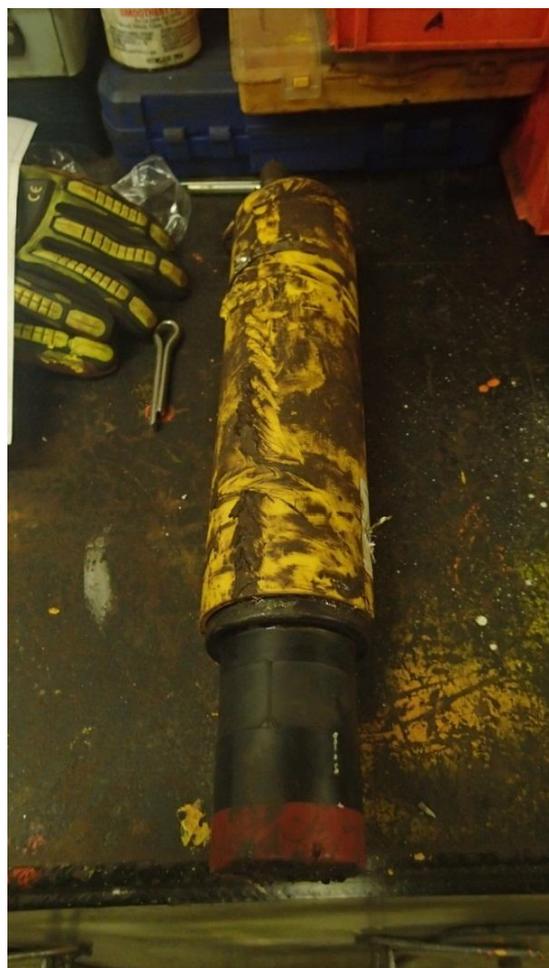
Once the assembly was lifted off its stands, the length of the whip line was reduced from approximately 7m to 3m, so that it would not get tangled with the main line. The incident happened as the knuckle boom was folded to adjust the rigging. The surface area of the knuckle boom increases when folded and both lines are drawn in as a result. The transponder on the whip line was caught up in the sheave, causing the transponder, which weighed approximately 4 kg, to fall from 30m to the deck. There were no injuries. The transponder sustained noticeable damage (see Figure 2).

Figure 2: Damaged transponder

- ◆ The mechanical hook level alarm installed on the whip line was disconnected because it was deemed too sensitive to grease build-up;
- ◆ The mechanical hook level alarm installed on the main line was not working because of corroded switches that had not been replaced;
- ◆ The above-mentioned switches were not waterproof;
- ◆ No-one, prior to or during the operations, spotted the two transponders that were on both lines and/or identified them as hazards associated with a risk of falling object;
- ◆ The whip line had been put back into service after three months of unavailability due to a problem with calibration;
- ◆ There was no specific procedure regarding the use of transponders on the crane's lines;
- ◆ Existing company safety management system procedures for management of change were not followed.

- ◆ Ensured personnel fully comply with existing company safety management system procedures, particularly with reference to management of change;
- ◆ Ensured crane operators are fully aware of the workings of their cranes – i.e. that the crane's lines are automatically drawn in when the knuckle boom is folded;
- ◆ Removed unnecessary transponders from crane wires.

- ◆ Ensure that the mechanical hook level alarm installed is tested each time the crane is started, and that this test is included in the vessel's planned maintenance system (PMS);
- ◆ Cover the use of transponders during lifting operations.

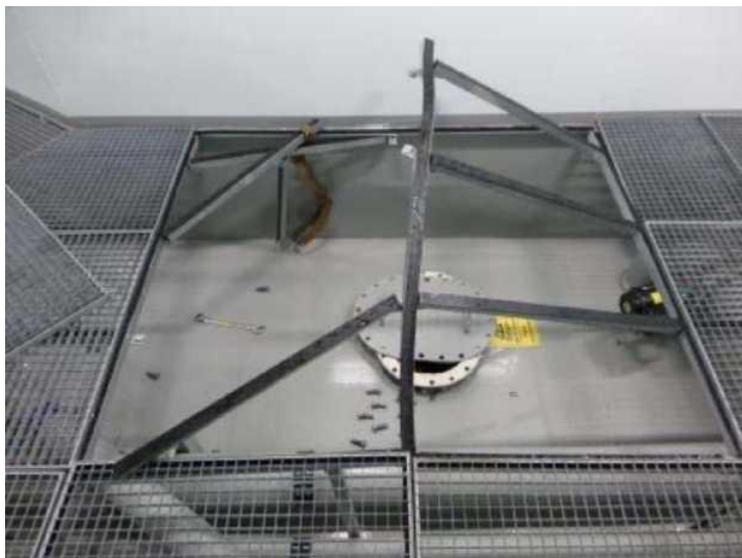
A member has reported an incident in which someone suffered a head injury, when water escaped from a tank when it was opened. The incident occurred during opening of vessel ballast water tanks for ventilation prior to cleaning and inspection. The wrong tank was opened; a tank containing ballast water (the majority of the volume of which was above the man-hole) was opened by mistake, and approximately 180 cubic metres of water flushed out of the tank. The person opening the tank was pushed aside by the flow of water and knocked against other structures, suffering head injuries as a result.

Figure: Showing damaged grating and manhole from starboard side.

- ◆ There had been no risk assessment before starting the task;
- ◆ No permit to work was obtained for the task;
- ◆ There was insufficient familiarisation of persons involved in the task;
- ◆ There was no proper communication with regard to which tanks were to be opened and when to open them;
- ◆ All nuts were removed from manhole cover prior to breaking the seal.

- ◆ Leave a minimum of bolts on the treads prior to breaking the seal of the manhole;
- ◆ Ensure personnel involved in a task have a full and common understanding of what is required before starting;
- ◆ Ensure personnel are aware that the job can be stopped if this is not the case;
- ◆ Identify requirements for permit to work, isolations and tool box talks before start of task.

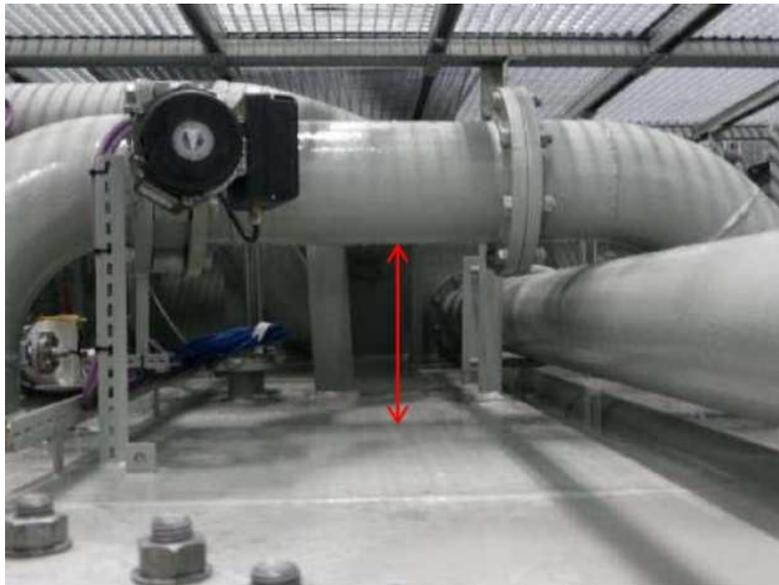
*Figure: Showing area against which crewman was pushed by flow of water. NB height from deck to the pipe is approximately 0.35m (red arrow)*

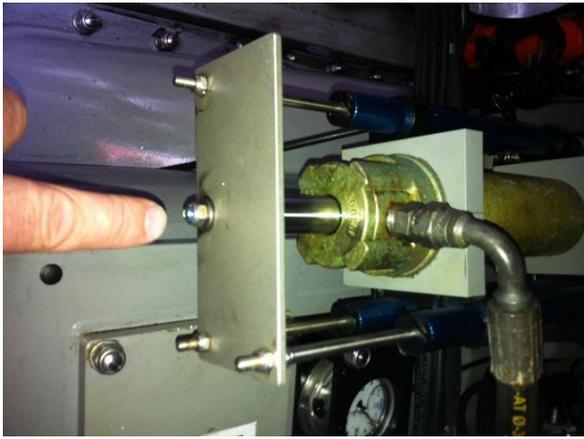
Figure: Transducer plate secured correctly to ram

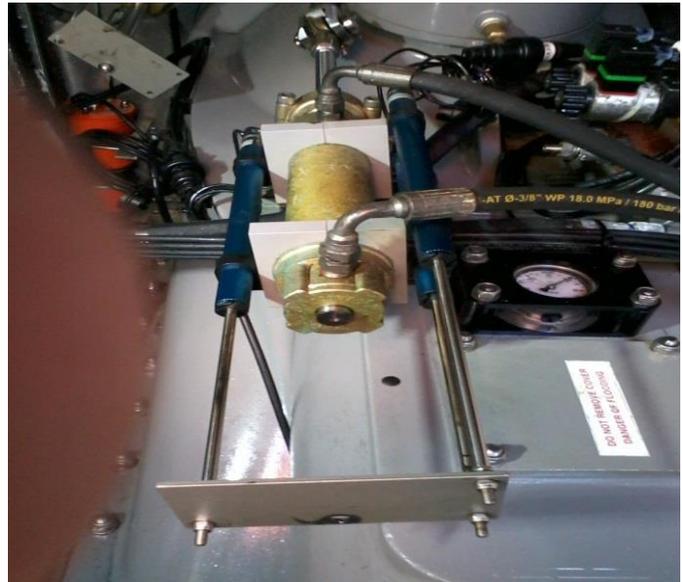
- ◆ An M6 size bolt, securing the steering feedback transducer plate to the end of the steering ram, had vibrated loose and fallen off into the bilge;
- ◆ This resulted in a loss of steering control of the unit.

Figure: Transducer plate secured correctly to ram transducer plate unsecured and steering ram retracted

- ◆ The steering feedback transducer plate was reconnected and LocTite or similar used on the nut and bolt;
- ◆ The repair operation could have been conducted offshore without returning to port;
- ◆ When the rams are disconnected from the transducer plate for maintenance purposes, the nut and bolt should be secured with an agent like LocTite or similar to prevent the bolt from vibrating loose;
- ◆ Wind farm vessel crews should have a thorough technical understanding of the vessels they are using.

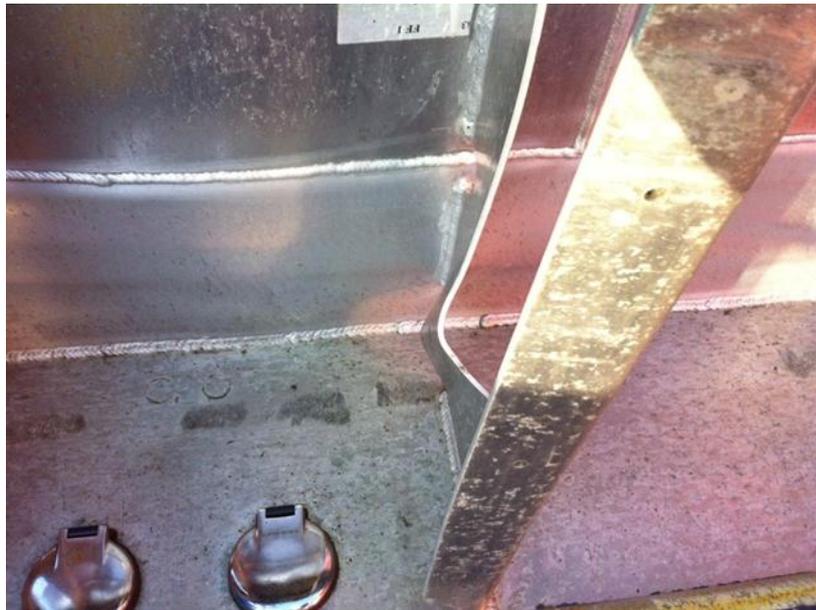
A member has reported an incident in which a wind farm service vessel collided with a turbine foundation, after failure of the vessel jet drive. The incident occurred after the vessel had disembarked passengers at the sub-station and had reversed away to drift, whilst standing by for the next assignment. The jets were disengaged and engines left running, as was common practice. Under the influence of currents, the vessel drifted towards another turbine foundation and when approximately 30m away, the vessel coxswain/skipper attempted to engage the jets. At this moment it was found that neither jet would engage. Several minutes were spent fault finding to no avail, after which the vessel coxswain/skipper assisted the deckhand with fenders. The vessel collided with the foundation, causing a buckled frame and bent plate in the port quarter bulwark, but no damage to the foundation.

*Figure: Showing buckled frame and bent plate, as a result of collision between wind farm service vessel and turbine foundation*

- ◆ It was common practice for wind farm vessels to be allowed to drift in field, whilst waiting for work;
- ◆ There was no guidance from the wind farm operator (the client) on a minimum distance of approach to offshore structures while drifting;
- ◆ At the speed the wind farm vessel was drifting, 30m was not sufficient distance to allow enough time to re-start the jets or to anchor;
- ◆ The jet drives re-engaged, once they had been completely shut down and re-started.

- ◆ Following any incident, the company office and client should be informed immediately, if necessary using satellite telephone;
- ◆ Jet drives should be engaged when within 100m of an offshore structure, unless the wind farm service vessel is at anchor or tied off;
- ◆ Following this incident, the wind farm client now allows wind farm service vessels to tie off on to foundations when waiting on work.
