IMCA Safety Flash 12/15

August 2015

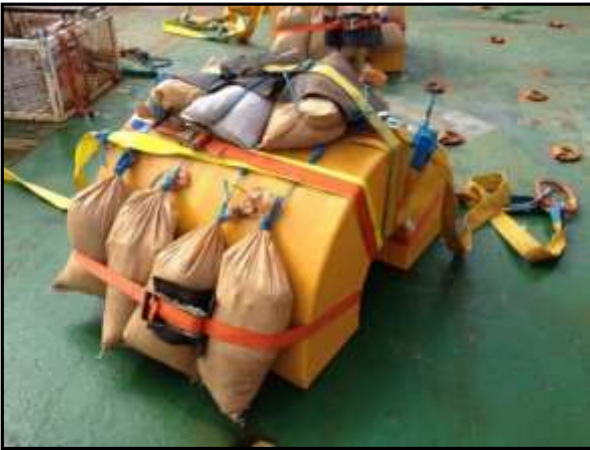
A member has reported an incident in which buoyancy problems were encountered with equipment being deployed subsea. During light subsea construction operations conducted from a DSV, there was a requirement to deploy two 'thermal tunnels' as a barrier between an existing pipeline and a new umbilical being laid. When the thermal tunnel was deployed it became obvious to the crew that despite it weighing 515kg in air it would not penetrate the splash zone. The thermal tunnel was too buoyant and would not sink.

After investigation it was discovered that the manufacturer's buoyancy calculations were incorrect; these were checked by the on-board engineering team. These thermal tunnels are manufactured for subsea use without appropriate quality checks being carried out by the manufacturer.

Thermal tunnel with additional weights

- ◆ Consulted with manufacturer to ensure that these findings were passed back appropriately;
- ◆ Generated a management of change process and applied a temporary solution, whereby additional weight was added to the thermal tunnel to assist with the installation. The thermal tunnel was successfully installed in position and covered with a concrete mattress;
- ◆ Ensured that all future deployments of thermal tunnels would have manufacturers' certification of wet test, or independent validation of mass detailing suitability for subsea use.

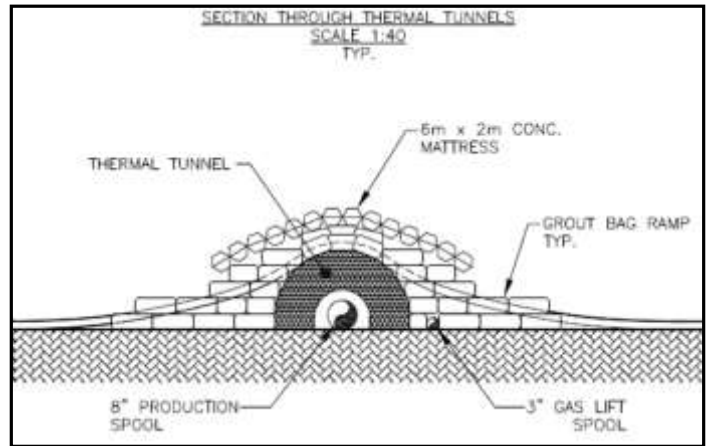
Section through thermal tunnel on seabed

It was noted that a remaining risk was that if the concrete mattress was subsequently removed and the weight fixings in the meantime had perished, the buoyancy issue would be realised again. This is an unknown but should be taken into consideration in future. Members using thermal tunnels may wish to review their procedures to mitigate the risk of tunnels floating to the surface, as this is a potential hazard to both divers and vessels.
