IMCA Safety Flash 12/17

May 2017

Theme: Fires

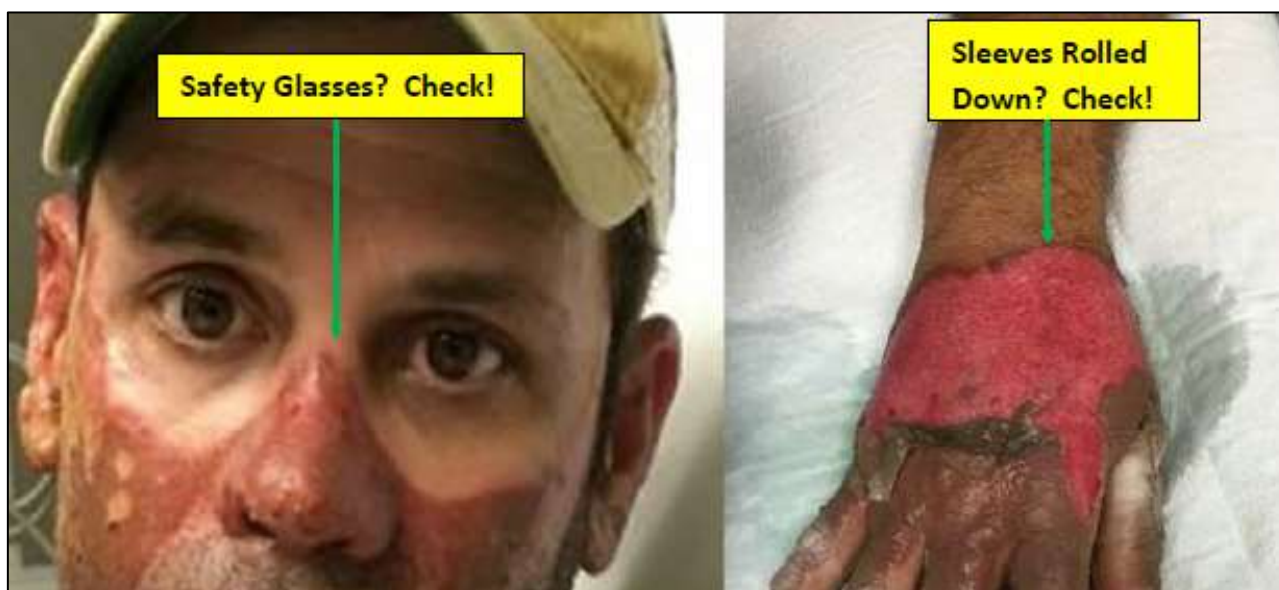
All three individuals were reported to have been wearing safety glasses, hard hats and flame resistant clothing (FRC), although at least one was believed to have rolled up his sleeves. Their injuries were described as a combination of first and second degree burns to their hands, forearms, neck and face. The BSEE considers that the proper use of appropriate PPE likely prevented additional injuries. The initial report can be found [here](#).

- ◆ Are YOU and your personnel all wearing proper PPE where the potential exists for thermal exposure from fire?
- ◆ Ensure that the PPE selected for the job reflects the probable and possible hazards of the job. **Are you wearing the correct PPE?**

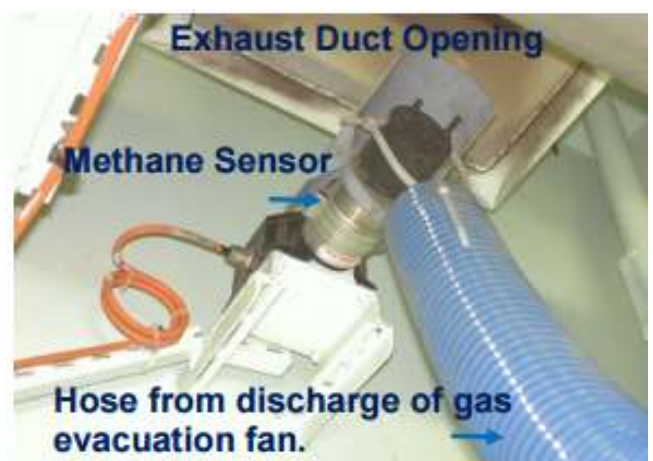
During a repair on one cylinder of a main engine vessel, engineers had to remove an expansion bellows. Upon replacement of the bellows an O-ring, separating its inner and outer sections, was damaged. This error went unnoticed until a crew member was making a round in the enclosed GVU room while the engine had been operating on gas. After entering the GVU room he was overcome by methane gas and nearly lost consciousness. Fortunately, he was able to exit the space into a safe atmosphere. After the incident, the GVU room atmosphere was measured to be 22 percent methane and 17 percent oxygen by volume. Methane is an asphyxiant which displaces oxygen and is extremely flammable. The installed methane sensor failed to detect the accumulation of gas despite not having malfunctioned.

Engineers had rigged a hose from the outlet of the gas evacuation fan, across the GVU room to the sensor at the entrance exhaust duct. This unauthorized arrangement, which was identified during a Coast Guard examination, could have likely disabled the sensor's ability to detect methane leakages from other components within the GVU room.

The US Coast Guard **strongly recommends** to Flag States, classification societies, underwriters and insurers that respective examiners, surveyors, and inspection personnel maintain an acute awareness regarding any system modifications, whether deemed potentially hazardous or not, to ensure such modifications have received the proper engineering reviews, approvals, and supporting documentation.

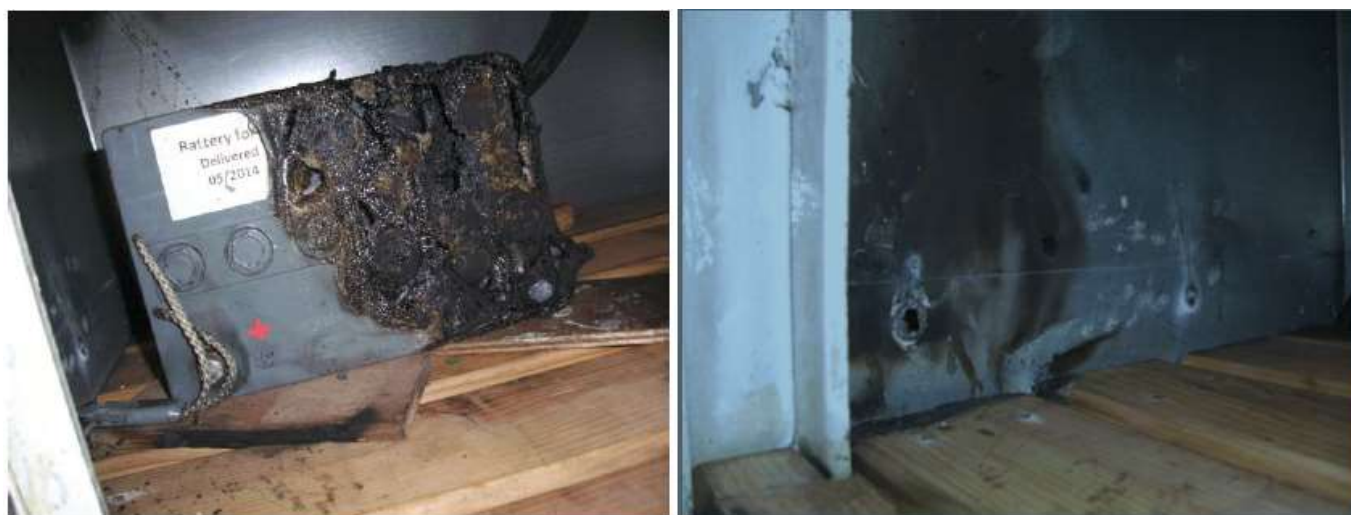
The Marine Safety Forum (MSF) reports an incident in which, during the early hours of the morning during a period of adverse weather, the fire alarm in the vessel battery locker was activated. The crew mustered and the fire team assembled and upon investigation it was discovered that there was a small flame and sparks being emitted from a spare battery that was stored in the battery locker on the top shelf.

The battery had been delivered during the previous port call and stored within the battery locker. Unfortunately, it had been placed on a storage shelf with no attempt to secure it in place. During a period of heavy weather, the battery tipped onto its side and slid against the steel lining of the bulkhead.

As the battery terminals were not covered, this caused the battery to short circuit and led to it overheating. Once the battery had reached ignition temperature, the casing melted, setting off the fire alarm.

- ◆ Everything loose on a vessel should be secured in place to prevent movement. Assume nothing; secure everything;
- ◆ All spare batteries should have the terminals covered with insulating material to prevent accidental shorting.

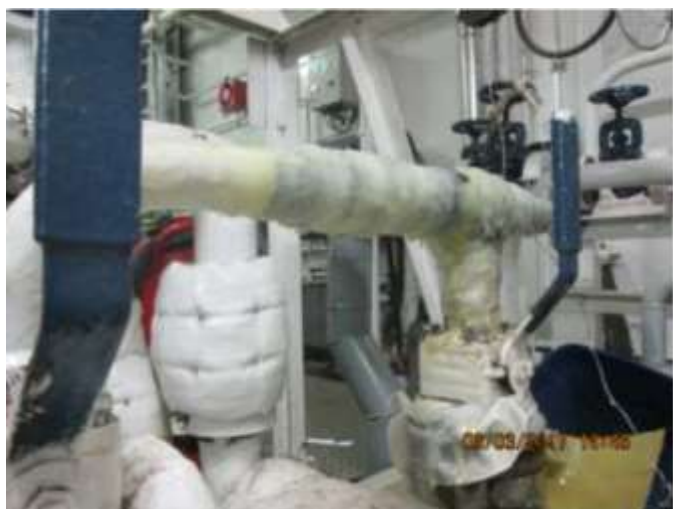
A potential fire hazard was discovered, caused by a failed fuel pipe connection on the supply line to the main engines. The Chief Engineer was called to engine room with a report of a leak on a low pressure fuel supply line supplying both main engines. Upon arriving in the engine room and assessing the situation, a temporary repair was effected, due to being unable to isolate the pipe. Self-amalgamating tape was used to reduce the leak to a weep and then fibre-glass resin and bandage was applied, to try and seal the weep.

Temporary repairs to the pipe

The **immediate cause** was found to be a failed weld on a T-piece of the pipe. The **root cause** is believed to be the age of the pipe, an original fit from the vessel's construction, incurring natural degradation over time.

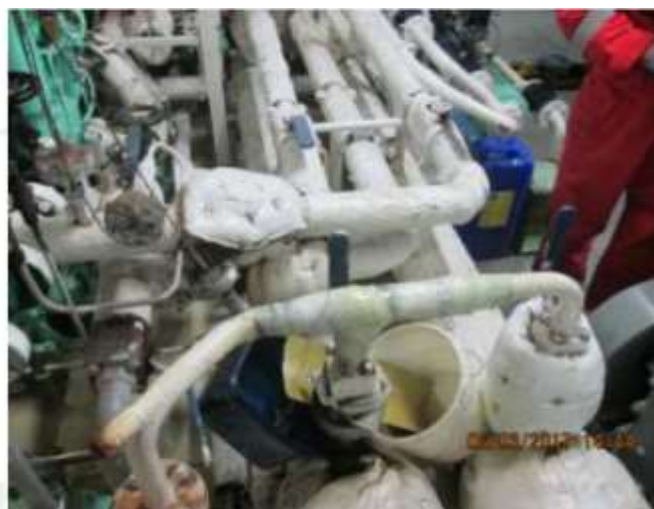
Complex shape and fitting of pipe

- ◆ Vibration, owing to the proximity of the main engines, is going to be an issue with equipment of this sort. Engineers should maintain awareness of equipment shortcomings and manufacturing design weaknesses;
- ◆ As such failures cannot always be predicted and vessels should always carry appropriate pipe repair solutions such as plastic steel, fibre glass resin, pipe repair clamps etc.;
- ◆ In this case, a trend in the failure of fuel supply piping was noticed; this was the 4th failure within 4 months.

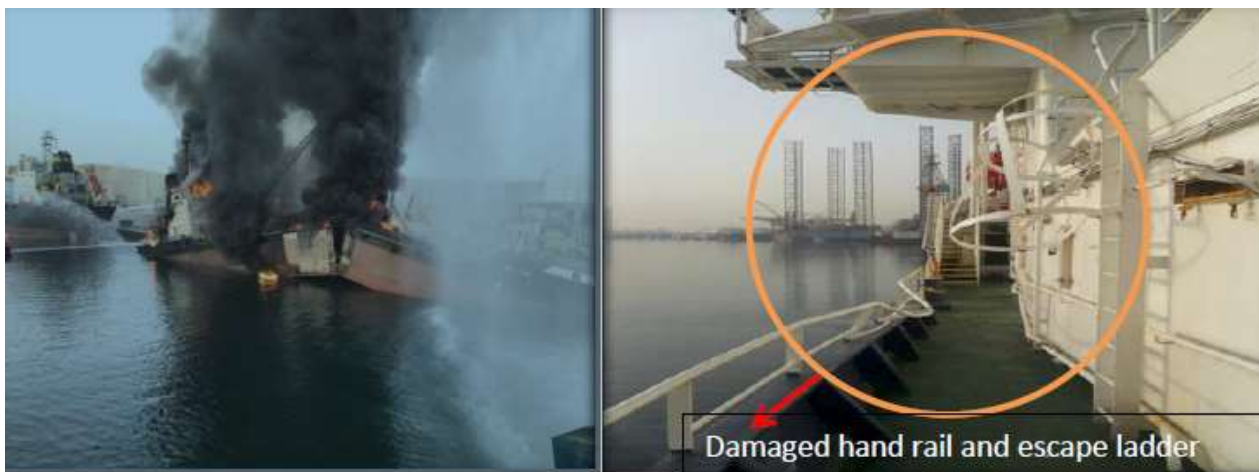
A vessel was double-banked alongside engaged with routine maintenance jobs, when a fire broke out on a vessel transporting a petroleum product which was berthed alongside at a berth 130 m away. There was a massive explosion and the tanker broke in to two. The Port emergency operation room was alerted immediately and the firefighters prevented the blaze from spreading to adjacent ships, and prevented oil spillage.

Our members' vessel sustained damage on the starboard side escape ladder and 5m of railings due to flying debris following the explosion. An emergency muster took place for head count, damage was reported to Port control, and engines were started immediately for emergency cast off to a safe location.

- ◆ Immediate action or response should be in place to cast off the vessel from the area in case of an emergency;
- ◆ All should be vigilant to what is happening on surrounding vessels.
