IMCA Safety Flash 12/18

June 2018

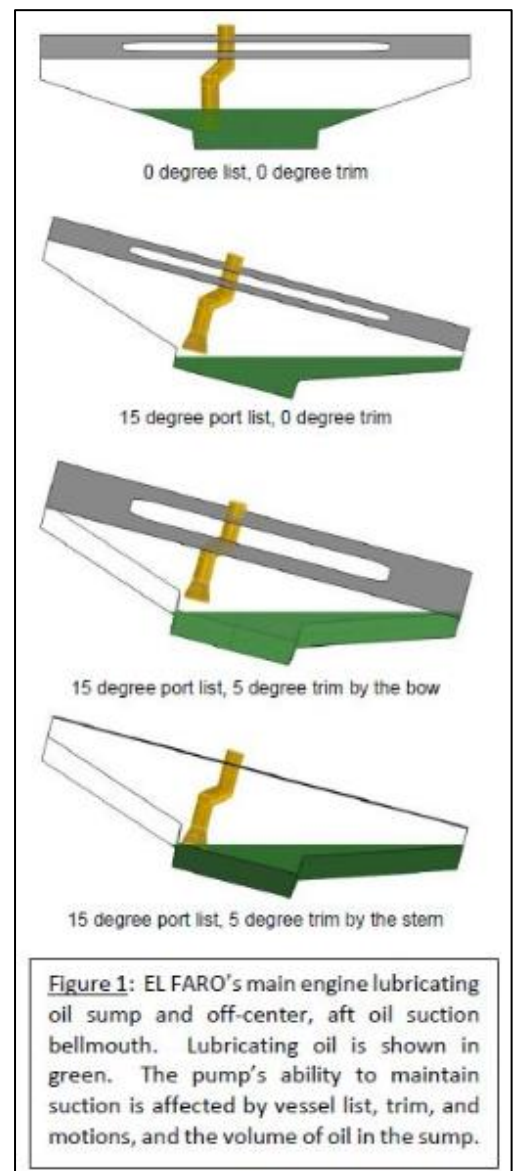
The USCG Marine Board Report on the sinking of the *El Faro* revealed that the loss of propulsion during extremely heavy weather was a contributing factor to the sinking of the vessel. The exact operational status of all vital *El Faro* engineering equipment during the hours preceding the casualty could not be determined. However, bridge audio recordings indicated that the vessel lost lube oil pressure to the main propulsion turbine and reduction gear bearings, resulting in loss of propulsion. It is believed that the vessel’s substantial list, coupled with trim by the bow, caused the main engine lube oil pump to lose suction. A detailed modelling and static analysis of *El Faro*’s lube oil system determined that a severe inclination of the ship, coupled with a relatively low volume of oil in the sump, would likely result in a loss of pump suction.

Figure 1 shows examples (at a constant lube oil volume) of the position of the suction bellmouth relative to the level of lube oil in the sump in several heel and trim conditions. This static model does not attempt to address the sloshing of lube oil in the sump caused by vessel motions.

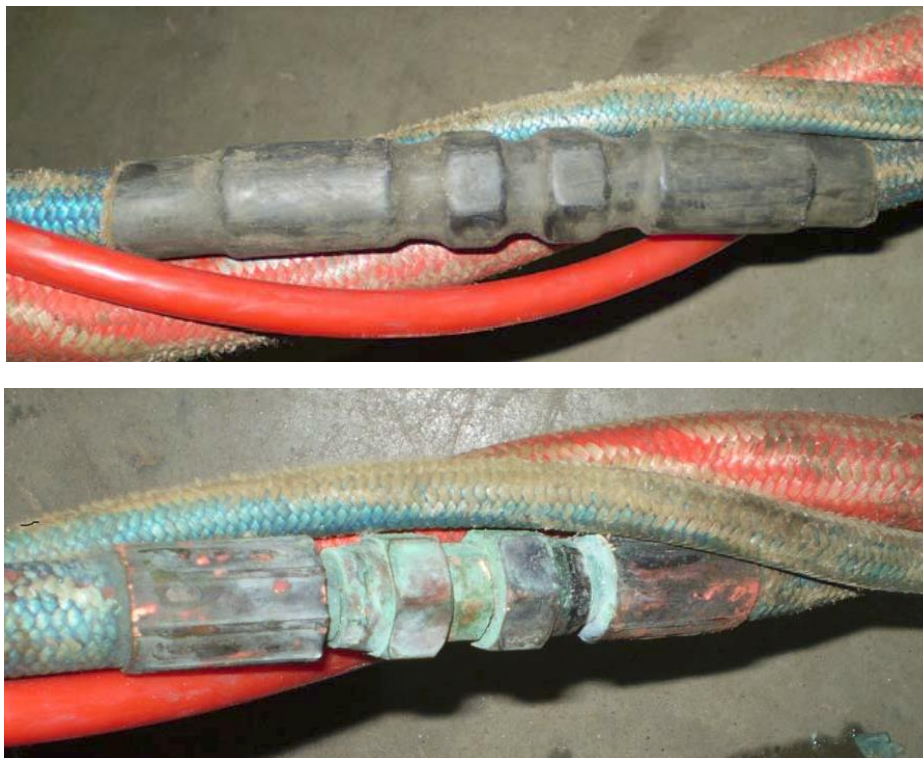
The non-reclaim umbilical was 80m long and had been in service for approximately 5 years; the repair was located approximately 5 meters from the umbilical end. The diver gas supply hose had a maximum working pressure of 1000psi. The joint was formed by standard umbilical end fittings with 6 JIC(F) swivels, connected by a 6 JIC(M) adaptor. The complete joint was then covered with a layer of black heat shrink:

Our member noted that potential existed to trap sea water within the repaired section of the umbilical, resulting in an increased corrosion rate to the fittings forming the joint. No evidence of the repair was found in the planned maintenance system (PMS). The failure of a diver umbilical could have potentially resulted in the loss of gas supply, activation of the secondary supply and the termination of the dive. The worst-case scenario, though unlikely, could have resulted in serious injury or death.

With this information now being circulated, it is hoped that all umbilical users will ensure that sufficient and correct information is made available to all applicable personnel. Our member noted that subject to maintaining diving operations, repairs such as this may take place, but only until a permanent fix is implemented and subject to the completion of a risk assessment and full management approval.

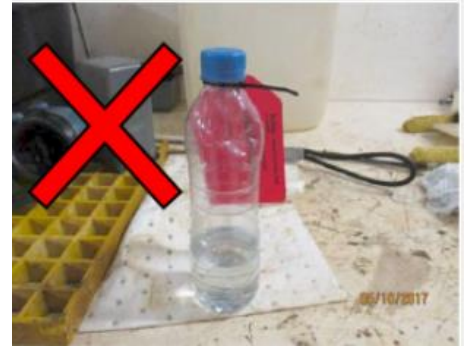
- ◆ Initial investigation revealed that the third-party contractors working onboard had temporarily stored thinner in the mineral water bottle;
- ◆ The third-party contractors were inadequately briefed and behaved in an unsafe way – unsafe practice was used by the third-party contractors.

Crew and third-party contractors were reminded to only store chemicals in proper, appropriately marked containers. Crew were recommended to refrain from drinking water from shared bottles in common places, and to carry their own bottle.
