IMCA Safety Flash 12/20

March 2020

1 Chain Hoist Failure Resulting in a Serious Near Miss

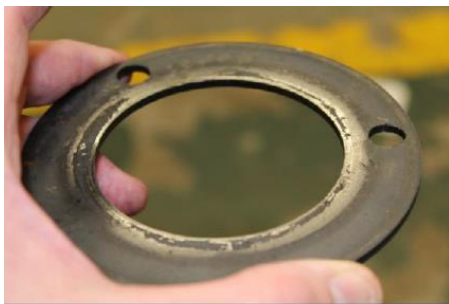
Hoist clutch plate (overload device) showing extensive corrosion on friction bearing surfaces.

The unit was infrequently used and was not subjected to internal inspection; this allowed the internal braking mechanisms to suffer corrosion, and this prevented the braking function operating properly when under load.

The above resulted in the clutch failing to hold the load, lowering the charge air cooler to the engine room deck plating in an uncontrolled and rapid manner.

- ◆ Full inventory made of all powered hoists (pneumatic and electric) to include both chain hoists and wire hoists and not restricted to permanently installed units;

- ◆ Additional relevant maintenance scope added to planned maintenance scopes for all these devices;
- ◆ Powered hoists fitted with overload devices should be set at working load limit +10% and checked annually as part of the planned maintenance regime.

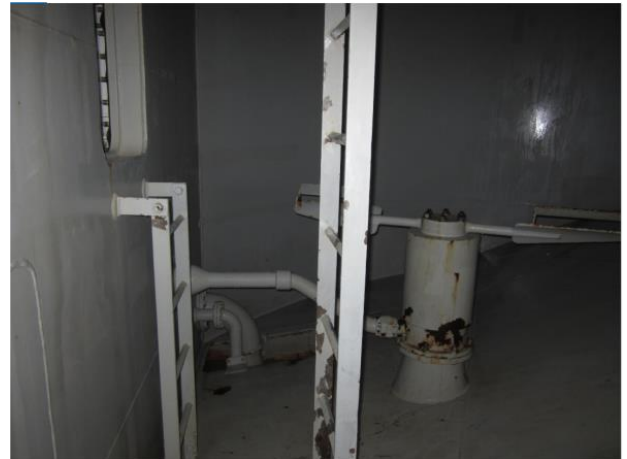
The contractor came on-board to wash mud tanks with a high-pressure washer. Mud tanks on the vessel had been emptied earlier in the day and agitators were running until the tanks were empty. The agitators were stopped on bridge IAS only and had not been isolated or locked out. As the last of three tanks was being washed, the agitator (42rpm) suddenly started with one person inside the tank. The person was hit by the agitator paddle in his lower back and fell to the tank floor. He had his back to the agitator at the time and didn't notice it starting. He managed to climb out of the tank by himself and was transported to hospital by ambulance. He was discharged the same day with bruises and one broken rib.

Picture of bridge IAS control left and properly isolated control valve hydraulic flow right

- ♦ **Physical verification** that safety isolations and barriers, controls and lockouts are in place – double check;
- ♦ Focus on how to **improve compliance with existing procedures**;

- ◆ **Review relevant risk assessment;**
- ◆ **Better communication** between bridge department and engine department, particularly relating to tank maintenance operations;
- ◆ Improve isolation routines to include lock and tag and issuance of isolation certificate;
- ◆ Third-party tank washers will **improve their procedure** to include physical verification that agitators are properly isolated before entering tank.
