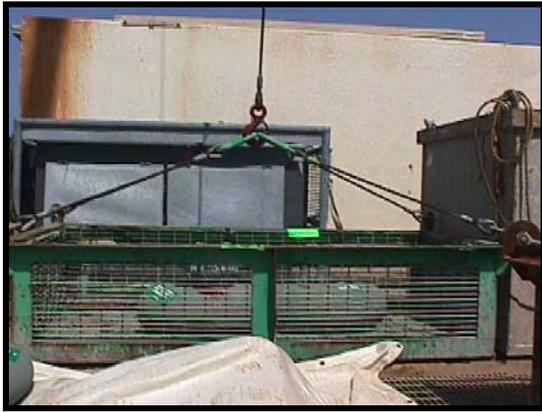
The cargo basket slings were too short to be utilized with a single point hookup causing an unstable load and one ring to pull through the hook;

The minimum recommended sling angle (60 degrees) between the sling and the load was not maintained. Actual angle was about 35 degrees;

Figure 1: Similar cargo basket with incorrect sling angle.

Utilisation of two-part slings when lifting similar cargo baskets;

Maintenance by crane operators and riggers of a minimum angle of 60 degrees between the sling and the load;

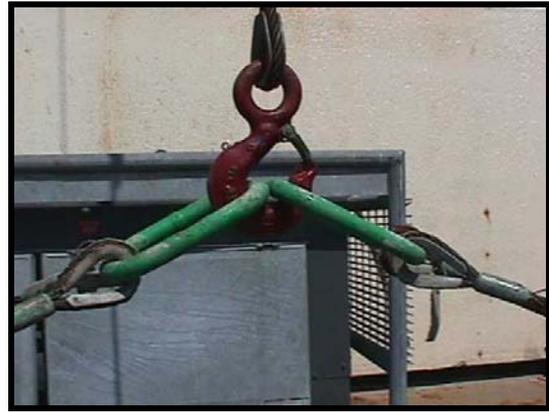
While making a lift from a boat to the platform, the operator picked up a cargo basket and proceeded to swing away from the boat. While swinging the basket, the cargo suddenly shifted causing the O-ring on the latch side of the hook to pull through the latch. When the O-ring pulled through the latch, the two part sling came unhooked from the stinger and the basket dropped on one side resulting in dropping some of the cargo into the water.

Figure 2: Similar hook point with incorrect sling angle=hazard.

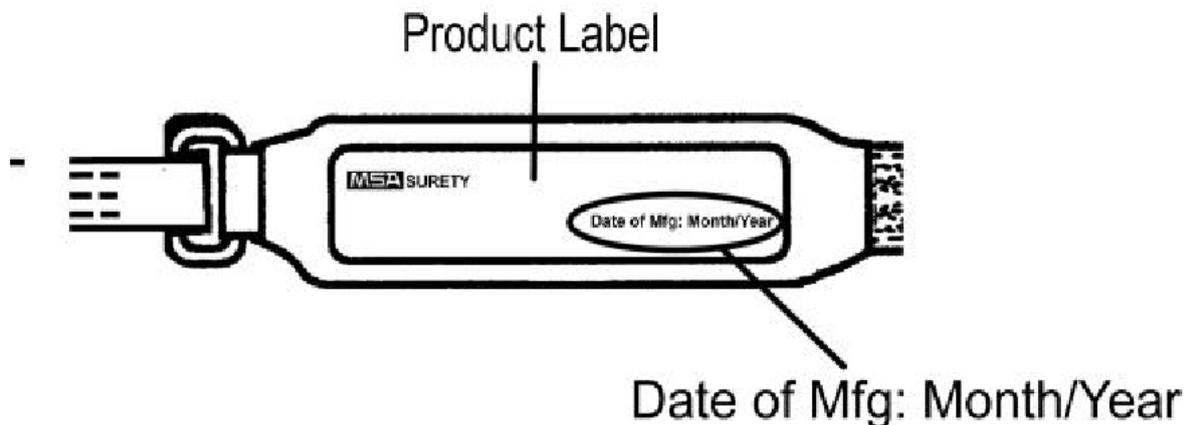
Upon examination of the lanyard involved in this incident, we found that there was an error in the stitching that secures one end of the shock absorber to the remainder of the lanyard. Since this joint is glued in preparation for applying the stitches and the shock absorber sleeve covers this area, this lanyard appeared functional. Even if the user tugged sharply on the lanyard, the assembly would still have appeared secure. However, a lanyard in this condition is not functional and provides no fall arrest protection to the user.

Inspect all Sure-Stop shock absorbers to determine the date of manufacture. The date of manufacture is located on the label affixed to the shock absorber sleeve (see diagram below). If this date is within the affected range or if the date cannot be determined, the shock absorber is subject to this notice and must be removed from service. As a reminder, this notice applies only to MSA Surety Sure-Stop shock absorbers and does not apply to products labeled “Surety Manufacturing & Testing LTD.”

Contact MSA Customer Service to make arrangements for the return and inspection of all affected products. Customers in Canada should call 1-888-396-1067. Customers in the United States should call 1-800-MSA-2222.
