## I Faulty Directional Flow Arrow on Valve

## 2 Incident Involving a McKissick N419 Snatch Block

## 3 Incorrect Pressure-Rated Manifold Fitted to Diver's Bail-Out

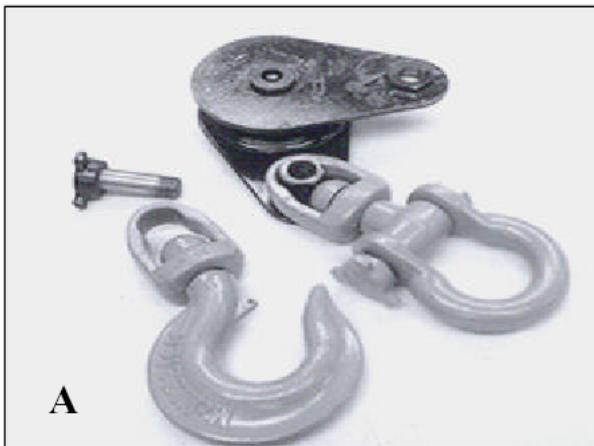
Correspondence between IMCA and the manufacturer showed that blocks produced prior to 1991 allowed removal of the head fitting, albeit after removal of the hairpin and bolt and rotation of the head fitting to an extreme position. Blocks produced since 1991 have a feature that requires a deliberate component removal to allow the head fitting to be removed when the block is open. There is a possibility that old, pre-1991 versions of the block are still in use.

*The N419 "Old Style" was designed to allow interchangeable fittings as can be seen in the above photograph. The design utilised a "triangle" shaped spool that allowed the head fitting to be rotated to an extreme position and removed after the side plate has been opened.*

The company involved has banned the use at its worksites of the McKissick N419 Snatch block in figure A, whose design allowed for interchangeable head fittings as depicted in figure A.

As a result the company will not use the 'old style' snatch block (figure A) in its operations.

- ◆ Check all snatch blocks on installations, and remove from service the 'old style' McKissick N419 snatch block;
- ◆ For applications where this type of device is required, ensure that the current McKissick N419 snatch block is used (Figure B);
- ◆ Make sure that all inventory lists of loose lifting appliances are updated with necessary information

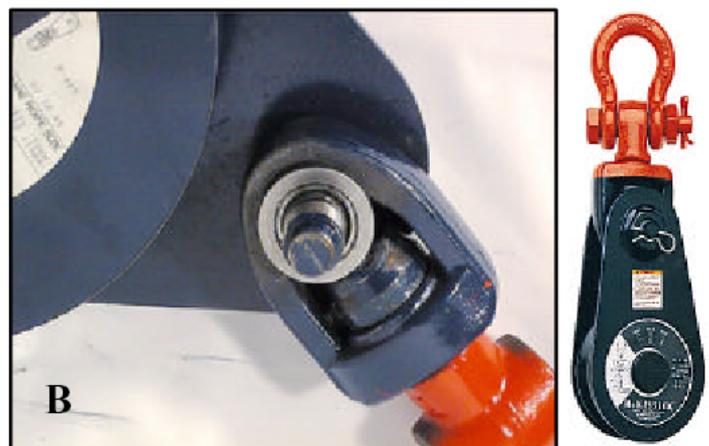
*The head fitting on the current N419 McKissick Snatch Block is secured to the block with a threaded round nut that is staked to the spool. This feature prevents the head fitting from being removed from the block, regardless of the position.*

The Crosby Group Inc. (manufacturer of the McKissick N419) has since 1991 added features to retain the head fitting regardless of the position of the block (Figure B). Both snatch blocks carry the same name, but production of the snatch block in figure A was discontinued in 1991.

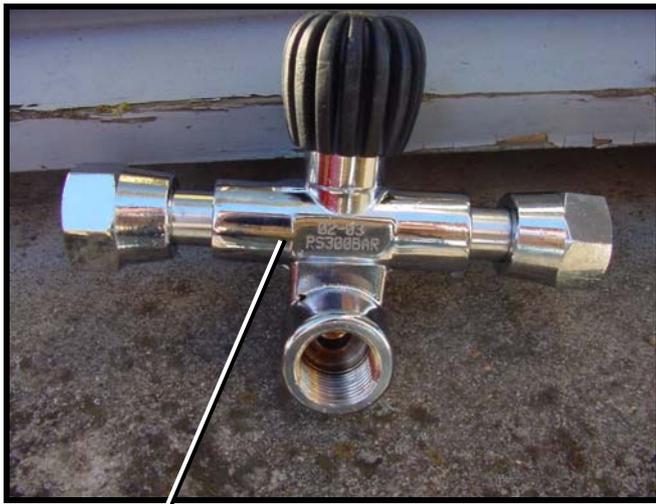
*Pressure rating of 300bar marked on manifold*

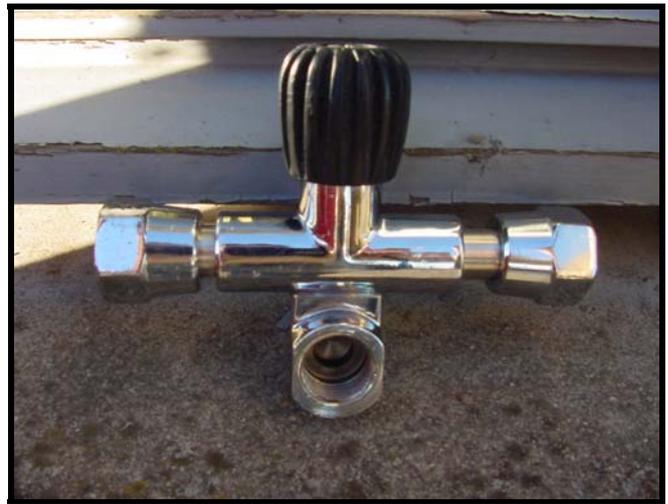
A member has reported an incident in which a manifold rated to 232 bar was fitted to a twin cylinder 300 bar bail-out.

The manifold in question had no pressure rating markings, as shown in the first picture below. The correct manifold is easily identifiable as it has its pressure rating marked clearly about the DIN female connection, as shown in the second picture.

*No pressure rating marked*

- ◆ All bail-out assemblies are to be checked by dive technicians to ensure correctly rated manifolds are fitted;
- ◆ Vessel-held stocks of bail-out manifolds are to be checked to ensure that only correctly rated and marked manifolds are in stock. Any unmarked manifolds which are identified are to be quarantined and sent back to the company's equipment department
