1 Flash Fire in Gas Supply Equipment Onboard Dive Support Vessel

2 Open Lifeboat – Corroded Tie Band Side Plates

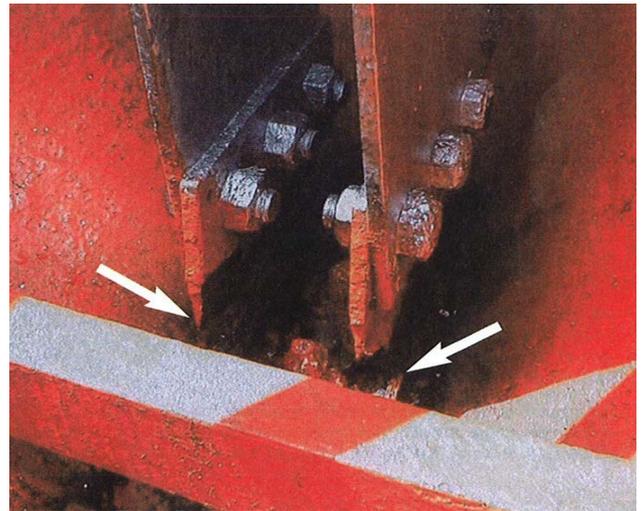
It is believed that the corrosive environment at the bottom of the lifeboat, combined with lack of maintenance over time, led to extensive corrosion of the tie bands. Access to them can be difficult, hampered by the presence of debris and bilge water.

Further tests were made of other similar lifeboats, and the tie bands on these lifeboats were also found to be heavily corroded. Though well painted and appearing to be well preserved, it was clear that these were in poor shape.

Figure 1 - Serious corrosion of tie band side plates at connection at bottom of lifeboat

- ◆ Lifeboat tie bands, hooks and release systems should be inspected and maintained according to the manufacturer's recommendations, and be included in the vessel maintenance schedule;
- ◆ All items encompassed by scheduled inspections should be properly examined on a regular basis;
- ◆ Access to, and cleaning of, the tie bands side plates should be made prior to inspection of lifeboats;
- ◆ Special attention should be paid to the cleanliness of lifeboat bilges;
- ◆ Corrosion damage of this sort may also occur on totally enclosed or partially enclosed lifeboats.

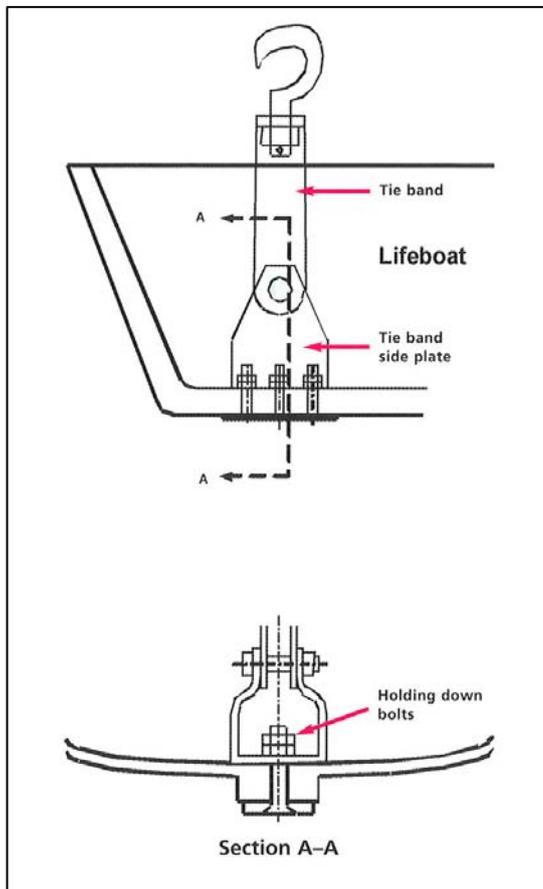
Figure 2 - Tie band side plates connected to the lifeboat with three bolts and with one counter-nut per bolt
