IMCA Safety Flash I3/08

August 2008

I Faulty Governors

2 Seaeye ROV Tether Arcing Incident

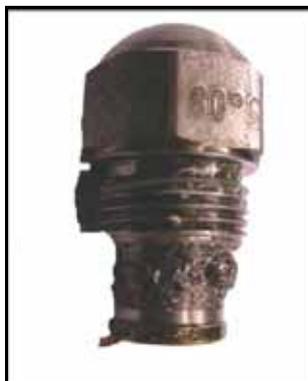
- ◆ Broken check valves were found in the governor oil pumps of both units;
- ◆ The oil spray nozzle filters were blocked in both units. Small metal particles and pieces of check valve were identified;
- ◆ The filter in the oil line to the torque motor was blocked in both units. Small metal particles and pieces of check valve were identified;
- ◆ Foreign metal particles were found inside one of the governor units. These particles had caused the filters to become blocked, preventing oil flow to the hydraulic valve.

Blocked oil spray nozzle

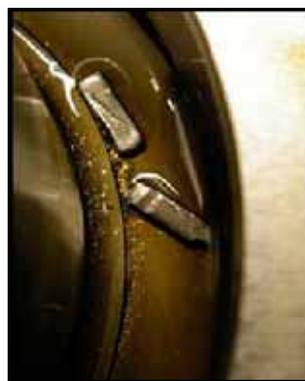
Although the governor can operate without the check valve, the pieces of broken valve were carried in the hydraulic system. This caused malfunction of the hydraulic valve.

Broken check valve

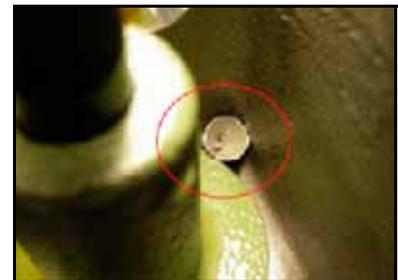
Foreign metal
