IMCA Safety Flash 13/11

November 2011

I Near Miss: Dropped Taut Wire Clump Weight

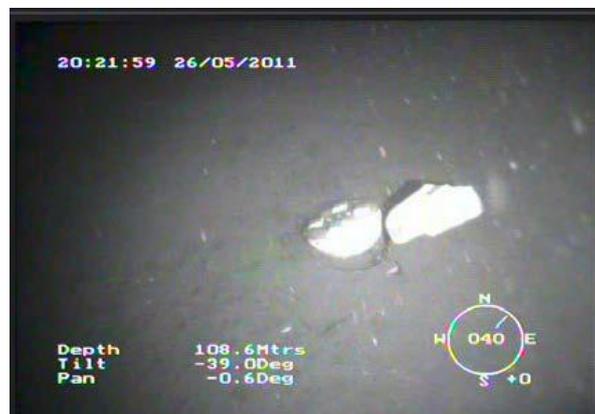
Clump weights landed on seabed

- ◆ A worn wire guide with sharp edges caused unnoticed damage to the taut wire, resulting in the wire parting;
- ◆ Procedures for protecting divers and subsea assets from dropped objects were properly followed and this prevented a potentially much more serious incident.

- ◆ The existing starboard taut wire was replaced in its entirety in case further damage had been sustained;
- ◆ The damaged wire guide was assessed and temporary repairs were undertaken. A complete new unit would be fitted at the next opportunity (dry dock);
- ◆ There would be a review of relevant inspection and maintenance routines.

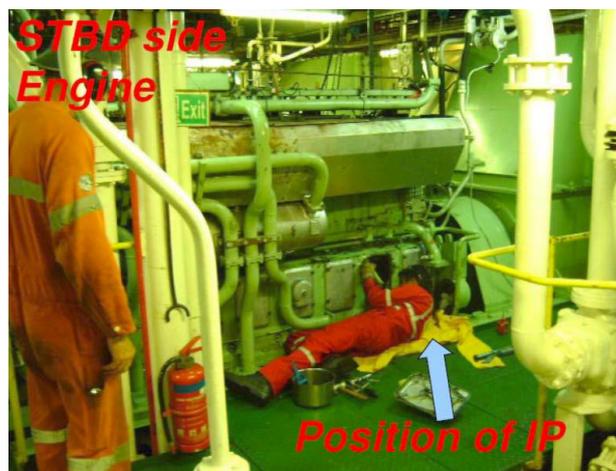
Position of the injured person at the time of the incident (re-enactment)

- ◆ Incorrect positioning of hands
 - The injured person's thumb was in the pinch point during movement of the load.

- ◆ Review relevant task related risk assessments to ensure all associated and potential hazards are clearly identified and recorded;
- ◆ Ensure all lifting equipment is correctly rated and inspected for the intended task prior to use;
- ◆ Communicate the importance of toolbox talks and safe working practices to ensure key hazards are identified, discussed and addressed.

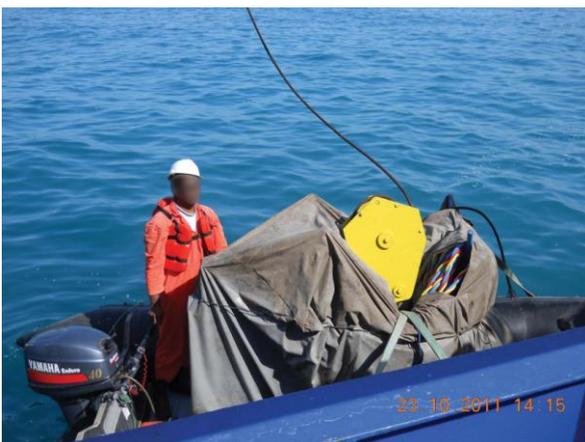
A member has reported an incident in which a crane winch wire parted and caused a crane block to fall 13m into a small boat. The incident occurred during the recovery of a small boat used by divers. When the small boat had been lifted approximately 0.5m above the water, the winch wire parted approximately 13m from its working end (the end made fast to the head of the jib). As a result, the block fell down into the boat and missed a crewman by a metre or so. There were no injuries or damage. However, this near miss incident can be regarded as potentially catastrophic.

Crane block landed in small boat

- ◆ If wires are required to be lowered into the water, then those lengths of wire which have been submerged should be thoroughly washed with fresh water ('freshed-off') on a daily basis after completion of work;
- ◆ A review of the type of grease/protective coating applied to the wires should be undertaken in order to confirm its suitability for protection of wires which become submerged on routine basis (reference to the crane manufacturer's manual might be of value in this regard);
- ◆ Additional inspection regimes should be considered to allow for the fact that parts of the fall wire are exposed to complete submersion from time to time;
- ◆ Personnel should not be in the small boat at the time of lowering or recovery, unless it is absolutely essential and then only providing suitable and stringent control measures have been put in place.

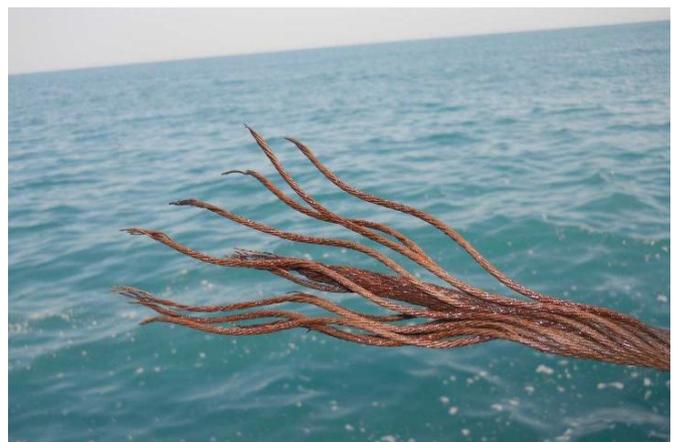
Parted winch wire

- ◆ The winch or fall wire parted approximately 13m from its (working) end due to lack of appropriate maintenance and the absence of a thorough inspection regime.
