## IMCA Safety Flash 13/13

September 2013

### I Near Miss: Un-noticed Expiry and Deterioration of Carbon Dioxide Absorbent Material

## 5 Dropped Object Near Miss: Wind Sensor

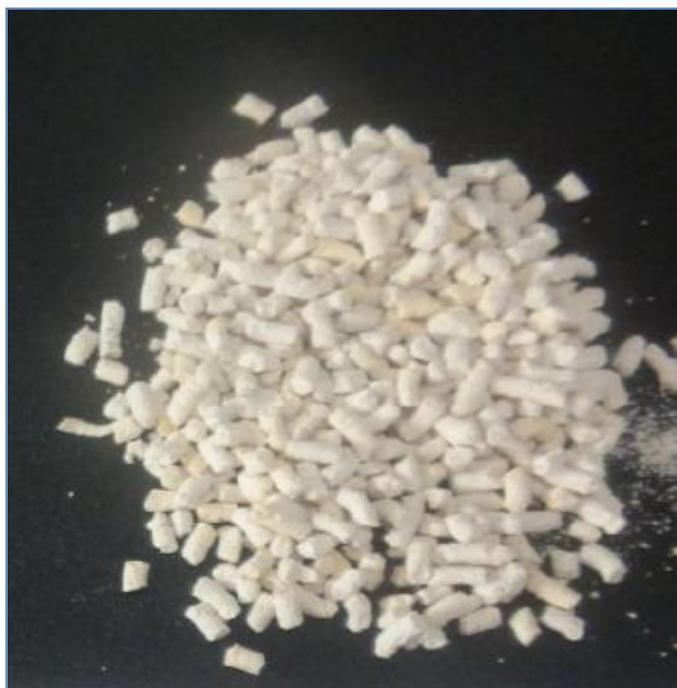
- ◆ 23 of the 27 drums of CO<sub>2</sub> absorbent received were found to be discoloured and had an acidic odour;
- ◆ Some of the containers did not have labels attached: some were past their "use by" date, and some were still in date;

- ◆ The caps of the containers did not seal correctly, exposing the material to salty moisture, extreme heat and high humidity (tropical environmental conditions);

Figure: Showing the discoloured CO<sub>2</sub> absorbent material (note flecks of stained or off-white pellets).

- ◆ All CO<sub>2</sub> absorbent material found to be discoloured or expired was immediately removed and replaced with fresh supplies of in-date absorbent material;
- ◆ Guidance on the correct handling and storage of CO<sub>2</sub> absorbent, including guidance on delivery inspection, was prepared and issued;
- ◆ Guidance on the management of materials that have a shelf life, and are subject to expiry dates, was prepared and issued.

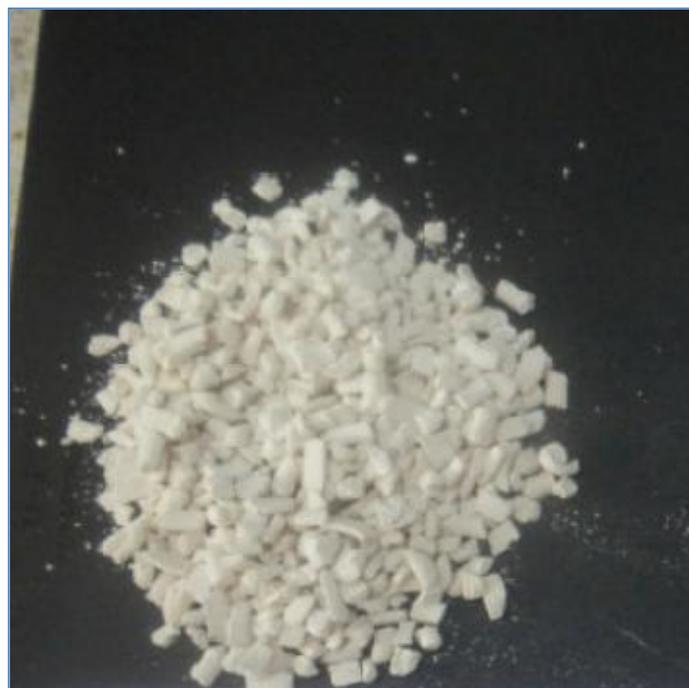
Figure: Showing good CO<sub>2</sub> absorbent material (note white pellets).

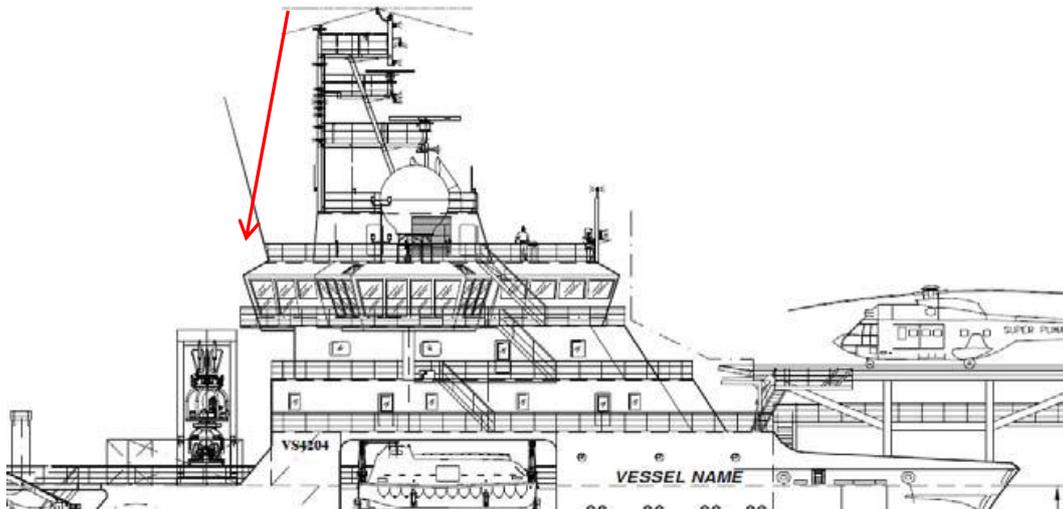
A member has reported an incident in which part of a plastic fixed unit wind sensor weighing 0.8kg dropped 10m to the top of the bridge roof. The wind sensor fell from the top of the aerial deck to the top of the bridge deck. At the time of the incident there were no works taking place on the ROV deck or on the roof of the bridge; there were no injuries. Weather conditions at the time were gusting southerly winds at 11 m/s or 21.3 Knots, and the vessel was heading into the wind.

Figure 1 - Showing where wind sensor fell, from the top of the aerial deck to the top of the bridge deck

- ◆ Ensured that all vessel departments have a robust DROPPED Objects inspection regime in place;
- ◆ Ensure all equipment at height is in a planned preventative maintenance program;
- ◆ Check fixed unit equipment to ensure that integral fixings are in place (if possible check securing means).

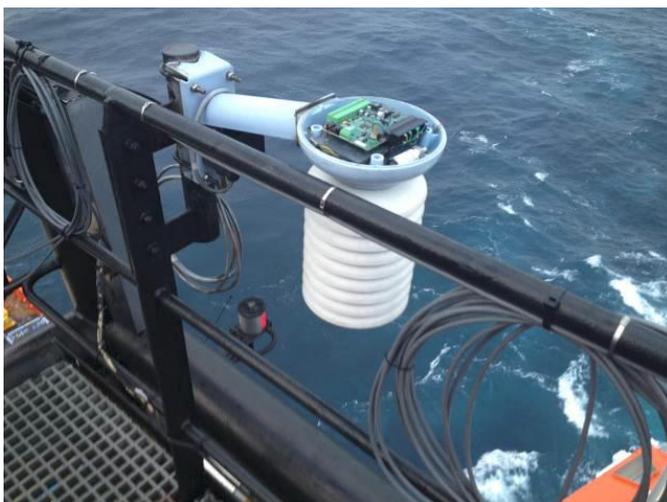
Figure 2 - showing wind sensor in situ without its lid

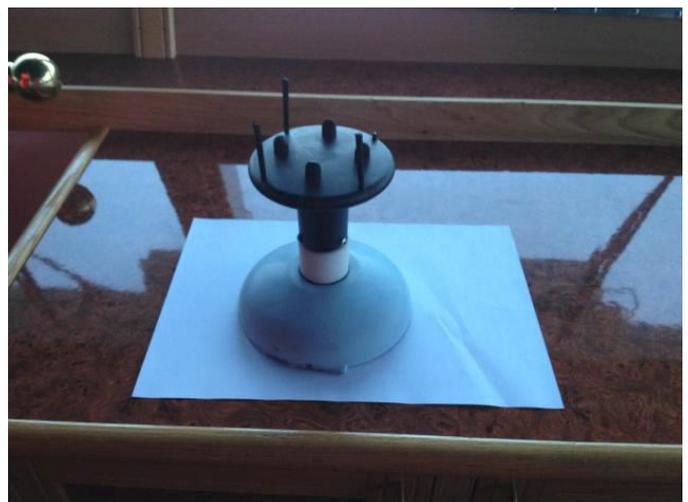
Use of the “DROPS calculator” for this dropped object showed that the potential had it actually hit a person was for a major LTI.

Figure 3 - Showing the lid of the wind sensor (weight 0.8kg)
