IMCA Safety Flash 13/15

September 2015

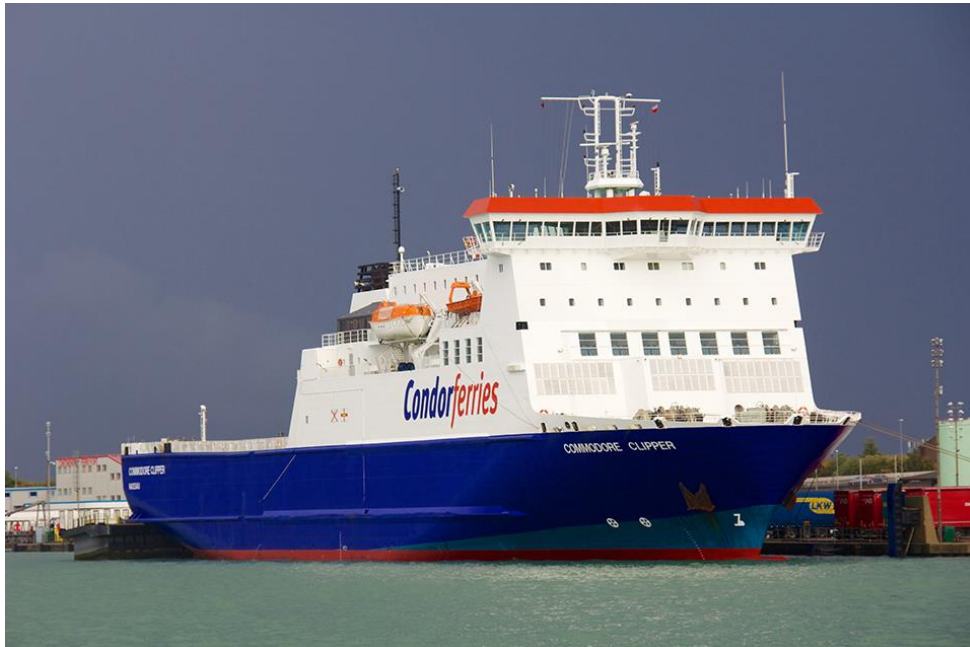
The UK Marine Accident Investigation Branch (MAIB) has published a report into the grounding and flooding of the ro-ro (“roll on roll off”) ferry *Commodore Clipper* in the Channel Islands in July 2014. The vessel raked over two granite pinnacles at full sea speed of about 18 knots; its hull was breached and seawater flooded into double-bottom void spaces. The grounding caused a noisy and shuddering vibration, but the crew did not immediately check for damage.

The report identifies the following safety issues:

- ◆ Insufficient passage planning meant that the bridge team were unaware of the limits of safe water where the vessel was heading, and so headed into danger without appreciation of the navigational risk. A number of issues were not properly considered:

- The very low tide;
 - The effect of vessel ‘squat’ in shallow water at high speed;
 - The accuracy of the chart data.
- ◆ The possibility that the vessel had grounded was denied. In the circumstances of a shuddering vibration, it is important that the crew establish the state of their vessel by searching for damage;

- ◆ The repetitive nature of ferry operations can induce a degree of complacency when planning;
- ◆ The electronic navigation system was not being utilised effectively because safety settings were not appropriate to the local conditions, warnings were ignored and the audible alarm was disabled;

- ◆ The local responsible port authority did not have an effective risk assessment or safety management plan for the conduct of navigation in its statutory pilotage area.

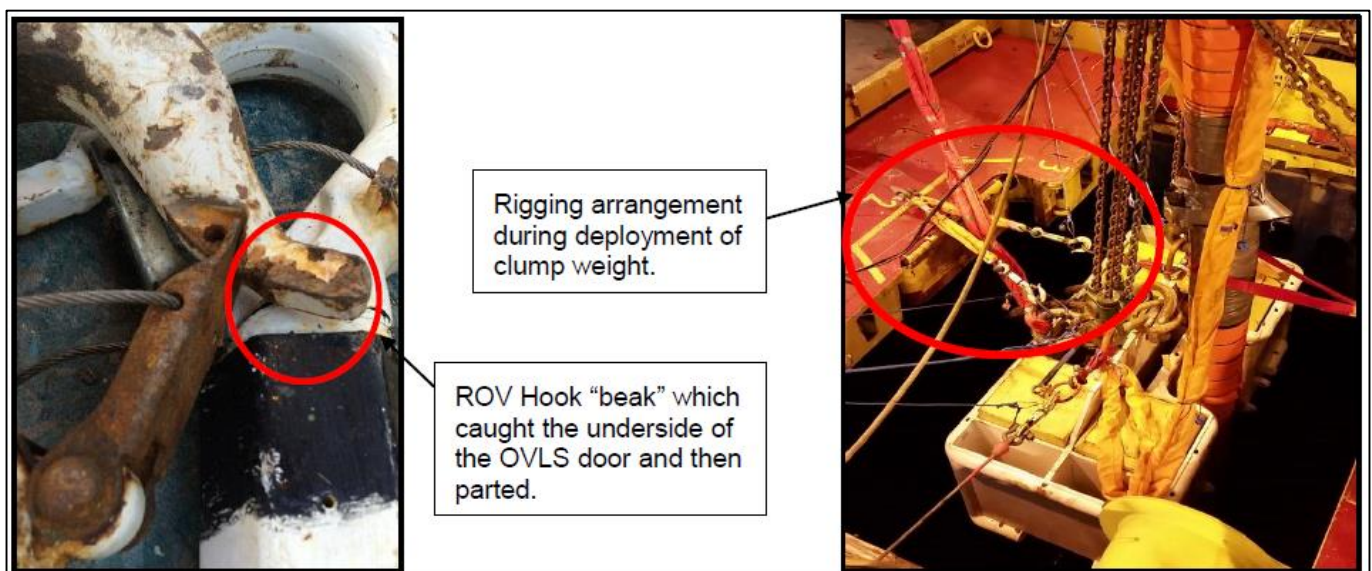
A member has reported an incident in which a rigger was struck by a winch wire and sustained a fractured arm. The incident occurred during attachment and deployment of a clump weight to a riser through the moonpool. The vessel was in the process of installing a riser as part of a large field development in 400m water depth. In order to prevent damage to the riser during deployment of the clump weight, a hold-back winch was connected to it via a two part bridle and ROV hooks. The winch would then pull the clump weight forward to allow it to be lowered without clashing with the riser.

Once deployment of the clump weight had come to a stop, tension was released from the hold-back winch, and a rigger was instructed to enter the work area and disconnect the two slack ROV hooks by pulling on release ropes. The deck supervisor then signalled for the winch operator to commence hoisting up on the winch. It was during the winch hoisting movement that the “extension beak” on one of the ROV hooks got snagged. The beak parted which resulted in the two part bridle complete with ROV hooks and winch wire flying up and striking the rigger knocking him off his feet to deck.

- ◆ Lack of hazard awareness and consequence for a routine task;
- ◆ Low risk perception to the task because of other associated higher risk tasks in the same area;
- ◆ The need to identify and mitigate all risks associated with a Management of Change (MoC) process;
- ◆ The Management of Change process should recognise where appropriate the introduction of required additional personnel into the task.

Showing ROV hook beak (left) and rigging arrangement (right)

- ◆ Deck review to identify potential snap back zones and all lines of fire zones for all winch operations;
- ◆ Review of where crew are standing whilst doing this particular job;

- ◆ Further crew briefings covering:
 - Toolbox talk training and workshops
 - Line of fire awareness briefing (IMCA);
- ◆ A review of the Management of Change process and Job Risk Analysis for this operation;
- ◆ Assessment of suitability of ROV hooks for deck rigging activities;
- ◆ Assessment of task procedures and risk assessments – are they available, understood and do they reflect the way the job is actually being carried out;
- ◆ Consideration of possible negative or unforeseen effects of changes made to improve how a task is done;
- ◆ Consideration of the required sequence of activities (e.g. who, what, when?) and agreement and confirmation of readiness before starting work;
- ◆ Identification of any operations/tasks which could expose personnel to a “line of fire” risk.

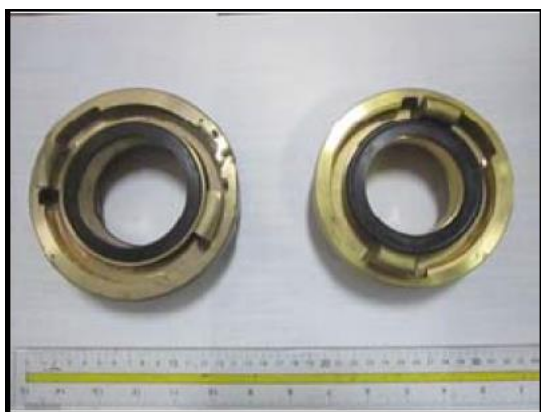
A member has reported an incident in which replacement fire hydrants were found to be fitted with incorrect coupling sizes, leading to them being incompatible with fire hose couplings. This would have severely impacted the firefighting capabilities of the vessel. The incident occurred following a number of earlier occasions in the previous five years in which fire hydrant valves in the accommodation had been found leaking. Replacement hydrants were ordered and fitted, but the couplings were found to be incompatible. It was found that the coupling on the hydrant valve in the port side forward thruster room did not fit the adjacent fire hose coupling. The hose coupling measured 65mm and the hydrant coupling measured 80mm.

65mm hose coupling on right and 80mm hydrant coupling on left

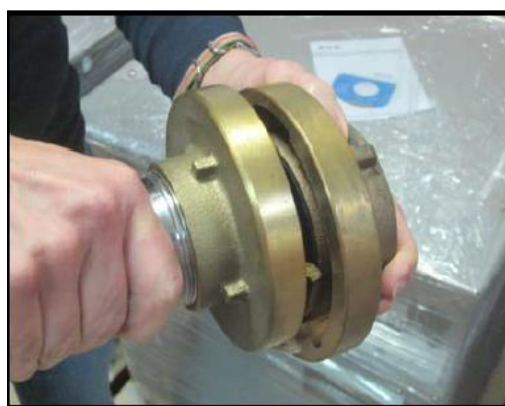
80mm hydrant coupling not compatible with 65mm hose coupling

- ◆ The hydrant/hose coupling incompatibility was not followed up in a timely manner. Six days elapsed between the discovery of the incompatibility and a Hazard Observation being made;
- ◆ A total of thirty hydrant couplings were found with 80mm couplings fitted instead of 65mm couplings. Had there been a fire these thirty couplings (incompatible) on the fire hydrants would not have been serviceable;
- ◆ Firefighting capabilities were not entirely restricted as the outside accommodation fire hydrants on each deck were still pressurised and compatible with the fire hoses onboard and the shipboard accommodation sprinkler fire suppression system was available.

- ◆ The need for vigilance and the importance of thorough inspections and correctly completing all checklists, including examination for missing or improperly installed components:
 - Lack of attention/due care/poor work practice
 - Failure to identify incorrect fire hydrant valve couplings during installation of valves
 - The thirty incompatible fire hydrant valve couplings were fitted in May 2014 and this had not been spotted for many months, despite maintenance, safety inspections and drills;
- ◆ When incidents, near misses, issues or concerns are reported, they should be followed up in a timely manner.

Members may wish to check their own fire-fighting equipment, to carefully and thoroughly inspect all equipment when first received, and to ensure that during fire drills, hoses are properly run and connected to hydrants, including in the accommodation areas.

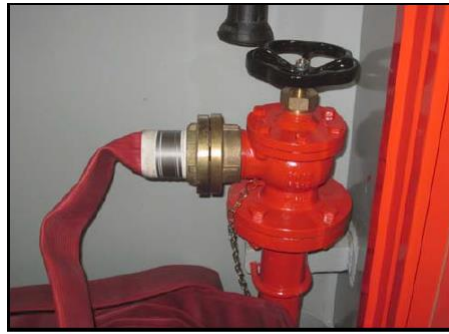
Fire hydrant with correct 65mm coupling
(compatible with 65mm hose coupling)
