IMCA Safety Flash 13/20

April 2020

Summary

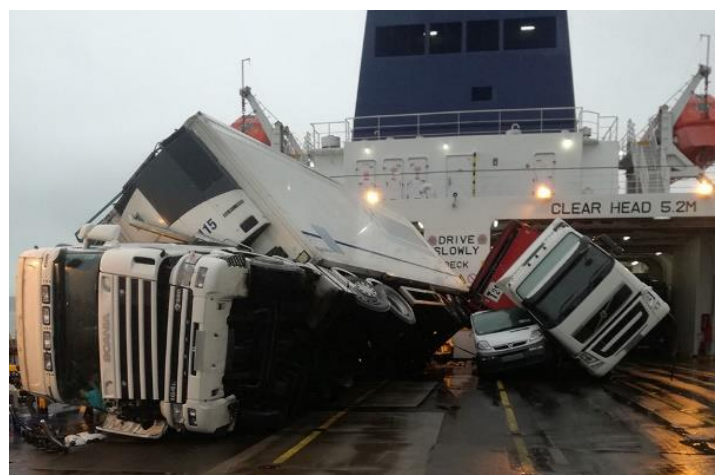
A roll-on/roll-off (ro-ro) passenger ferry rolled heavily in very rough seas and very high winds during its voyage from Larne, Northern Ireland to Cairnryan, Scotland. The violent motion caused several freight vehicles to shift and nine to topple over. This resulted in damage to 22 vehicles, some damaged severely. At least six freight vehicle drivers had remained in their cabs on the vehicle decks during the crossing and four were found in cabs of vehicles that had toppled over. One driver was trapped and had to be freed by the emergency services when the ship arrived in Cairnryan.

- ◆ The route being followed had not been adjusted sufficiently to mitigate the effects of the sea conditions and reduce the likelihood of severe rolling;
- ◆ The sea fastenings for the vehicles were insufficient for the forecasted weather conditions;
- ◆ The vessel's approved cargo securing manual provided limited guidance to crew;

- ◆ Drivers remaining in their vehicles during the ferry's passage, in contravention of international regulations and company policy.

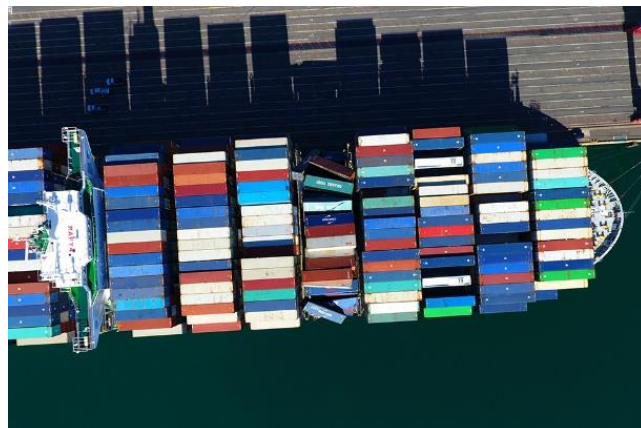
A container ship unexpectedly rolled 20° to starboard, paused for several seconds, then rolled 20° to port. The ship was experiencing very heavy seas in the North Pacific Ocean while on passage from Xiamen, China to Los Angeles, USA. In daylight the following morning, the crew found that three container bays had collapsed, with 137 containers lost overboard and a further 85 damaged.

- ◆ There were non-standard 53ft containers with reduced structural strength;
- ◆ There were inaccurate container weight declarations, mis-stowed containers and loose lashings.

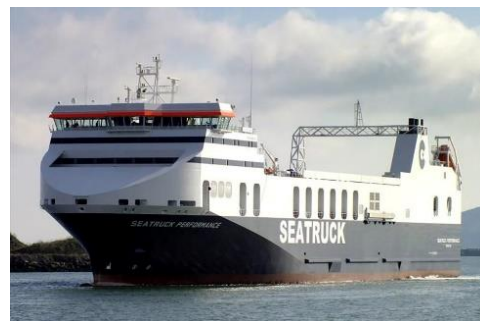
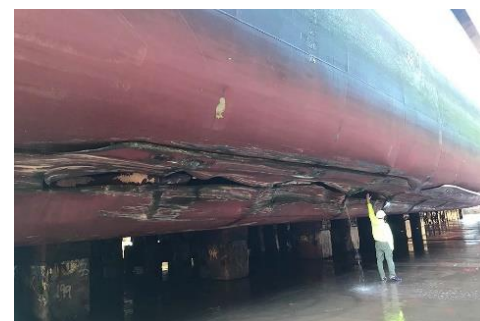
This roll-on/roll-off (ro-ro) freight vessel ran aground while transiting the Greenore Channel in Carlingford Lough, Northern Ireland, soon after departing Warrenpoint for passage to Heysham, England. The ferry quickly developed a 7° list but was able to return to Warrenpoint without assistance. There were no injuries to its 11 passengers and 22 crew, nor any pollution. Subsequent survey and dry dock identified that a tank and a void space on the ferry's port side had been breached. The ferry was out of service for 3 weeks.

- ◆ The potential for **squat** was not considered when calculating the ferry's under keel clearance before departure, or when considering its speed;
- ◆ Shallow water effects were experienced as the ferry approached the intended alteration, which affected both heading and speed, due to the under keel clearance and the proximity of a charted bank on the south side of the channel;
- ◆ The Master was steering by hand, which reduced his ability to maintain an overview of the situation, and a lack of support from the bridge team made him a single point of failure;

- ◆ The navigational practices being used by *Seatruck Performance's* bridge team did not fully incorporate the electronic aids available and were insufficient to assure the vessel's safe outbound passage, at night.

- ◆ Raise awareness of shallow water effects and improve on-board passage planning;
- ◆ Take further measures to optimise the use of electronic navigation systems and enhance bridge resource management training.

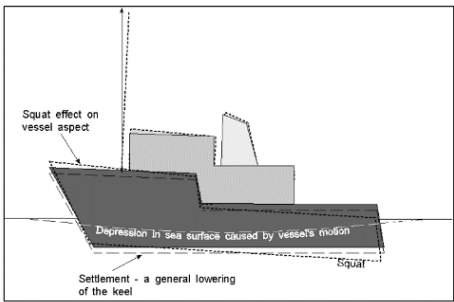
Figure 3 – Squat and settlement effects

'Squat' refers to changes in trim of a vessel underway and is generally marked by a lowering of the stern and a rise at the bow. Major factors that influence squat are hull shape, location and mass of load or ballast, vessel speed, and depth of water under the keel.

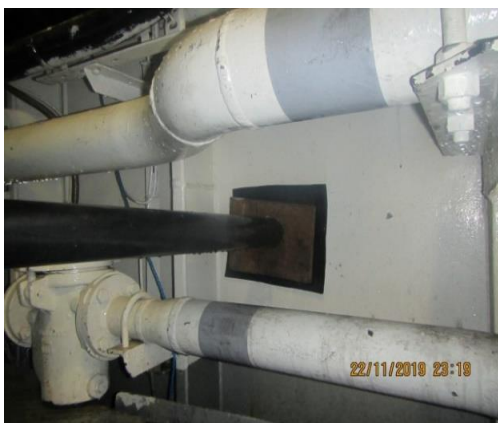
A vessel suffered flooding and loss of integrity, caused by sea water ingress into the engine room, due to a hole developing in the box cooler bulkhead.

A high level bilge alarm occurred at night. It was found that there was significant water ingress in the engine room. The Master raised the alarm and the crew were mustered. A little over an hour later a hole with diameter 1cm was found on a box cooler bulkhead. The flooding was brought under control using hand pumps. The Master and Chief Engineer assessed the situation as an emergency and decided to return the vessel to port immediately. Continuous monitoring and double watch was maintained in the engine room.

Water ingress temporary repair

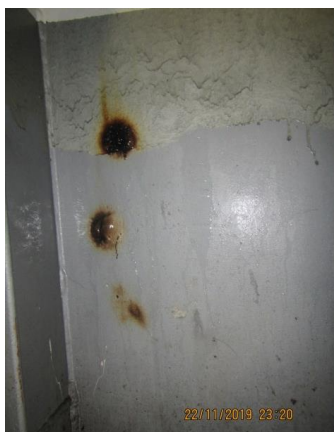
Showing condition of sea chest

Subsequent inspection in dry dock revealed that the aft bulkhead and inboard longitudinal bulkhead for the aft of the two forward box coolers had more corrosion problems than the one hole in the aft bulkhead. The inboard longitudinal bulkhead was severely pitted over (approximately) its upper half. The aft bulkhead had isolated areas of deep corrosion, also predominantly at its upper half. All other sea chests were internally examined, and no substantial corrosion found.

There was no indication at survey that the insulators of the copper anodes of the marine growth prevention system (ICAF) had failed or that the power supply wires had failed leading to the possibility of stray currents from the system. It was not possible to verify the correlation between the reported malfunction of the ICAF system (marine growth protection) and the observed substantial corrosion.

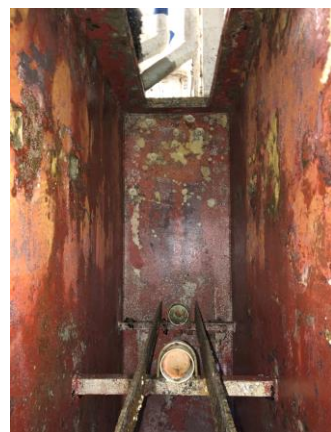
Additional anodes installed

- ◆ Following repairs, additional sacrificial anodes were installed;
- ◆ Possible installation of an impressed current cathodic protection (ICCP) system, which further improves corrosion protection.
