## IMCA Safety Flash 14/08

September 2008

### I Serious Injury Incident During Routine Crane Maintenance

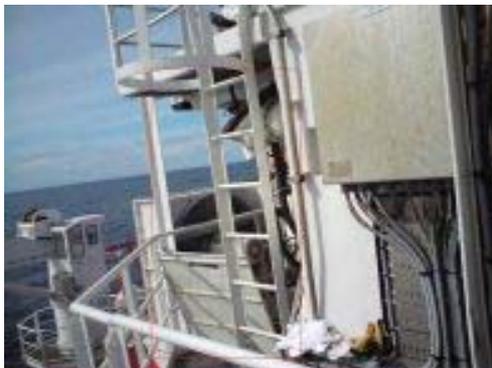
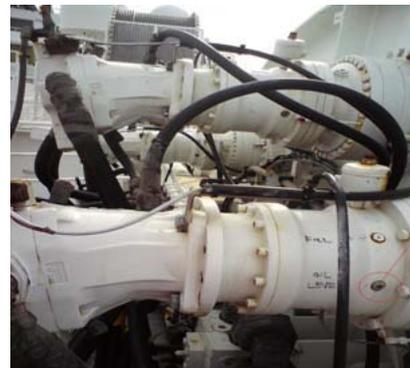
Access to the crane cab level was via a stairway from the main deck, leading to a vertical ladder which then gave access to the upper crane platform. At the time of the incident, routine planned maintenance was being carried out on the crane winch pumps on the upper crane cab level, as shown below:

A crew member was carrying out routine maintenance on the upper crane platform, checking gearbox and pump oil levels, of which there were twelve to be checked. The oil check involved manually removing a plug. The crew member's gloves and boot soles became contaminated with hydraulic oil and, when descending the vertical ladder, the crew member slipped on the ladder rungs and fell approximately two metres to the crane cab platform below. During the fall the crew member's left leg became trapped in one of the lower rungs, causing injury.

A ladder access survey did not fully recognise the potential risks around safe access/egress from the upper crane platform. The design of the vertical ladder and its location/position was considered to be inadequate and unsuitable:

- ◆ 'Backscratcher' was considered to be ineffective and did not provide adequate fall protection;
- ◆ there was no suitable handrail fitted;
- ◆ there was no anti-slip to the ladder rungs;
- ◆ the ladder's position relative to the upper crane platform meant that it was only possible to step on to it in a 'backwards' position.

- ◆ Routine planned maintenance activities should be reviewed to assess if there are any similar ones which may fall under the WAH category and should include a PTW;
- ◆ Risk assessments should be in place and be reviewed for routine tasks;
- ◆ Vessel supervisory staff should actively involve themselves in toolbox talks for marine routine activities and ensure that, where appropriate, they are recorded;
- ◆ The design and location/position of the existing ladders should be reviewed to ensure/improve safe access/egress.

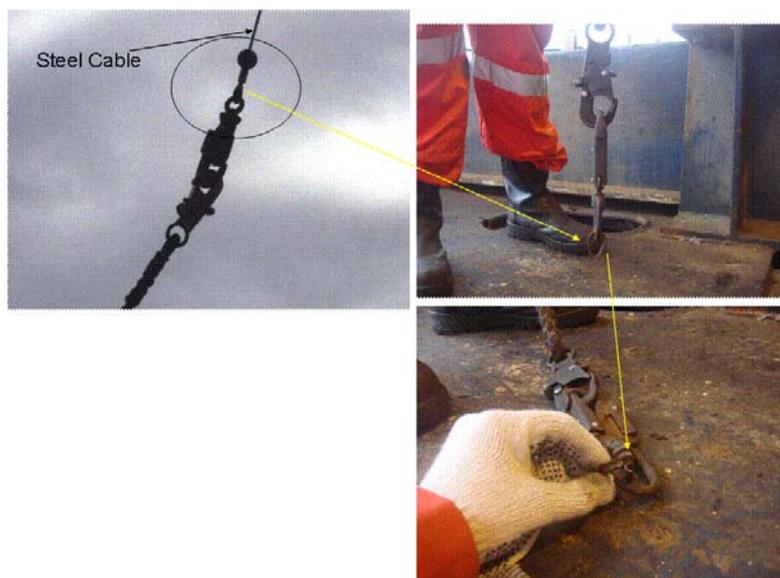
A member has reported several incidents onboard vessels where fall arresters have been found to be defective. Although the incidents have not resulted in any injuries to personnel they may have had very serious consequences.

It is believed that the failure of the equipment was lack of inspection and/or maintenance. It is of utmost importance that appropriate maintenance and inspection of fall arrest equipment is carried out in accordance with the manufacturer's instructions.

Below are pictures from one of the failed equipment:

Members are recommended to remind vessel crews to go through the inspection and maintenance regime to ensure fall arrest equipment is maintained to a safe standard.
