IMCA Safety Flash 14/09

October 2009

1 Failure of Gas Supply to Diving Bell

2 Torn Ankle Ligaments

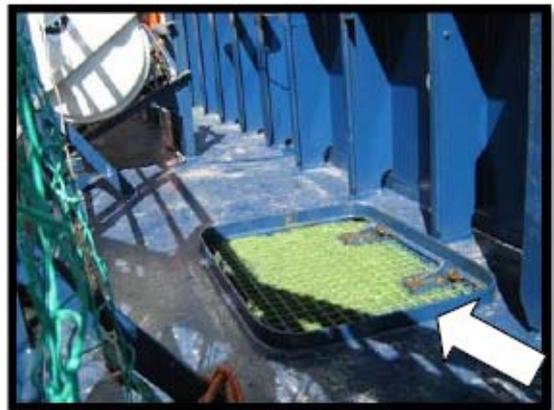
A vessel was moored along side another ship, port side too. No means of gangway was available, due to the fact that the lay out of both vessels differed. He climbed from the rail fence of the vessel on to the fence of the vessel alongside, turning around with his face towards his own vessel and placed his right foot on an edge of a hole of the deck (see picture for clarification). Because he stepped on this edge (which is about 3 cm high) he twisted his right ankle resulting in the injury as described. He was aware of the grid, but did not see the edge around it.

- Edge is the same colour as the surrounding deck
- Due to the different shape of both vessels, no means of gangway was installed
- Crewmember did not see where he put his right foot, possibly caused by the shadows of the railwork.

Preventive actions Using a gangway when leaving the ship or coming on board is essential. All efforts must be taken to avoid people climbing and scrambling from one vessel to another. When alongside other vessels, contact your colleague on the other vessel, when you think a safe passageway can not be created.

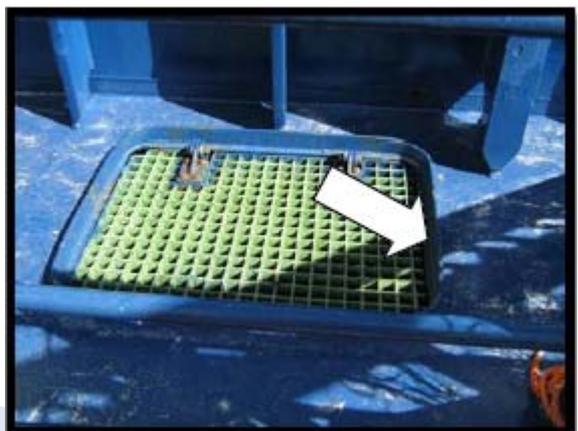
The vessel where the accident took place has been requested to mark the edges in a different colour, to pinpoint the difference in height.

We advise all vessels to check all decks and identify and mark all possible obstacles.

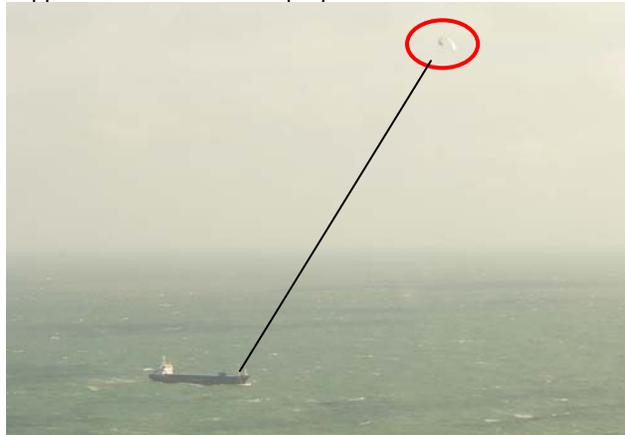
The aircraft was descending to the operating area in the Dutch offshore sector and identified a large kite/skysail flying at around **1000 ft** (just below the clouds) ahead of a vessel.

The 'skysail' itself was in the flightpath of the aircraft as it headed towards a nearby installation and, although difficult to see against the cloudy backdrop, was seen to be moving around ahead of the vessel in an erratic manner. The long cable, on which the skysail was extended, was also difficult to see.

The vessel can be seen in the picture below with the 'skysail' circled in red. The approximate line of the cable has also been marked on the picture.

The introduction of new, 'environmentally-friendly' propulsion methods posing a potential threat to aviation.

The issue has been raised with the Dutch Coastguard and the Regulatory Authorities to allow them to consider the issue in broader terms.

Interim solutions will be explored to identify the potential threat posed by this specific vessel when operating under Skysail within the Southern North Sea.

For now, all crews are to be aware of the existence of this threat and should report any sightings through the local ATC frequency to allow other aviation assets to be made aware.

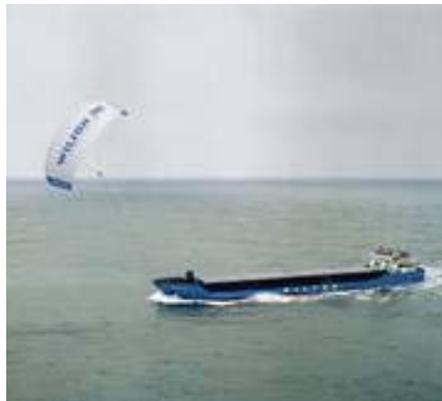
- EUROCONTROL Agency has been informed of an incident that happened on 15 September 2009 over the Southern North Sea:
 - **“The aircraft was descending and identified a large kite/skysail flying ahead of the vessel and at around 1000 ft (just below the clouds).**

It was attached to the vessel and was in the flight path of the aircraft as it headed towards a nearby installation. The 'skysail' was extended on a long cable and was moving around the vessel in an erratic manner

- Aviation Authorities are invited to review their kite flying legislation, rules, applicable constraints and required coordination.
- Aviation Service Providers are invited to note the subject and investigate the relevance in their operational environment.
- Aviation Professionals are invited to share their knowledge and experience about the described issue.
