IMCA Safety Flash 14/11

December 2011

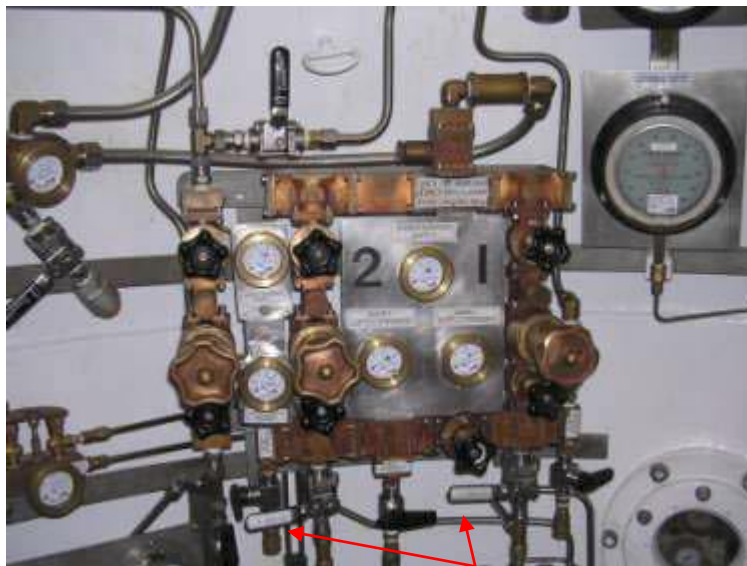
*Dive bell panel with valves in original closed position
(Note: valves turn anti-clockwise to open)*

- ◆ The main cause of the incident was that when the bellman lost his footing as the bell heaved during marginal weather conditions, he fell against the diver's gas supply valve and knocked it toward the closed position. The design and positioning of this valve arrangement, in the context of the confined space within the bell, was a potential hazard that had been overlooked.

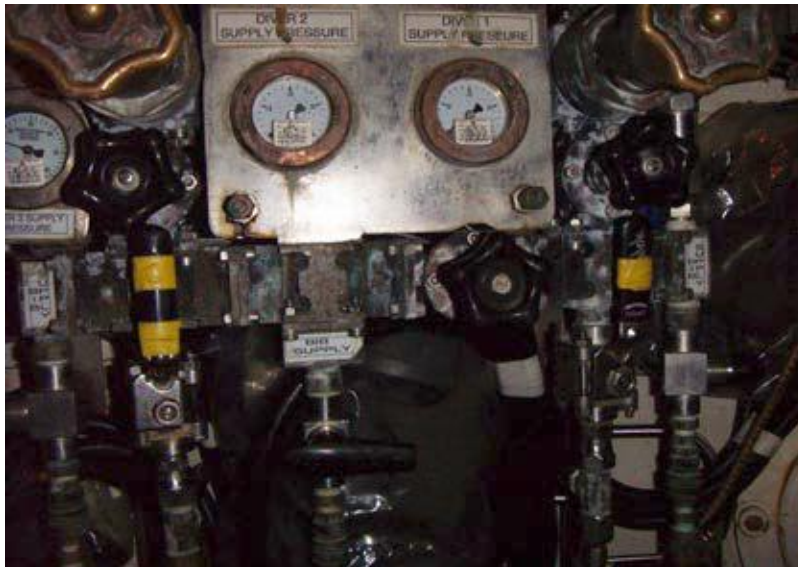
Dive bell panel showing modifications to the valve handles

The valve control handle was reconfigured and turned 180 degrees from its original closed position, which will ensure that when the valve is in the open position, that it cannot be accidentally knocked to closed.

- ◆ Diving operations were suspended until corrective actions taken, and the black box hard disk recording was copied;
- ◆ The bell was surfaced for investigation and repositioning of the valve/valve handle to prevent a recurrence;
- ◆ The dive team were fully briefed on the incident and actions taken to prevent recurrence.

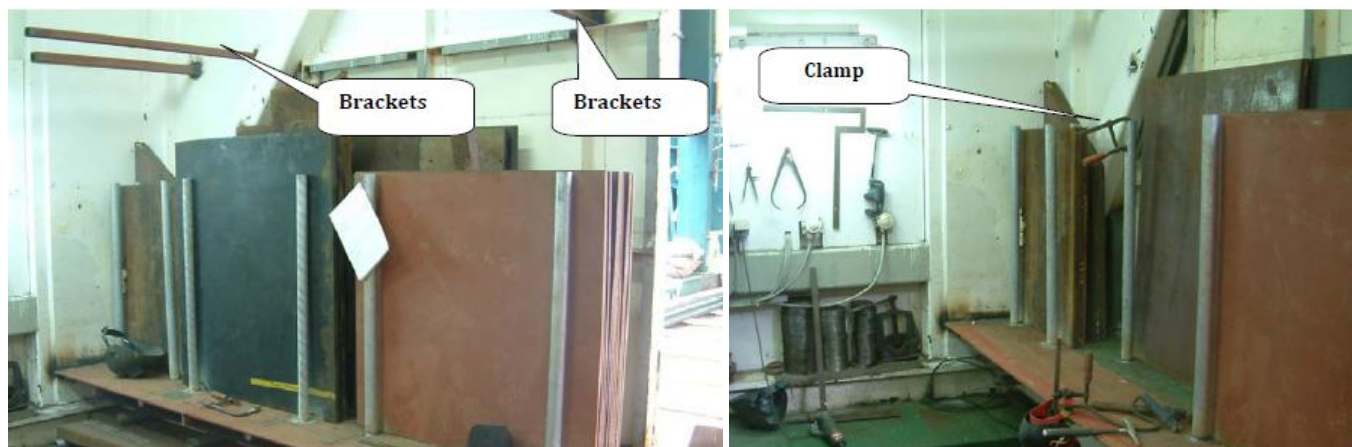
During the job a securing clamp was inadvertently knocked off while crewmembers manually moved one of the plates into its final position. As a result the plates fell over towards one of the crew members. He saw them coming, but owing to the weight of the plates he was unable to push them back and instead tried to jump out of the way. He was not successful; the plates came into contact with his body and he hit his head on a nearby column, resulting in small fractures to the skull and shoulder.

Showing welding bay storage area

Showing securing clamp

- ◆ The job was considered routine and no Job Hazard Analysis was conducted. Though the handling of steel plates is a routine activity on board this vessel, the creation of a new storage area was not routine;
- ◆ Manual handling of steel plates weighing 250kg is inherently risky;
- ◆ A workplace inspection prior to the activity would have revealed the risks posed by the obstructing brackets on the bulkhead;
- ◆ The clamps used to secure the steel plates temporarily were not adequate or safe for the activity being conducted;
- ◆ There were too many people in too small a work space.

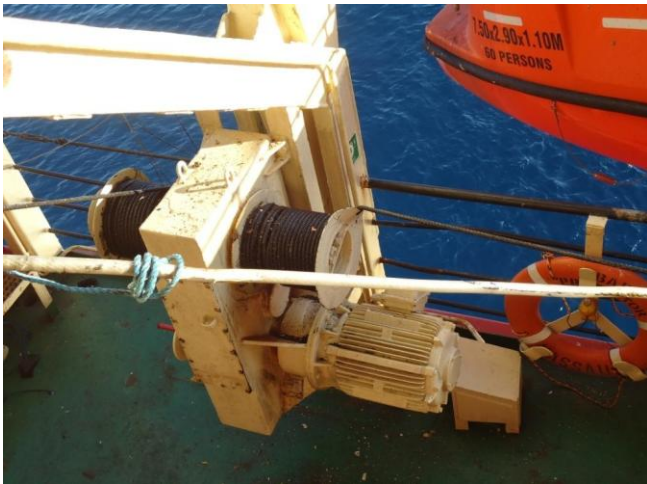
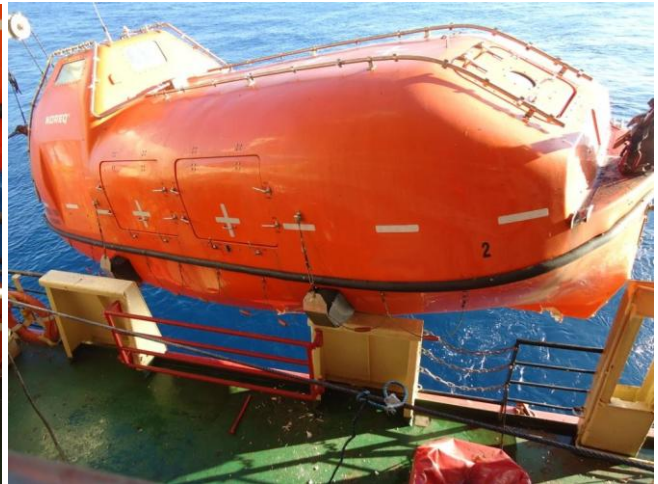
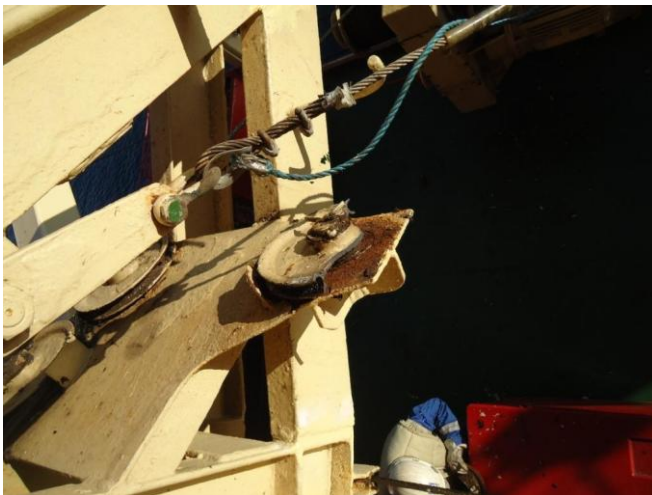
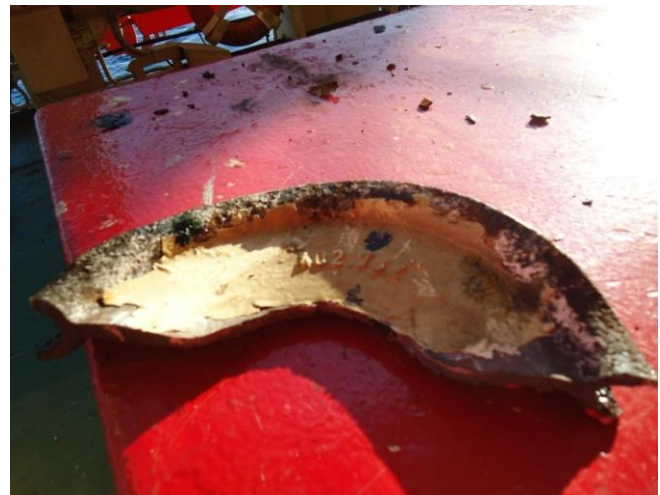
A member has reported an incident in which equipment failure allowed a lifeboat to fall free from one side of a vessel. The incident occurred during periodical function tests performed on the vessel lifeboats. When the port side lifeboat was recovered, one of the wire rerouting sheaves from the launching/recovery system buckled and broke off allowing the lifeboat to free fall from one side. The lifeboat and launching system were seriously damaged. No personnel were on board the lifeboat at the time, and there were no injuries.

- ◆ When the incident occurred, one davit arm was in its rest position, while the other one was still under recovery;
- ◆ Severe deformation of the sheaves and their support plate indicated an 'out of plane' loading;
- ◆ The sheave had signs of groove wear and corrosion of the bottom side;
- ◆ Though the functioning of the entire lifeboat launch and recovery system was tested periodically, there was no preventive maintenance programme for separate pieces of equipment within the system.

- ◆ Replaced lifeboat lift wire with particular attention to the length adjustment;
- ◆ Replaced damaged (bent) support plate;
- ◆ Thorough cleaning and removing old paint from boom guide and sheaves, replacing as necessary;
- ◆ Non-destructive testing on pin from sheaves.

It was also noted that owing to the work environment and equipment criticality, a preventative maintenance schedule for individual parts on the lifeboat launch and recovery system should be developed, as this would reduce the likelihood of this type of equipment failure.

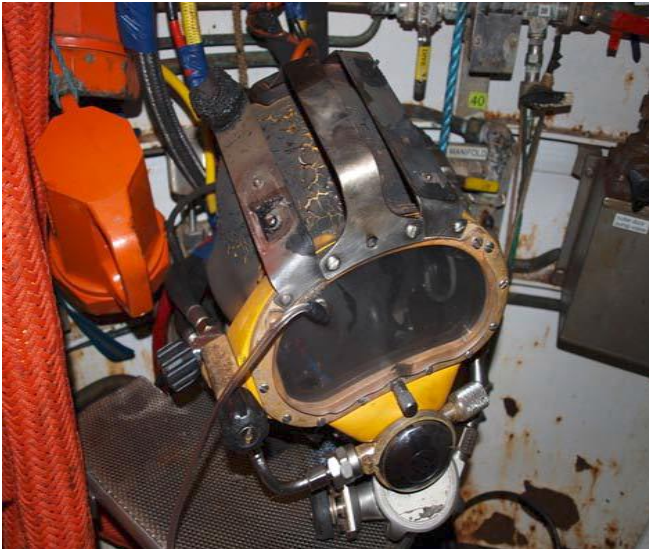
Damaged Kirby Morgan I7B helmet

An investigation established that the source of the fire was a dive helmet hat light which overheated to the point that the outer casing caught fire. The light overheated because it was inadvertently switched on whilst the equipment was on the surface and without any type of cooling in place, such as seawater.

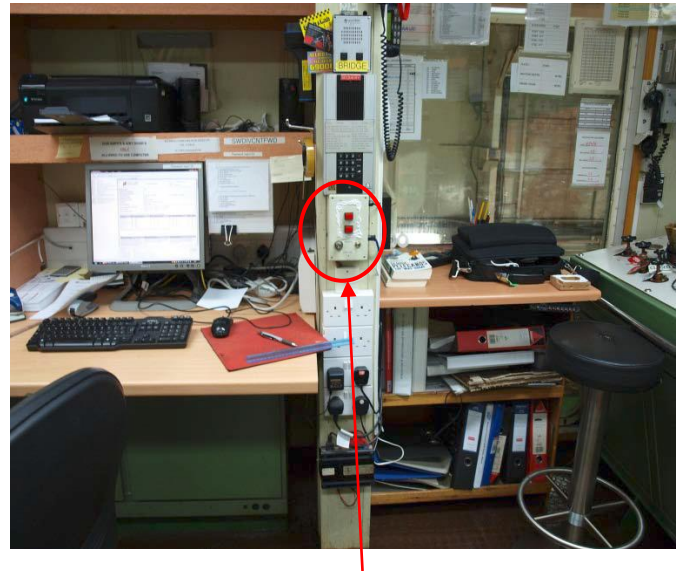
Location of helmet light control switch

The helmet light is operated via a surface mounted push button located in dive control forward of the dive control panel. Some twenty-five minutes before the incident occurred, the dive crew had held a short meeting in the immediate vicinity of the push button switch box that controls the helmet lights in the forward bell for both diver 1 & 2. It was surmised that during this meeting an attendee inadvertently leaned against the push button switch and turned on the helmet light. Nearly half an hour elapsed before the first smell of smoke was reported.

- ◆ There were no safeguards to prevent the activation of the push button controlling the helmet hat light. Temporary protection was put in place on the switch box, and the control boxes replaced with guarded switches to prevent inadvertent activation;
- ◆ The hat light would overheat without seawater cooling, and consequently should not be used for long periods in air. A new design for this model of light incorporates a positive temperature coefficient (PTC) thermistor device which prevents the unit from overheating.

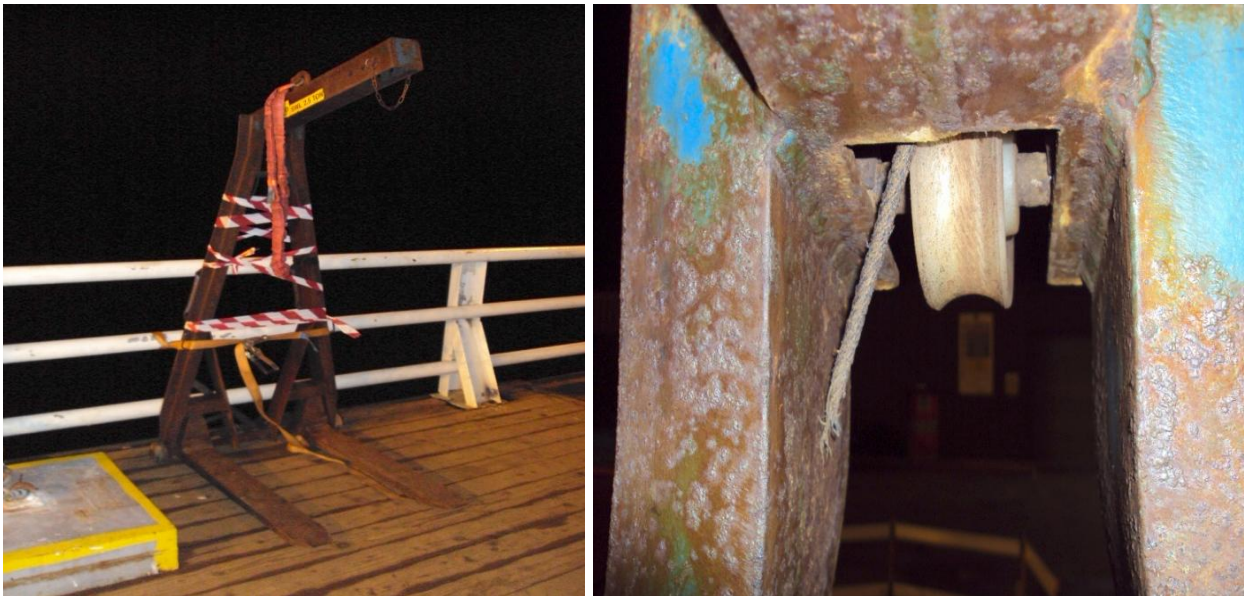
Pallet lifter after parting of wire rope

- ◆ On further inspection, the general condition of the pallet lifter, and the wire rope in particular were found to be in poor condition and showing signs of corrosion and poor maintenance. This should have been noticed;

- ◆ The 3rd party inspection company which had completed a thorough inspection of the lifter to allow its updated colour-code and continued use had clearly not provided a sufficient standard of inspection to ensure this piece of equipment was safe for work on this vessel;

- ◆ All lifting equipment should be given a full visual inspection by the user prior to any lifts, with all defects or concerns being raised immediately. The condition of this lifter should have been noticed and highlighted by the onboard team;

- ◆ There was no on-going maintenance on this kind of equipment and they are used until failure;
- ◆ Had the pallet lifter been entered into the vessel planned maintenance system this would allow for regular inspections to take place, with paint and greasing regimes to be implemented as necessary;

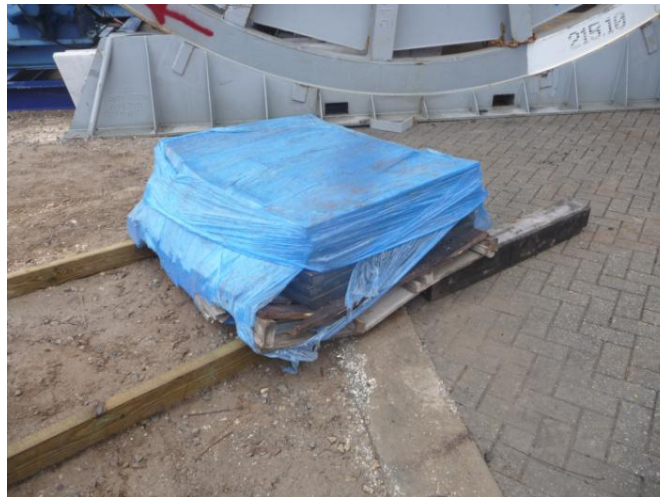
This lifting operation involved inserting the pallet lifter forks, and the load being raised slightly to allow a secondary cargo strap to be positioned around the load and prevent any movement during the lift. However, as the load was raised approximately six inches off the quayside to attach the cargo straps, the plates moved, sliding forward and to the left of the forks. The pallet lifter and load was then returned to the quay and the forks removed from the pallet. Once the pallet lifter had been removed from the pallet it was evident that the left fork had been twisted due to the load moving and overloading the pallet lifter fork.

Pallet of steel plate for loading

- ◆ A permit to work and lift plan had been completed for this operation but no consideration was given to the lack of information about the load to be moved or the limitations of the pallet lifter. This should have been highlighted in the lift plan risk assessment and the toolbox talk prior to moving the pallets. Hazard awareness and correct lifting procedures were not applied during this lifting operation;
- ◆ As the steel plate loads had no clear indication of the weights contained on each pallet, a lifter which has a SWL of 2.0T should not have been used without confirmation that the working limits would not be exceeded by the load;
- ◆ Good practice for transporting of plate onto vessels should be to transfer the load into a certified lifting basket ensuring the lifting of all plates in a contained and controlled manner.
