IMCA Safety Flash 14/20

April 2020

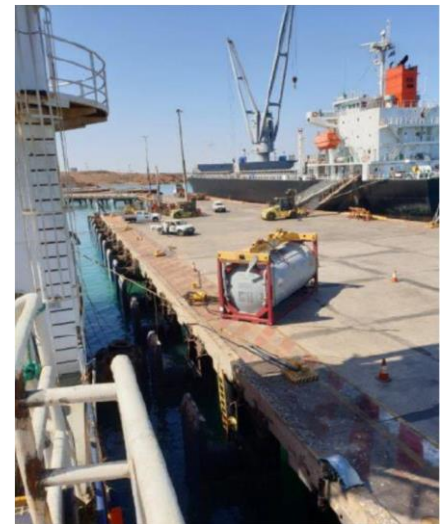
When conducting a standard lifting operation of a 24.5te storage vessel and lifting frame (approximately 36% of the crane 70te maximum rated capacity) the wire hoist rope (WHR) failed causing the load, main block and length of wire to drop approximately 3m to the wharf. No personnel were injured.

The maintenance, inspection, and testing regime applied to the WHR was consistent with general industry practice, guidelines, and company requirements and included third-party examination and certification. However, localised internal corrosion of the wire hoist rope (WHR) went undetected.

The metallurgical examination conducted on the wire hoist rope after the incident concluded that the wire hoist rope failed by a ductile overload mechanism following corrosion damage during service, particularly of the core wires. The lack of protective zinc galvanised coating on the wire hoist rope was a significant contributor to the eventual failure.

- ◆ Reliance on ‘industry practice and guidelines’ alone when maintaining, testing and inspecting wire hoist ropes may not be sufficient. Frequency of use, intended loads, environmental conditions, time in service, and criticality of the wire hoist rope should be specifically considered;
- ◆ Implement crane wire maintenance regimes for specific individual wire rope types using original equipment manufacturer input coupled together with a competent person’s assessment of the risks, giving due regard for the operating environment and intended use of the crane/wire rope;
- ◆ Establish criteria to determine when and how magnetic wire rope (MRT) testing should be applied (frequency, triggers, length of wire).

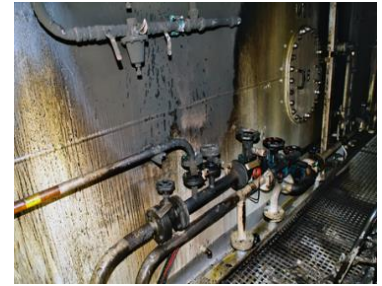
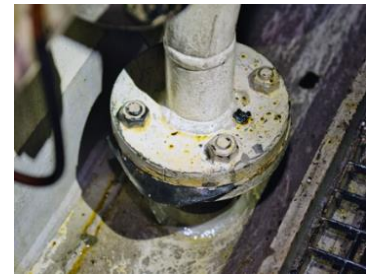
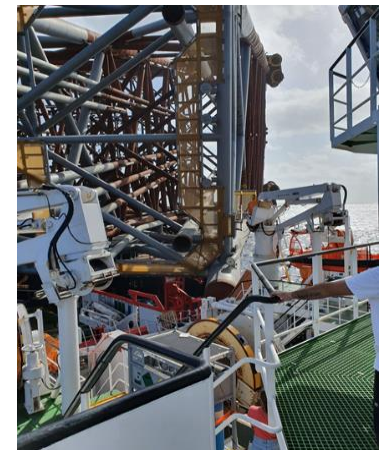
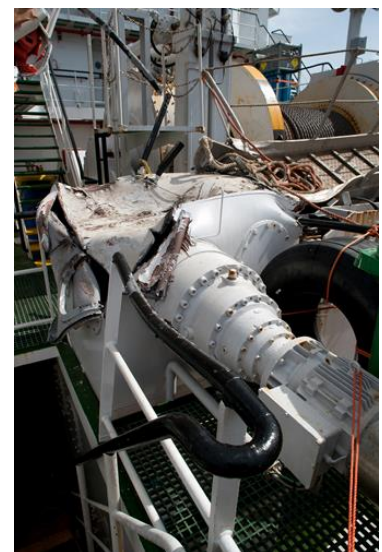
During the tow of a structure to location, a fire occurred in the engine room of the tow tug. This led to a blackout resulting in a collision with the structure on the transport barge.

The crew's interpretation of a project specific requirement led to a pressure test being conducted on the fuel oil system. During this test fuel oil started spraying out of a gasket in the engine room. The fuel oil spray was eventually ignited by the heat of the engines. The fire in the engine room caused a short circuit which was followed by a blackout. With the failing of the power supply, the tow tug started drifting. The transport barge drifted past the tow tug; however, the structure, which protruded outside the stern of the transport barge, struck the tow tug.

- ◆ The emergency generator failed to start, resulting in a black out;
- ◆ The fire extinguisher system did not activate (the fire was extinguished with a combination of the sprinkler system and the residue fuel oil burning out);
- ◆ Crew were not familiar with characteristics of fire-fighting systems on-board;
- ◆ Unreliable gasket material used in the FO system;
- ◆ The engine emergency stop button in the engine control room could not be accessed by the crew as too much smoke had escaped from the engine room;
- ◆ The permit to work (PTW) failed to address or communicate the specific situation related risks;
- ◆ There was reliance on third-parties' expertise during design, build, commissioning and operations.

- ◆ Any non-standard activity should be subject to control of work procedures;
- ◆ Offshore and onshore organization need to communicate proactively when non-standard activities are considered/required;
- ◆ There should be thorough familiarization of emergency and fire-fighting systems on-board – this is a must. Not only how they are operated, but also specific characteristics of the system and the effectiveness of the medium used;
- ◆ Ensure that the PTW is also used as an effective communication tool.

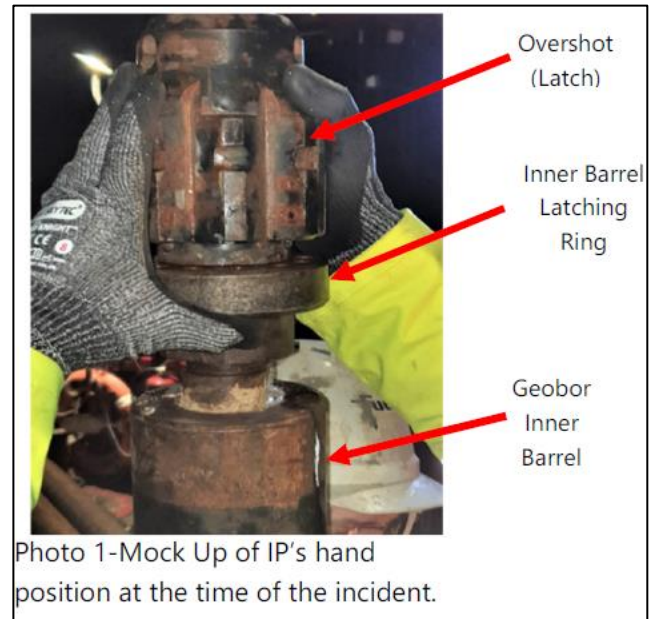
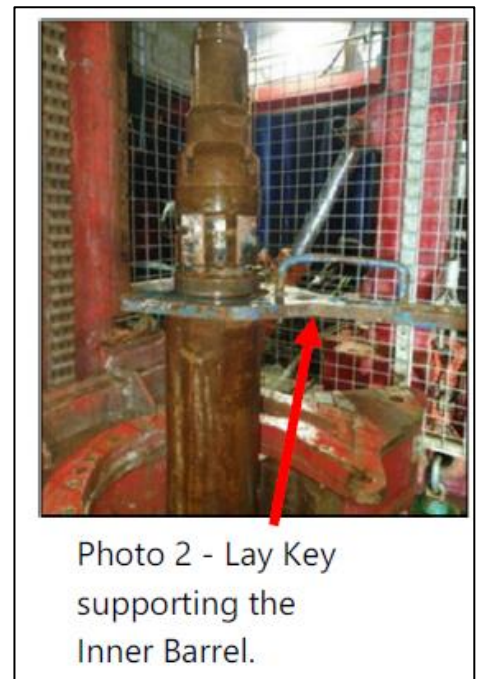
During drilling operations, a worker got his thumb caught under a part of a drill being lowered into position, resulting in the amputation of the thumb just above the knuckle. The incident occurred during operations to retrieve core samples from the borehole. Our member notes that an Inner Barrel is deployed by freefall to latch into the Bottom Hole Assembly (BHA) of the drill string. The Inner Barrel was lifted into position by winch, attached to the Overshot, and lowered into the casing, ready to be deployed. On this occasion, whilst deploying (de-latching) the Inner Barrel from the Overshot the assistant driller positioned his hands as shown in the photograph to depress the latch release keys. As the Inner Barrel dropped under its own weight his left thumb was caught between the latching ring and the top of the casing resulting in the amputation of the thumb just above the knuckle.

- ◆ Bypassing safety controls: the injured person failed to understand or use safety-critical equipment or follow procedures applicable to this task;
- ◆ 'Line of Fire': the injured person got in the way of falling/moving objects.

- ◆ Full review of all aspects of this task including revision of task work instruction and method statement;
- ◆ Drill crews have been reminded to use the appropriate Lay Key intended for this task.

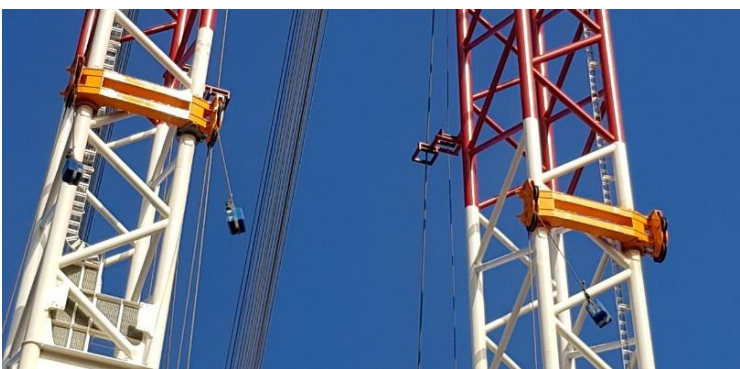
A clump weight fell approximately 30m to deck and landed around a metre to where a rigger was working. The incident occurred just after the boom of the main crane was lowered towards the cradle for sea fastening prior to transit. It was dark, windy and raining. The crane operator stopped lowering the boom to verify using the camera that the boom was in the correct position. As the camera view was blurred by rain and glare from the lights, the operator leaned forward to look at the boom. At that moment, his elbow unintentionally touched the tugger winch lever. The tugger winch started pulling on the tugger wire and pulled the rigging onto the sheave in the boom. Since a wedge socket was part of the rigging, the wedge was pushed down when the wedge socket hit the sheave, releasing the tension on the wire. As a result, the wire was pulled out of the wedge socket. The wedge socket, shackle and clump weight dropped 30m to the deck and landed one meter from where a rigger was working.

- ◆ No safeguards in place to prevent unintentional activation of the tugger winch by operator;
- ◆ No mechanisms in place to stop rigging being pulled onto the sheave;
- ◆ A wedge socket was recently introduced into the rigging configuration (changed from original spelter socket);
- ◆ The lever of the tugger winch was installed as per design, positioned close to the elbow.

Clump weight on crane

- ◆ Verify if controls can be activated unintentionally and consider what would be the possible (worst) consequence;
- ◆ Evaluate if there are mechanisms in place to stop equipment from making contact e.g. limit switches;
- ◆ Consider what the weakest component is in the equipment configuration and what the consequence might be when it fails.

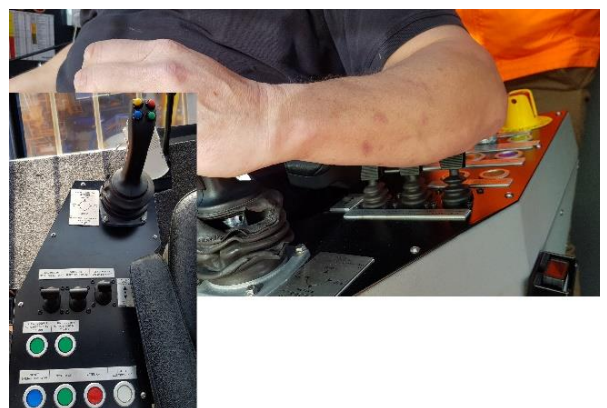
Situation in crane cab

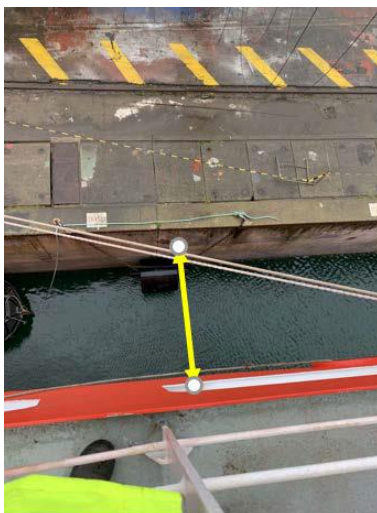
During stormy weather, there were sudden and violent gusts of wind of greater than 50 knots, resulting in a vessel alongside being pushed off the quay. This resulted in the gangway rolling off the platform tower and falling approximately 5.2m to the quay. The vessel's side of the gangway remained attached to the vessel. There was no-one nearby at the time; no-one was harmed; however, the incident had the potential to cause fatal injury.

- ◆ The potential risk of a falling gangway was not considered or recognised. There was no previous history of issues or incidents with this setup, the task was considered as a **low risk routine duty** by the shipyard (IMCA bold);
- ◆ During sudden, violent gusts of wind, the mooring ropes stretched allowing the vessel to move away from Yokohama fenders and quay. Mooring ropes worked as designed;
- ◆ In response to the available weather forecast, precautions were put in place, including additional mooring lines, additional manpower to monitor mooring lines and gangway watchman closely observing gangway movements;
- ◆ There was no consideration for safety in design. The positioning of the stairs in front of the platform forced personnel to pass underneath the gangway which can be classified as supported load;
- ◆ The incident had the potential to cause a fatal injury.

Vessel moves away from the quay, pushed by sudden and violent gust of wind

- ◆ Damaged gangway was removed, and alternative gangway fitted to a lower deck direct to the quayside;
- ◆ Ensure weather reports are reviewed with regard to operations that involve equipment which does not belong to vessel;
- ◆ Could this happen on your vessel? Ensure that risk assessments suitably address concerns related to safe access and egress to your vessel.

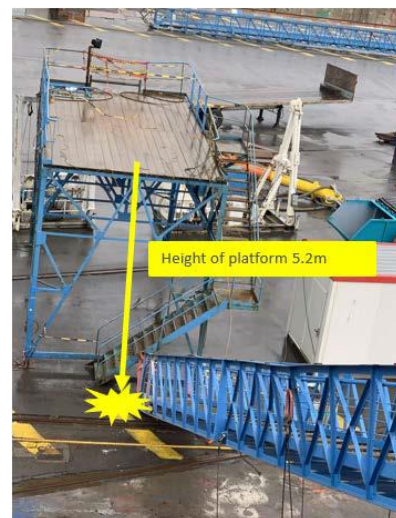
Gangway moves with the vessel and falls off the platform tower
