## IMCA Safety Flash 15/08

October 2008

### I Crew Member Injured During ROV Maintenance

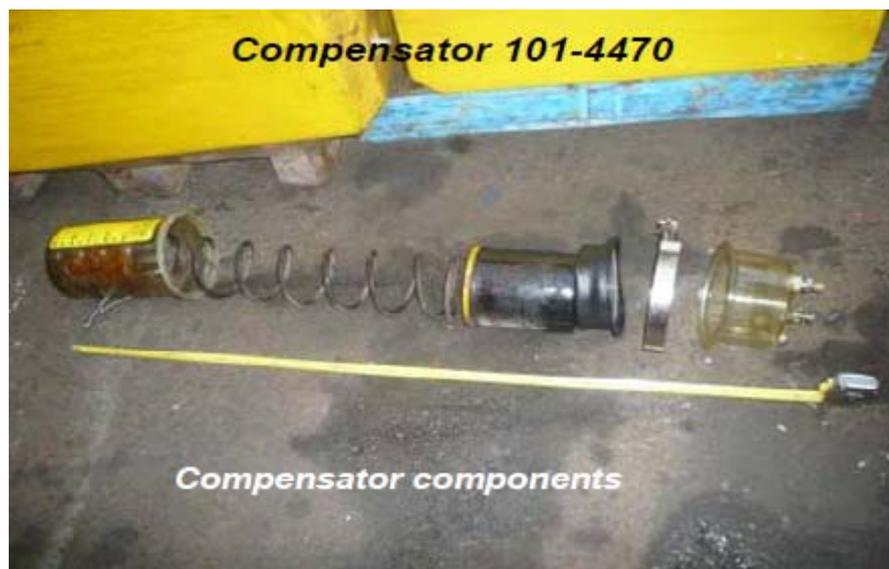
The ROV crew was servicing the manipulator and had restrained the compensator spring and removed the bladder assembly. The perspex spring housing showed clear signs of contamination and it was decided to dismantle it further for cleaning purposes. The compensator spring housing was not user serviceable according to the Schilling maintenance manual. In attempting to remove the spring, the stored energy in the spring was instantly released in an uncontrolled manner and in the process the ROV technician sustained an impact injury to the chin.

- ◆ This was a high potential incident as the consequences of the uncontrolled energy release could have been much worse;
- ◆ The instructions and warnings clearly stated in the manual were not followed;
- ◆ Components with stored energy (mechanical and/or electrical) should always be treated with respect.

*Schilling Titan 3 Manipulator: Compensator 101-4470*

- ◆ The removal of the compensator spring on these compensators is not a user serviceable task and units should be returned to the manufacturer's approved agents for servicing;
- ◆ Ensure sufficient spares are available on each ROV spread.

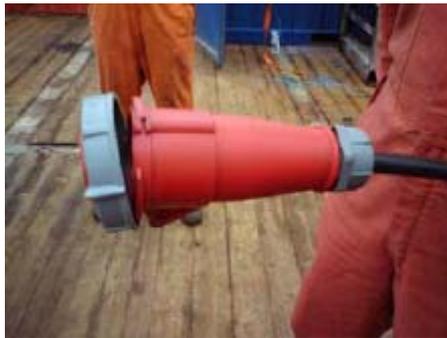
It proved impractical to reroute this cable as it had been passed through a small 'mousehole' in a sea fastening during mobilisation and the plug was too large to pass through this mousehole. The sub-contractor technicians then attempted to remove the plug in order for the cable to pass through the mousehole. During this process one of the sub-contractor technicians felt a slight shock and realised that the cable was still live. The job was immediately stopped and their supervisor was called. The supervisor immediately asked the project electrician to isolate the supply and make it safe. The individual who received the shock was checked by the medic and had suffered no injuries.

- ◆ No toolbox talk had been held before the start of the job;
- ◆ No permit to work or electrical isolation was in place;
- ◆ No risk assessment had been conducted or put in place;
- ◆ Established procedures were not followed;
- ◆ The sub-contractor personnel did not receive adequate induction when they started the job;
- ◆ The sub-contractor personnel involved were in unfamiliar surroundings and were not fully aware of the potential hazards of 440v mains power;
- ◆ There was inadequate active supervision.

*Plug after disassembly*
