IMCA Safety Flash 15/13

September 2013

I LTI: Dropped Object Incident

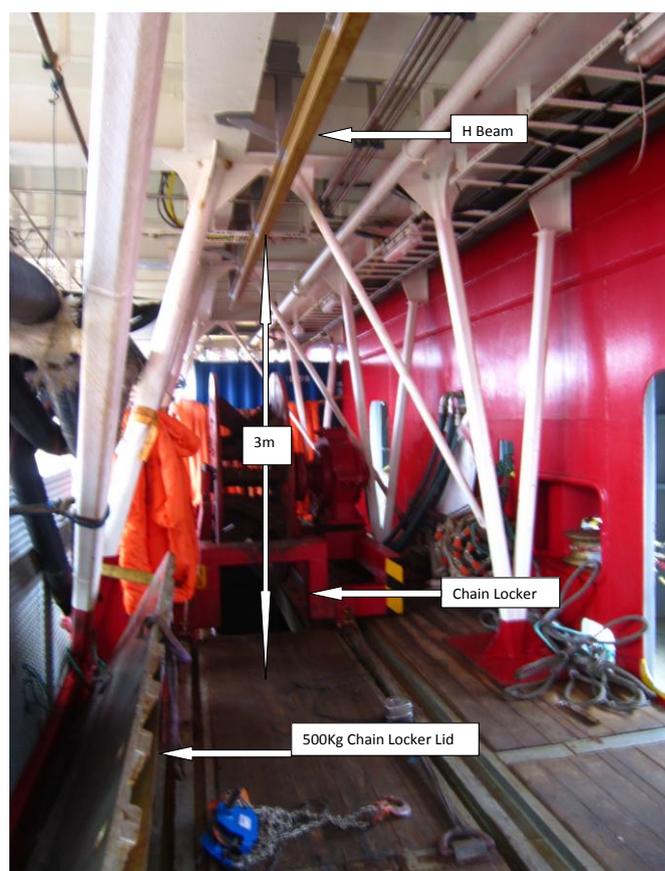
A member has reported an incident in which someone sustained a serious neck injury as a result of a dropped object incident. The incident occurred whilst members of the crew were using a chain block/tackle assembly on a H-beam, to assist with manoeuvring the heavy lids to the chain lockers which were located on a mezzanine deck. As chain locker lids are too heavy to move manually, two months previously, an H-beam had been installed in this location to permit the use of a chain assembly/trolley.

Figure 1 - General arrangement on mezzanine deck

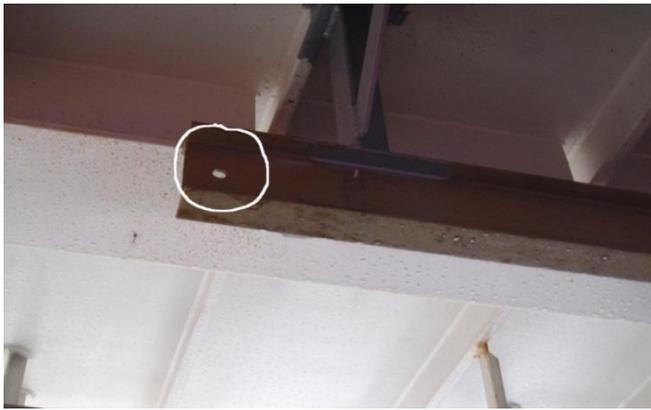
One of the persons conducting the work manually pulled the chain aside; momentum caused the trolley for the chain block assembly to run along the H-beam track. There was no end stopper and the trolley fell off the H-beam. It fell approximately 1.2 meters, glancing off the injured person's helmet and landing on deck. The total weight of the trolley and chain block assembly was approximately 33 kg. The injured person walked off the job unaided, and was attended by the onboard medic. The initial prognosis was a fractured neck. A neck brace was applied and then the injured party was medivaced by helicopter.

Figure 2 - H-beam with missing 'Trolley Stopper'

- ◆ There was no 'trolley stopper', or similar device, on the H-beam, to prevent chain assembly/trolley from falling off the end of the beam;
- ◆ The injured person was working under a unsecured load and ostensibly unaware of the consequences of pulling the chain assembly along H-beam when there was no trolley stopper;
- ◆ The injured person disconnected the chain from chain locker lid.

- Work equipment was allowed to be used, despite being known and identified as 'faulty'. The day before the incident it had been reported that there was no 'trolley stopper' on the retrofitted H-beam. No action was taken to address this very serious omission;

- ◆ Installed a trolley stopper on that particular H-beam;
- ◆ A fleet-wide "time out for safety" was carried out, and further DROPS awareness training was organised;
- ◆ A DROPS survey was performed with all similar beams inspected and maintained at member worksites;
- ◆ Checked certifications of H-beam, lifting equipment and chain assembly requested for inspection.

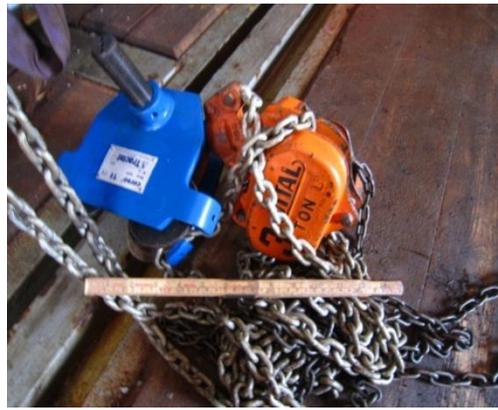
Figure 3 - Chain Assembly

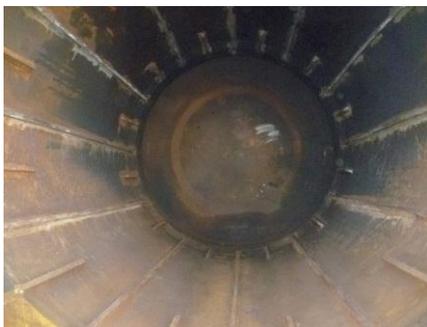
Incident #1 - after a test blow of a hydraulic hammer, it was discovered that a scaffold pipe was damaged between the anvil and the casing.

Immediate cause: Although the site was inspected, the hazards were not recognised.

Scaffold pipe hits anvil of hydraulic hammer

- ◆ Perform a full workplace risk assessment before starting the work;
- ◆ Keep walkways clear of obstacles, or otherwise mark obstacles;
- ◆ Never modify scaffolding;
- ◆ Remove all scaffolding material after the job, and contact scaffolding supervisor when scaffolding material is left behind.

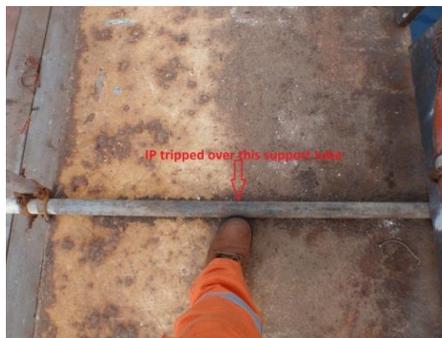
Incident #2 - a crewman was injured after tripping over a scaffold tube (supporting the handrail) whilst carrying an angle bar of approximately 15 kg.

Immediate causes: Poor co-ordination of the work activities, and there was no signage in place to warn of the obstacles.

Tripping over scaffold board

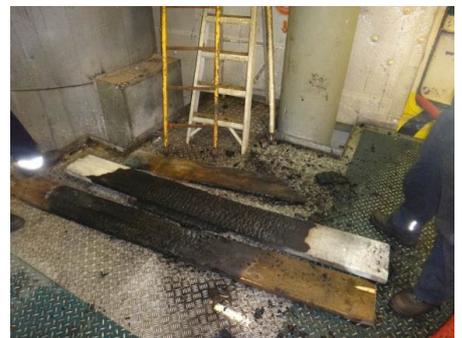
Incident #4 - scaffolding boards, which were out of sight, on top of the exhaust line, were left over from repair works and started to smoulder due to the heat of the exhaust line.

Immediate cause: Improper housekeeping after work was finished.

Smouldering scaffold boards

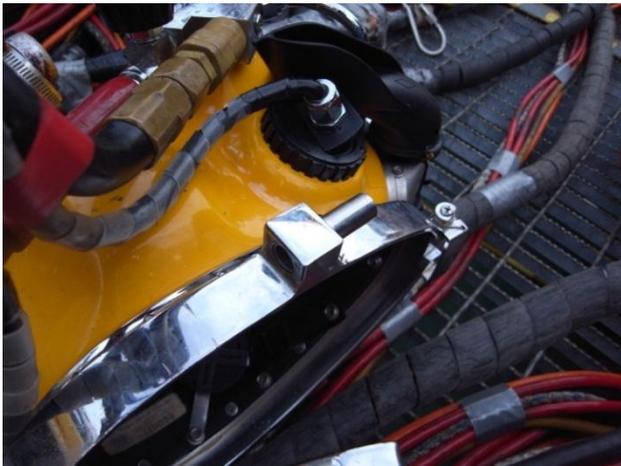
A member has reported an incident without injury in which the knob of a sealed pull pin assembly (p/n 505-110) on a Kirby Morgan diver's helmet came apart. The incident occurred after an air dive, when the dive team was assisting the diver to remove his helmet. On the block side of the hat, the sealed pull pin came apart whilst undressing the diver. Upon inspection, the dive team found that the threaded part of the shaft on the plunger, at the base of the threading, just above the square key, had broken and the knob had separated from the pull pin assembly. The Nyloc lock nut was connected to the top threaded section and still in the end of the knob. All parts of the pull pin assembly were recovered. Both sealed pull pin assemblies on the helmet were removed and replaced.

Our member contacted Dive Lab to discuss the incident. From photographs and information sent by our member, it was determined that the pull pin shaft had crevice corrosion.

Helmet sealed pull pin slot after failure

- ◆ Pre- and post-dive checks;
- ◆ Regular careful inspection of pull pin assemblies, in accordance with Dive Lab checklist appendices A2.1, A2.2 and A2.23;
- ◆ Regular check of pull pins for signs of leakage and corrosion, and to ensure that pull pins are operating properly;
- ◆ All torque specifications for fasteners (10-15 inch/lbs for the Nyloc Lock Nut on the pull Pin assemblies) should be strictly followed.

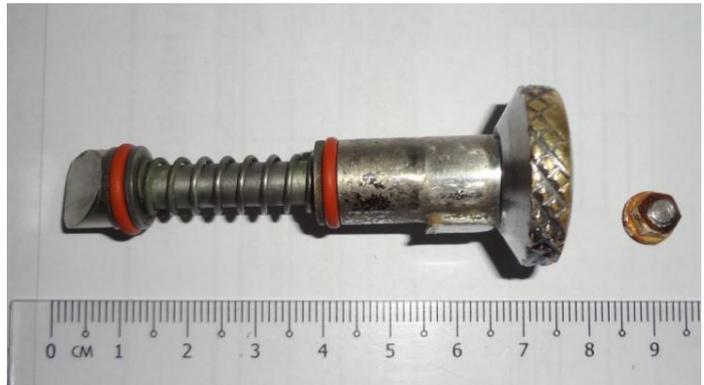
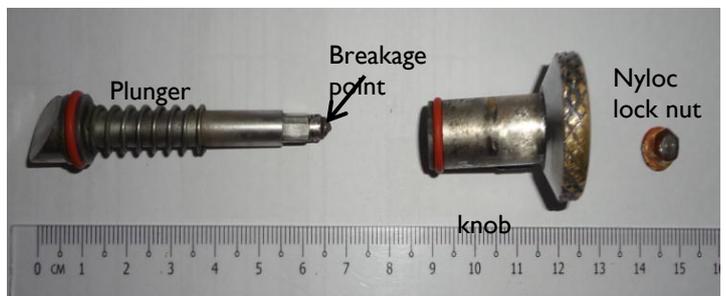
Parts of failed sealed pull pin
