## IMCA Safety Flash 15/14

September 2014

### I Dropped Object Near Miss – Unsecured Plastic Box fell from Load being Lifted by Mobile Crane

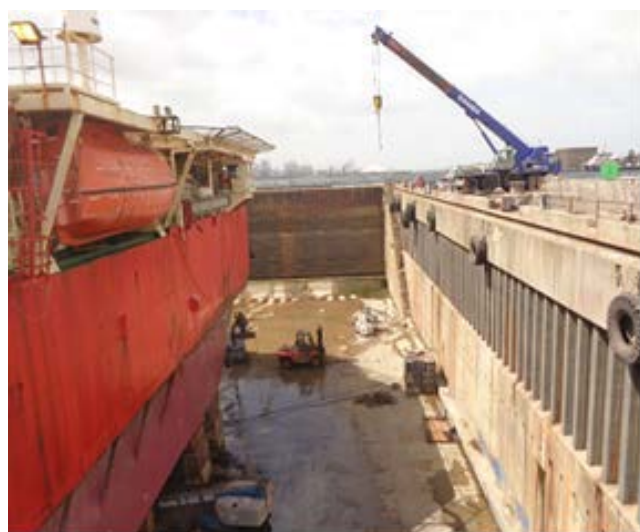
Dockyard personnel were lifting a piston from one of the vessels thrusters to the top of the dry dock, using their mobile crane. In order to contain residual oil remaining on the piston, the lifting team attached a plastic box to the piston. The piston was securely slung. However, the plastic box was insecurely slung, using pallet wrap. Wind speed was gusting to approximately 40mph. As the load reached the top of the dry dock (height 11-12m), a gust of wind blew the plastic box off the piston, which resulted in the plastic box falling back to the bottom of the dry dock. There was no one working on the floor of the dry dock where the box landed. There were no injuries and no damage.

Figure 1: vessel in dry dock with mobile crane

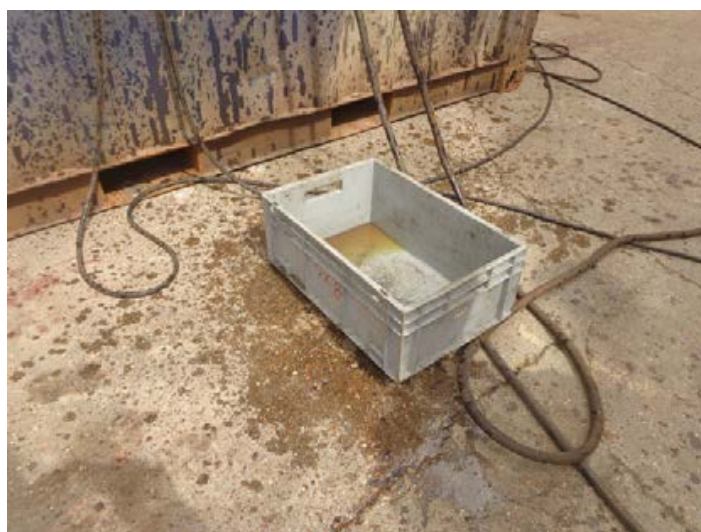
Figure 2: plastic box

- ◆ Forecasted adverse weather further affected the work schedule that day. Dockyard personnel used an incorrect tool (a plastic box) and an insecure method for attaching the box, in order to mitigate possible delays, believing the onset of more severe weather – possibly preventing the use of the crane - may have been imminent.

In this case, the dropped objects prevention scheme (DROPS) calculator provides only an indication of possible outcomes. The box in question had a relatively large surface area which wind resistance would have slowed during descent. Notwithstanding this, it still had the potential to cause serious injury or even a fatality.

- ◆ Reiterated to all personnel that the vessel must have oversight of all lifts (including risk assessment, methods of work, times, locations, projected environmental conditions (wind, fog etc) even if vessel personnel have no direct involvement in the lift;
- ◆ Ensured that correct tools and lifting methods are always used, even where the vessel has no direct involvement in the lift;
- ◆ Reiterated to both crew and dockyard staff, during all dockings, that there is not only a right, but an obligation to ‘stop the job’ if they see anything that they think is unsafe.

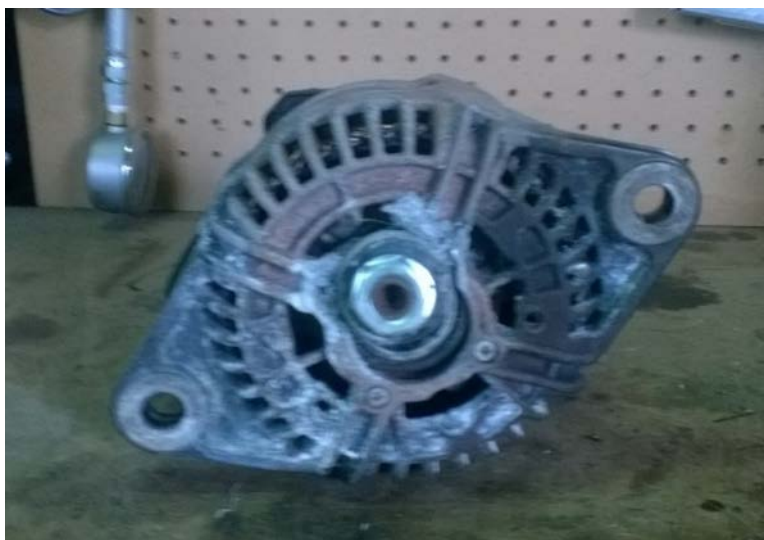
A member has reported an incident on a workboat used in the offshore wind farm industry, in which there was a serious failure of an alternator bearing, leading to a small engine room fire. The vessel crew noticed a sound change from the engines and a reduction in revs (dropped by about 100 rpm) followed immediately by the fire alarm. The crew shut the fire flaps, and the fuel and ventilation shut off using the emergency stops. The engine room was checked, and smoke and small flames or glowing were observed from the alternator. The fire was extinguished, the safety of crew, passengers and vessel was confirmed, and the vessel returned to port on one engine.

*Figure: showing damaged alternator with shaft out of alignment due to bearing collapse*

- ◆ The crew were trained to respond to a fire alarm in a certain way and did so in a swift and professional manner;
- ◆ The problem was found to have been caused by a bearing collapse in one of the alternators.

- ◆ All alternators should be checked regularly for signs of damage which may manifest itself as 'Black fluff' in the windings;
- ◆ When the engines are shut down the alternators should be checked for overheating.
