IMCA Safety Flash 15/15

October 2015

Focus: incidents occurring lifting operations

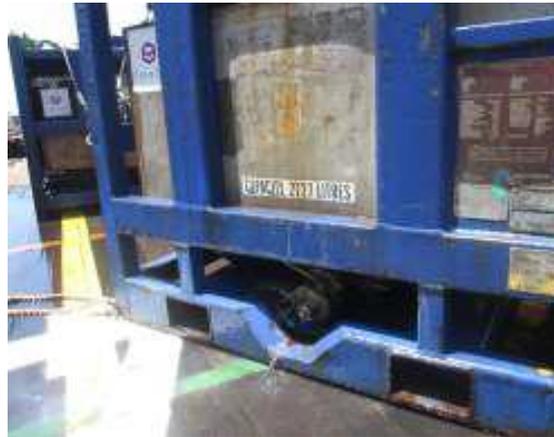
A member has reported an incident in which the valve on a cargo tank was damaged, causing a leak of approximately 1000 litres of methanol. The incident occurred during cargo operations; an FPSO crane operator was lowering an empty methanol tank onto the deck of a support vessel. On lowering, the empty tank struck another full tank of methanol already on deck, causing damage to a valve, which caused the spill.

The Master of the support vessel immediately instructed the FPSO to remove the leaking tank and it was rigged for hoisting by the FPSO crane. Despite this request, the crane operator failed to lift off the leaking container and simply lowered it back to the deck. The crew of the support vessel responded immediately by deploying fire hoses and continuously dousing the deck area and leaking container, to disperse the spilt cargo.

Damaged leaking valve of the methanol tank after the incident

- ◆ The crane operator on the FPSO failed to follow instructions given by the deck crew and Master at a critical moment;
- ◆ Existing procedures were not properly followed:
 - The support vessel's DGC (Dangerous Goods Certificate) did not allow for methanol cargo to be carried; this was not reviewed by vessel staff prior to cargo operations
 - There had not been a full review of the cargo's MSDS (Material Safety Data Sheet) before operations started;
- ◆ Had the officers on the support vessel correctly reviewed the necessary documents, they would have been able to proactively exercise the **STOP WORK POLICY** and prevent this incident from occurring.

- ◆ Immediate request for assistance from Master to FPSO to remove the leaking container;
- ◆ Following aborted cargo lift, Master immediately departed the Safety Zone to safe distance;
- ◆ Immediate and effective action from deck crew to flush the deck with water, douse the tank and subsequently also flush the tank out until all traces of methanol had dispersed.

- ◆ Dangerous Goods Certificates and Material Safety Data Sheets should be reviewed on-board before starting cargo operations, to ensure that full compliance is assured at all times. In case of doubt, Masters should check with appropriate company authority ashore;
- ◆ In this case despite the identified failings and high potential to become a serious incident, the entire crew responded swiftly and effectively to prevent the incident escalating, highlighting the importance of good drills, exercises and emergency response awareness.
