## IMCA Safety Flash 16/08

October 2008

### 2 Pallet Lifter Failure

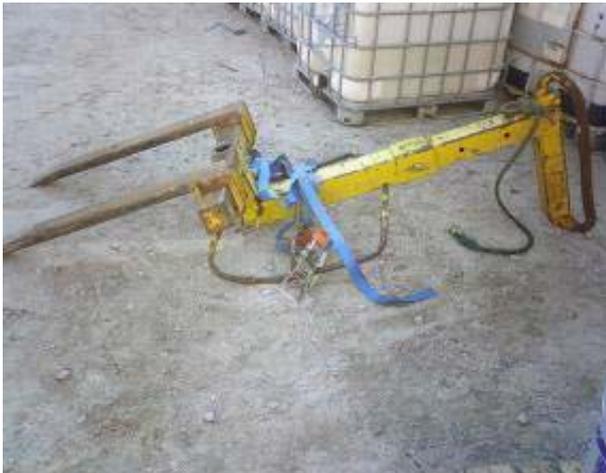
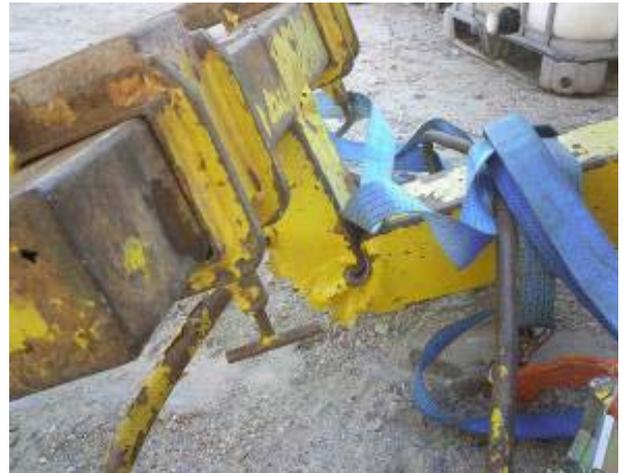
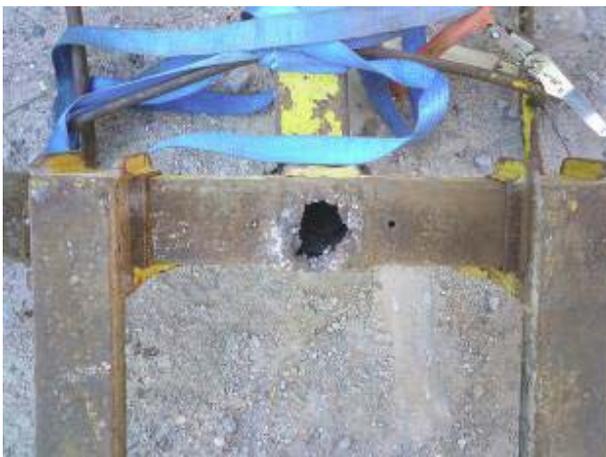
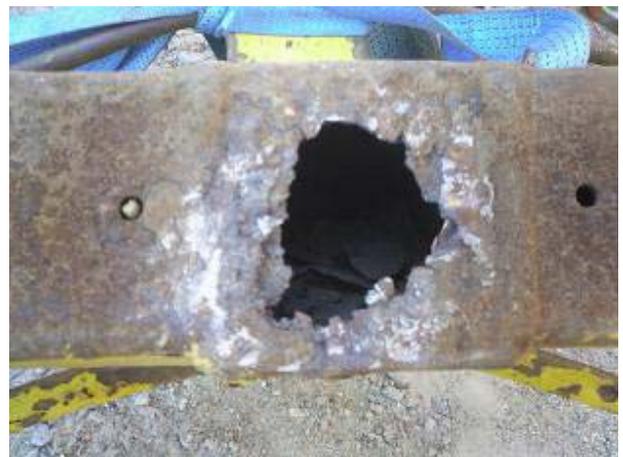
The pallet lifter had failed at a point on the stem near the forks, where it had buckled through 90°. The pallet lifter was disconnected and left on the quayside and the crate re-rigged and successfully lifted onboard.

Further investigation of the pallet lifter revealed an area of corrosion on the underside of the forks where a hole had appeared. In addition the small hole on the otherwise smooth plate end of the cross beam indicated that deterioration was taking place inside and working outwards and would not have been evident unless the pallet lifter had been turned on its side. The pallet lifter had been inspected four months previously during the six-monthly rigging inspections and the corrosion was not identified. With the extent of the corrosion, some signs would have been evident during this inspection but were not spotted or highlighted.

- ◆ The corrosion had weakened the structure to such an extent that the pallet lifter could not operate within its working limits. This highlights the fact that reliance on rigging certification is not enough and a regime of continued close and thorough monitoring of lifting equipment should be maintained at all times;

- ◆ Vessel crews should thoroughly check the condition of any pallet lifting devices they have onboard, with particular focus on the corrosion experienced by this unit. Any devices found to be in an unsatisfactory condition should be removed from service immediately and quarantined;
- ◆ Failure of lifting equipment should be reported immediately rather than 24 hours after occurrence, in order to enable an effective investigation to be carried out;
- ◆ Personnel involved in lifting operations should ensure that the weight of a load is accurately known prior to starting a lift; if there is any doubt or the information is not provided, the lift should be delayed until accurate information is found;
