IMCA Safety Flash 16/09

November 2009

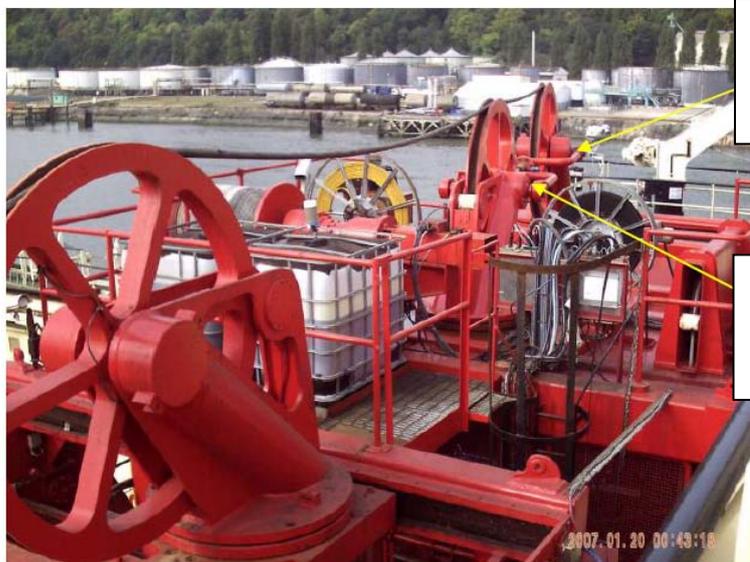
At this time someone was threading a turnbuckle into the yoke. Due to the weight of the yoke this came out of his grasp prior to the yoke landing and his hands came clear. There were no injuries.

Turnbuckles of outboard yoke arms were being reassembled at the time of the incident

Yoke connects to both sheaves; outboard yoke arms were being supported by quay crane

Site of yoke being supported by shore-side crane

- ◆ Teams conducting lifting operations should ensure that they are familiar with and follow their own company procedures for lifting operations;
- ◆ All lifts should have a lift plan – teams involved in lifting are to ensure that lift plans are in place prior to the lift starting;
- ◆ All persons involved in lifts should be included in the toolbox talk prior to the start of operations;
- ◆ Third-party contractors involved in members' operations, particularly lifting operations, should be fully briefed beforehand and personnel should be fully aware of the required level of subcontractor supervision;

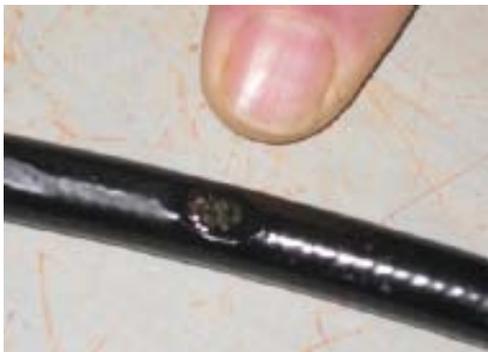
The person involved was unaware that hydraulic pressure remained on the system following shut down of the pump and that this pressure had actually increased for around two seconds after the pump shut down (owing to back pressure). Hydraulic fluid burst through the damaged spot on the hose and was injected through the double gloves into the person's index finger. Surgery was required to find and remove the injected oil from the finger and hand of the person.

Damaged spot on hydraulic hose

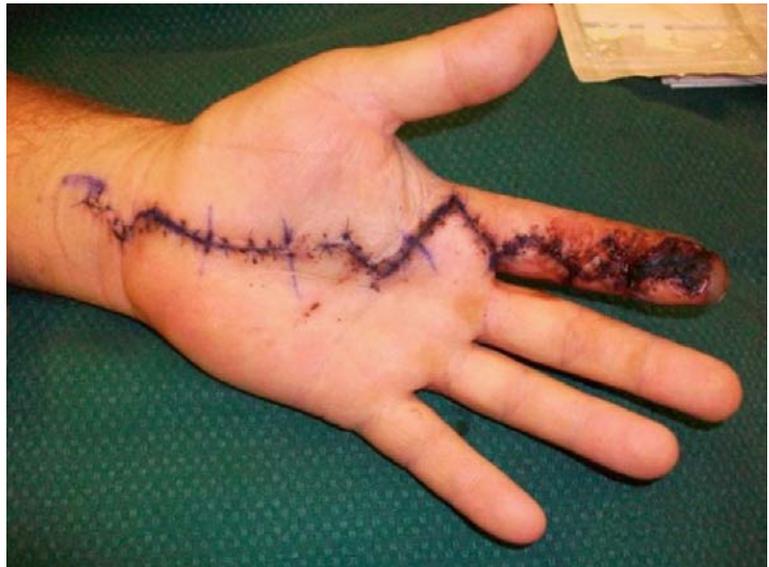
Major surgery was required to track and remove the injected hydraulic oil from the person's hand

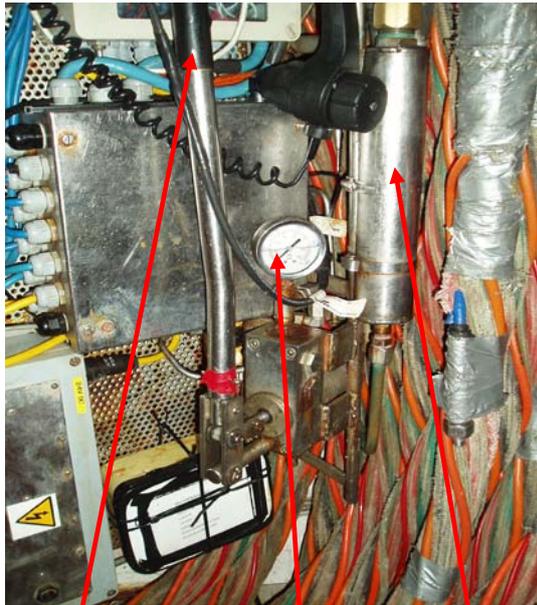
Pump handle Gauge Hydraulic reservoir

Check plate

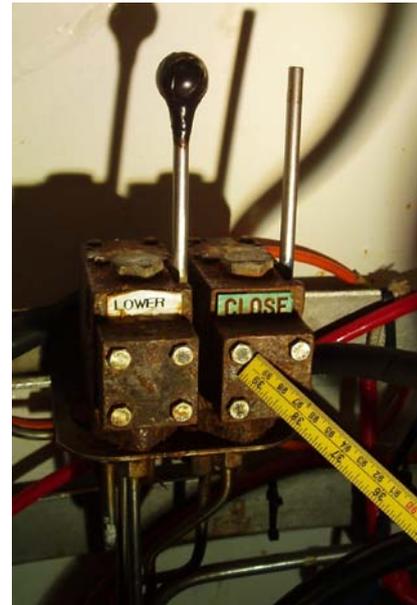
The member noted that the individual operations of opening/closing and rotation of the bottom door were controlled by directional control valves (DCVs) and that both valves could be operated simultaneously, so that in essence both opening/closing and rotation could be carried out at the same time.

Direction control valves (DCVs) to select raiser/lower or rotate

- ◆ visual system designed inside the dive bell to show that castellations are in line, to allow for better control by the diver;
- ◆ interlock between directional control valves fitted;
- ◆ procedure for operating bottom hatch posted locally in bell and in dive control;
- ◆ familiarisation, training and exercises improved for dive bell bottom door operation;
- ◆ technical description and emergency procedures prepared and posted in dive bell and dive control;
- ◆ failure modes and effects analysis (FMEA) reviewed with regard to bottom hatch operation;
- ◆ maintenance plan reviewed.

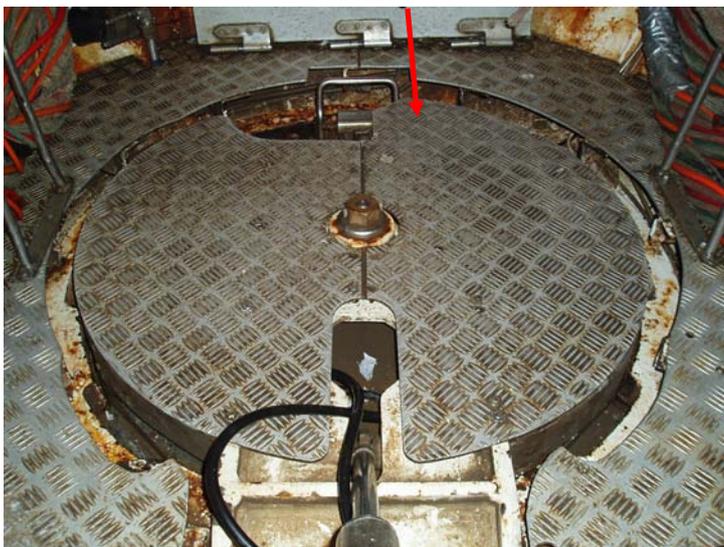
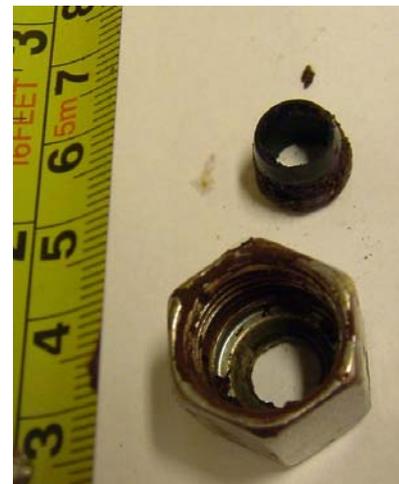
The cause of the failure was found to be a ferrule which had become detached from a hydraulic pipe in the control system, rendering the bottom door hydraulic system inoperable.

Actual ferrule and nut from the bell

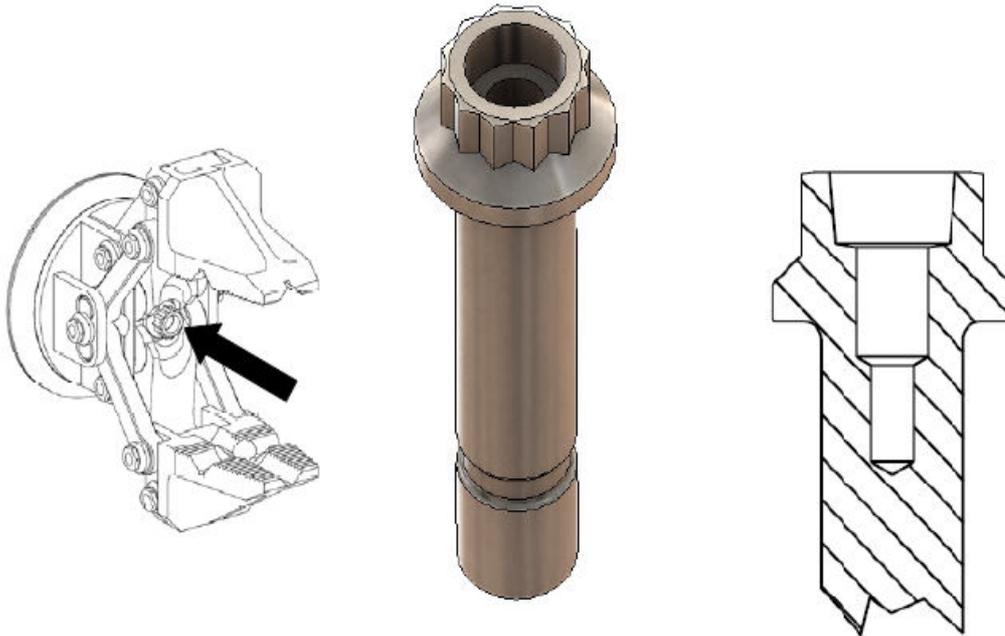
Figure 1 Fuse-type jaw bolt: location (left), machined hole in head (center, right)

Fuse-type jaw bolts 001-5382 and 001-5397 (based on jaw type). They have a machined hole in the bolt head and are located as shown in Figure 1 on the following page.

We have been informed that a fused jaw bolt sheared as the jaw function was being tested on-deck. Part of the bolt was ejected from the jaw at a high velocity, narrowly missing a crew member. This incident highlights the importance of always using PPE and staying clear of the slave arm's range of motion at all times to avoid risk of injury.

Inspect each slave arm jaw to determine if a fuse-type bolt is used in the jaw. Fused jaw bolts have a machined hole in the bolt head as shown in Figure 1 on the following page.

2. If you decide to replace a fuse bolt, use the slave arm or manipulator system technical manual to determine the part number for the existing fused jaw bolt. Then determine if a non-fused, replacement jaw bolt is available in spares:

- Fused jaw bolt 001-5397 (shaft length 3.123-in.): Replace with jaw bolt 001-7520.
- Fused jaw bolt 001-5382 (shaft length 2.116-in.): Replace with jaw bolt 001-7519.
