IMCA Safety Flash 16/13

October 2013

2 Fatality – Man Overboard

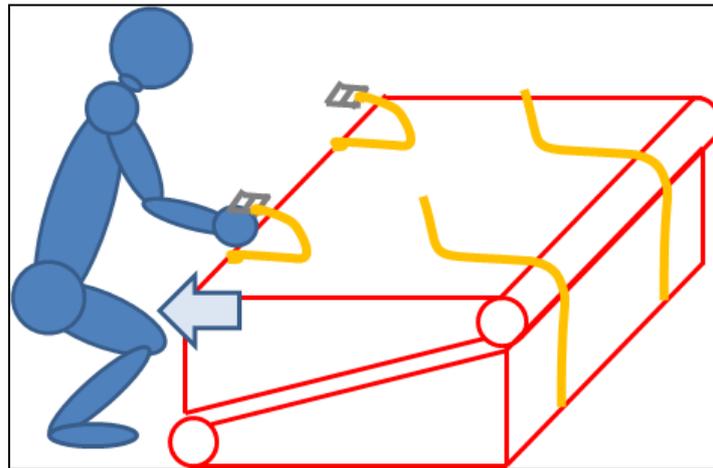
A member has reported an incident in which a crew member was lost overboard and drowned whilst working on a load on deck near to the side of the vessel. The incident occurred when a team of riggers was working on deck at night securing a load composed of two metal elements (bulwarks) one on top of the other. One of the riggers was approximately 3 metres to one side, in an area where temporary barriers were installed to prevent falling into the sea. During the operation, there was an unexpected movement of the metal structure on the top in the direction of the vessel side. The rigger moved backwards to avoid the movement of the load toward his position; after 2-3 steps back he fell backward and passed through the barriers, falling into the sea.

Position of worker as upper element started to move

- ◆ The area where the injured person was working (3m away from side) had been previously risk assessed as “safe” with regard to the risk of falling into the sea, and so the requirement for a life jacket had not been identified for the task;
- ◆ During the operation, the worker was positioned “in the line of fire” of the metal bulwark element on the top;
- ◆ Temporary barriers were found not appropriate, just beside the workplace of the injured person, due to a missing stanchion for holding barriers.

- ◆ A new risk assessment for bulwark removal and storage;
- ◆ Reinforce implementation of safe system of work;
- ◆ Verify vessel search light possible improvements and purchase night visors and personal locator beacons in order to improve the performance of MOB rescue;
- ◆ Replacement of missing post in port side temporary over-the-side protection;
- ◆ Increase housekeeping control on the deck;
- ◆ Complete audit and evaluation of MOB emergency procedure to be carried out utilising all required emergency equipment.

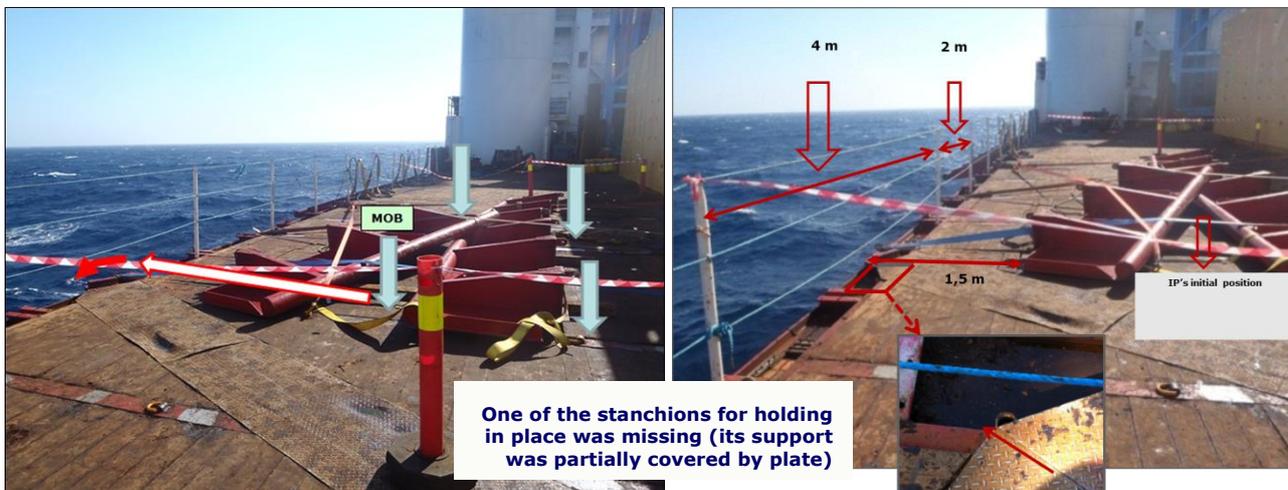
One of the stanchions for holding in place was missing (its support was partially covered by plate)

Showing site of incident
