IMCA Safety Flash 16/16

June 2016

1 Dropped Object: Signage Dropped From Crane Boom

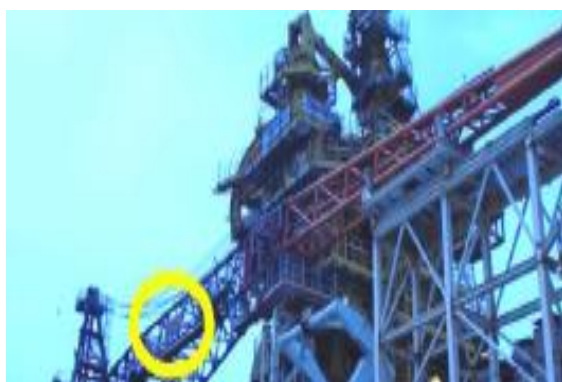
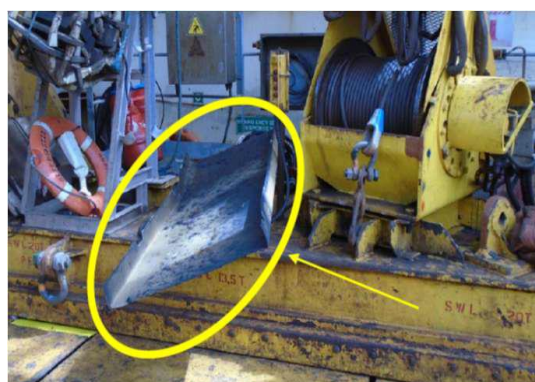
A member has reported an incident in which a piece of metal fell from a crane boom. The incident occurred on a vessel whilst alongside during the testing of the luffing motors' braking system on the main crane. During this testing the crane boom made an uncontrolled descent into its crutch, resulting in a 60 kg steel sign falling 15m down to the deck.

Investigation revealed that the sign was fixed by 4 x stitch welds, of which three were completely rusted away.

- ◆ Review standard operating procedures for testing the brakes of the cranes;
- ◆ Review the associated Permit to Work requirements (e.g. further consideration of what areas nearby should be barriered off);

Thorough inspection of all elements and parts of the crane (main, auxiliary and signage) before further testing and use.

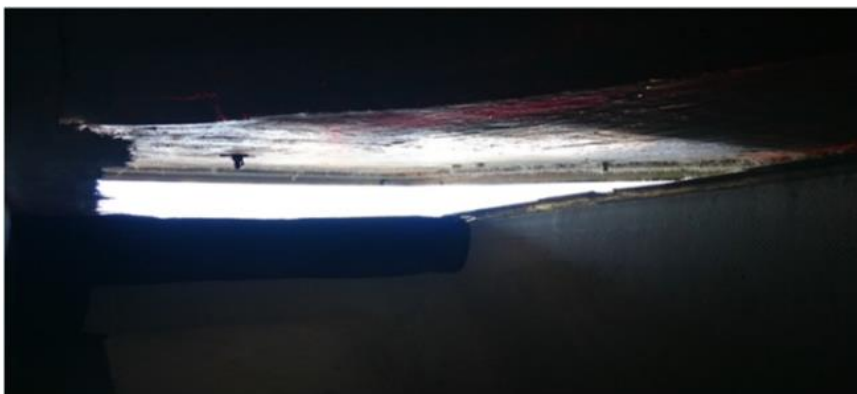
A member has reported an incident in which a small boat was damaged during offshore survey operations. The incident occurred during offshore transit to port. The boat experienced a ‘following wave’ that overtook it, causing the boat to drop into the trough of the next wave, causing the foredeck to partially detach from the hull.

- ◆ The foredeck and the hull section was insufficiently bonded together when the boat was built in 2011. A detailed analysis indicated that:
 - Less than 10% of the bonding surfaces showed signs of aggravated rupture by splintering or de-lamination, indicating that they were incorrectly bonded at build stage
 - The GRP (glass-reinforced plastic or fibre-glass) bonding was likely to have been incorrectly performed due to the restricted space available in the foredeck
 - The vessel had undergone a competent and third party inspection that had concluded that no structural defects were identified in the GRP construction.

The **cause** of the incident was found to be a material failure of the hull as a result of insufficient bonding during the build phase of the vessel. Whilst the weather, as with most marine operations, was an influence, this was not a major contributing factor given that hull designs of this nature should be able to operate under the experienced conditions.

- ◆ Plan and implement better QC for bonding processes during construction of these boats;
- ◆ Planned regular Inspections for significant indicators (cracks in secondary internal bonding) to be included in maintenance routines;
- ◆ This particular boat underwent additional bonding and stiffening processes and was subjected to both marine and authority assessments before it was returned to operations;
- ◆ Further careful checking and verifying of the competence of third-party inspectors who carry out vessel surveys. Crews, owners, charterers and auditors need to be able to satisfy themselves that these surveys are carried out to the highest standard.

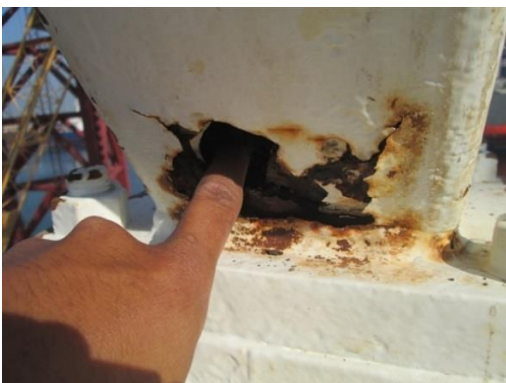
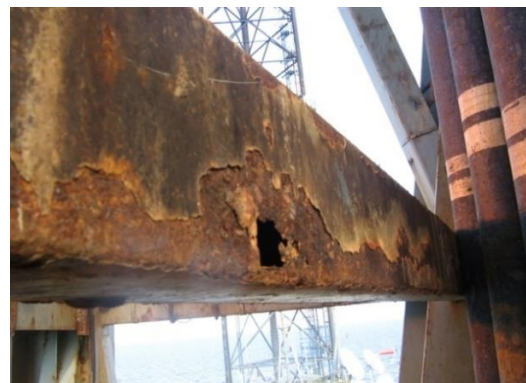
IMCA's attention has been brought to instances of potentially serious corrosion on certain types of derricks on jack up offshore drilling rigs. During the periodical inspection of drilling structures, a significant structural integrity issue has been identified. The derricks affected are mostly all 1.2 – 1.3m hook load or GNC derricks built in the early 1980's.

The issue discovered is advanced corrosion of load bearing members within hollow section members on certain models of drilling derrick. This corrosion on the derrick members has been shown to be serious enough to affect the performance and therefore the load bearing capacity of these derricks. In the worst case scenario, there is the potential for member failure which could in turn overload other structural members or create a significant structural failure and/or DROPS incident.

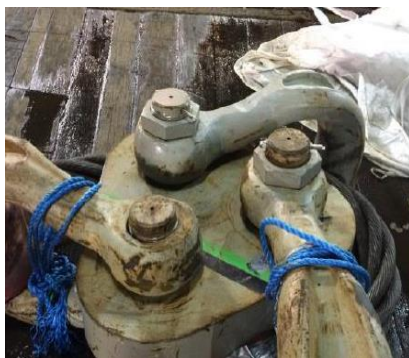
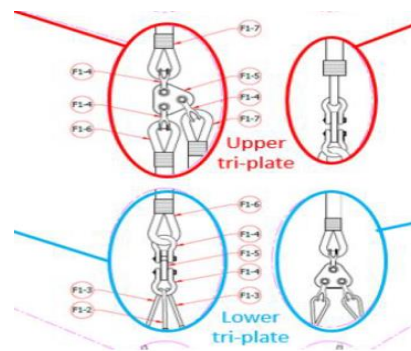
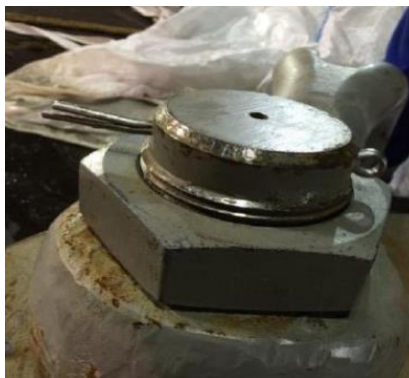
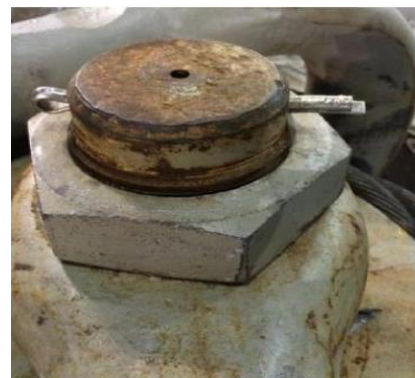
A member has reported an incident in which rigging was recovered to deck with missing parts. The incident occurred when a rigging composed of two tri-plates was recovered to the vessel deck, and crew noticed that a nut was missing from one of the shackles. The installation rigging included two tri-plates, one in the lower section of the rigging arrangement just above the suction pile, and the second one on the upper end of the rigging arrangement connected to the crane's auxiliary block. The shackle from which the nut was missing was one of the three installed in the upper tri-plate which was used to transfer the pile from the crane auxiliary block to the Abandonment & Recovery (A&R) winch when lowering the pile to the seabed.

Showing cotter pins (split pins) not spread open as they ought to be. These pins were loose and could be moved back and forth easily

- ♦ The cotter pin (split pin) was incorrectly installed (not opened out enough);
- ♦ There was no thorough visual inspection of tri-plate shackles by rigging crews (onshore or offshore);
- ♦ The tri-plate was secured on deck with shackles facing downward;
- ♦ The pre-sail-away checklist did not include checks of tri-plate shackles;
- ♦ The offshore rigging crew were unaware of observation following previous pile installation;
- ♦ There was a lack of training of onshore rigging team provided for barge mobilization.

- ◆ Environment – rigging arrangement not allowing straightforward inspection of cotter pins;
- ◆ People – lack of communication between onshore/offshore and project/vessel teams. Onshore project team were aware of the prior observance of a similar hazard. A presentation was developed and meeting held on shore but no evidence could be found that it was ever shared with the teams on board the vessel;
- ◆ People – lack of attention/due care/poor work practice. Lack of pre-lift check of shackles by riggers, and failure to fully check rigging prior to barge sail-away;
- ◆ Organization – failure to vet the onshore rigging team supplied by co-contractor’s subcontractor.

- ◆ Inspection of all rigging arrangements on the other piles;
- ◆ Reviewed pre-sail-away checklist and integrated into it all specific checks such as nuts and securing cotter pins;
- ◆ Updated the risk assessment and lift plan to reflect the hazards of missing/incorrectly installed pins in shackles;
- ◆ Onshore and offshore riggers to check thoroughly the presence of securing cotter pins after installation and before lifting operations;
- ◆ Project team to ensure that subcontractor’s rigging teams are properly vetted for competency prior to future barge mobilizations.

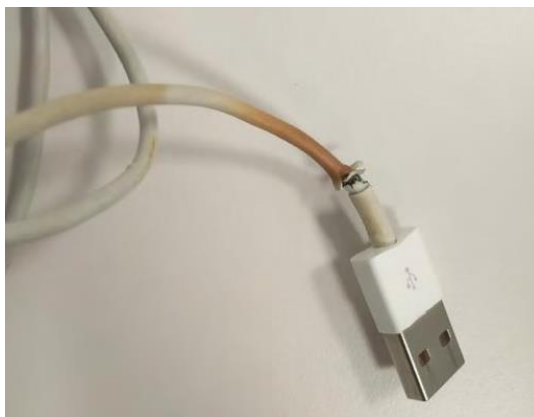
A member has reported an incident in which a charging cable for a mobile phone was discovered smouldering. A shore-based member of staff was at work at their work station when they noticed that their phone adaptor charger, which was plugged in and charging their phone, began smouldering. The employee immediately turned off and unplugged the charger and reported the occurrence.

On inspection of the phone charger, it was noticed that the charger cable was damaged and in an old and worn out condition which lead to it overheating.

- ◆ The stop work policy actually worked: The adapter was immediately unplugged and the burned cable was removed from use, and the occurrence was immediately reported;

- ◆ A safety stand down was conducted with office personnel to discuss the importance of being more attentive to the condition of electrical appliances;
- ◆ A monthly office inspection schedule was established and implemented, emphasizing the checking of electrical equipment, fire detection equipment and fire-fighting equipment.
