IMCA Safety Flash 17/08

December 2008

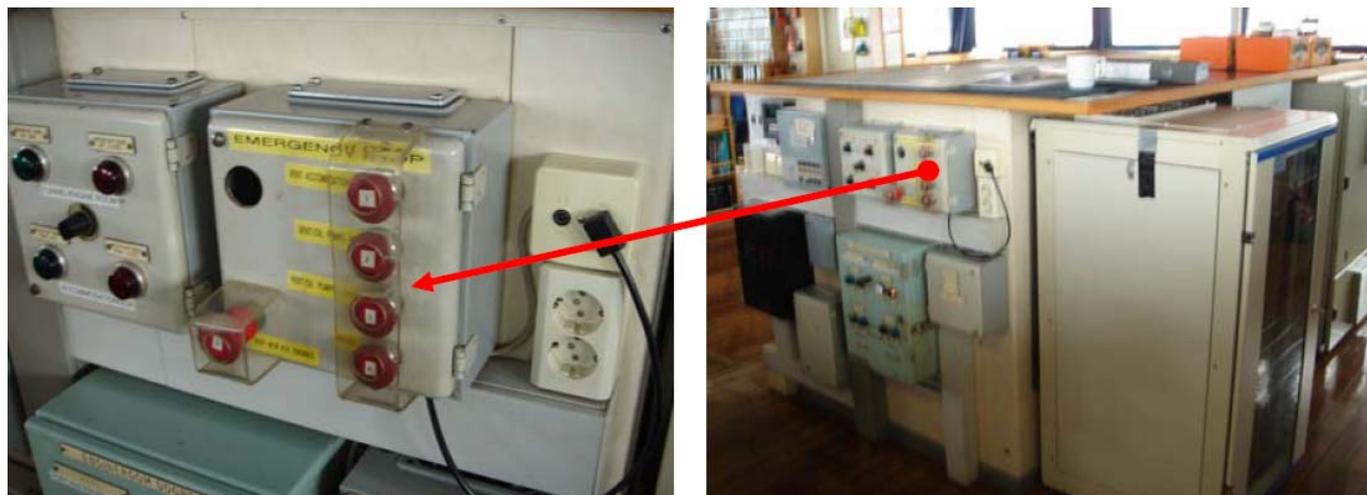
It was discovered that the Perspex cover in place to prevent accidental activation was so flexible that it bent in sufficiently to press against and thus activate the emergency stop buttons when the crew member accidentally pressed against it.

Emergency power switches

- ◆ The Perspex guard was temporarily strengthened and steps were put in place to fabricate and install a permanent guard at the next port call.

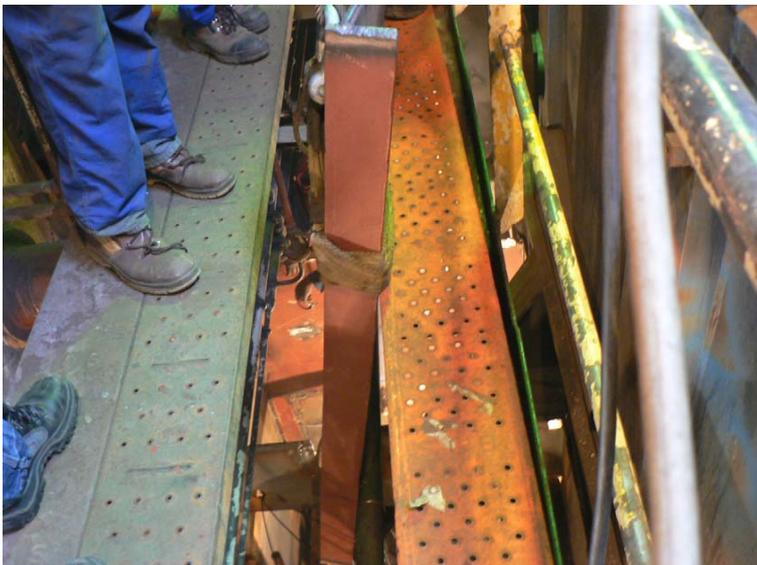
For unexplained reasons, the lift nonetheless continued without the padeye. Workers in the bottom of the ballast tank were asked to move away as a lifting operation would shortly be in progress but not all of them did so. As the angle plate was lowered into the ballast tank, it or its web strop rigging got stuck on an obstruction, such that the plate slipped within the choked sling and then fell free. The plate fell to the bottom of the ballast tank and struck a worker who had not moved away, causing fatal injuries.

Beam being lowered into ballast space (re-enactment)

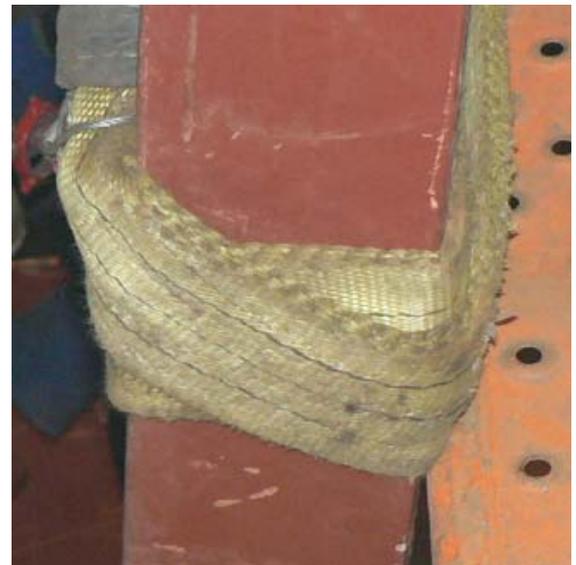
Detail of webbing strop getting caught

- ◆ Bad rigging practices; specific rigging rules were not followed – a nylon flat webbing sling was used to rig the angle plate rather than a safe welded padeye welded as required by the safety officer;
- ◆ Lack of communication between sub-contractors and poor management of simultaneous operations;
- ◆ Instructions from safety officer were not followed;
- ◆ There was no proper control of the lifting operation:
 - the area under lift was not controlled
 - proper communications (radios) were not employed
 - a rigging supervisor was not involved;
- ◆ Insufficient personnel were involved in the operation, which involved lifting via a narrow opening, through two different levels down inside a ballast tank, with poor visibility, a load not vertical and no rigger at the landing area to receive the load.

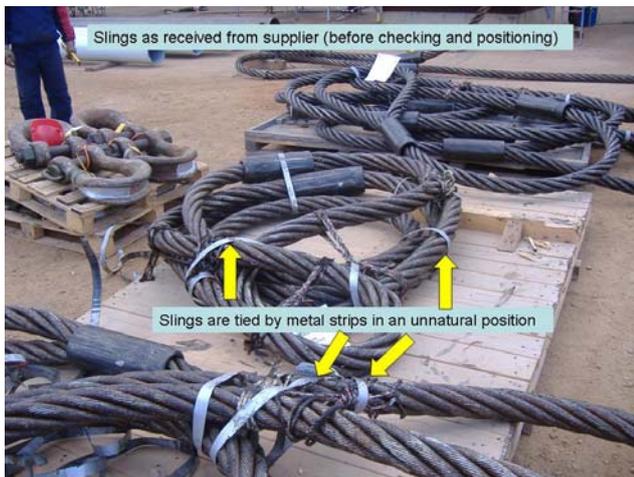
Slings are received from supplier

- ◆ High levels of stored energy resulting from extreme compression while coiling/packaging to optimise transportation on one pallet;
- ◆ Inadequate pallet, not large enough to handle this kind of package;
- ◆ Lack of communication on the part of the supplier of the relevant hazards (stored energy/slings under tension) and inadequate instructions for safe removal of the metal wraps;
- ◆ General lack of communication between supplier and user about residual risks related to handling packages of this kind;
- ◆ Team did not use available equipment to contain the sling under tension whilst cutting the wraps;
- ◆ Risk was not appropriately assessed before the start of the job; no relevant job safety analysis took place.

- ◆ Improve communications between supplier, client and user so that hazards of such packages were fully understood and risks appropriately controlled;
- ◆ Supplier of slings to send relevant information and instructions for the safe unpacking of its products;
- ◆ Develop procedures for safe unpacking of metal slings;
- ◆ Make full use of existing safe systems of work;
- ◆ Perform risk assessment and job safety analysis before starting the job.

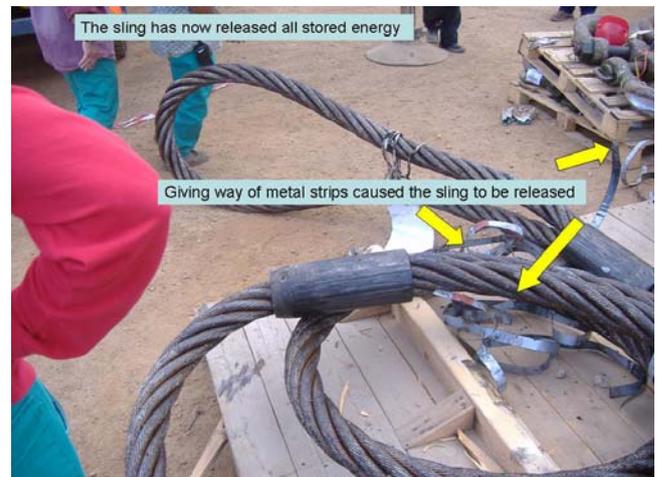
Five slings were unpacked and positioned by the team without any difficulties. During the unpacking and positioning of the sixth sling, as one of the two retaining metal straps was cut, the second strap became over-tensioned and gave way. The sling acted as a spring and moved violently outwards, striking the crew member on the helmet and ankle. Following first aid the crew member was taken to hospital for further examination. The crew member was unable to return to work for 20 days.

Sling after stored energy was released

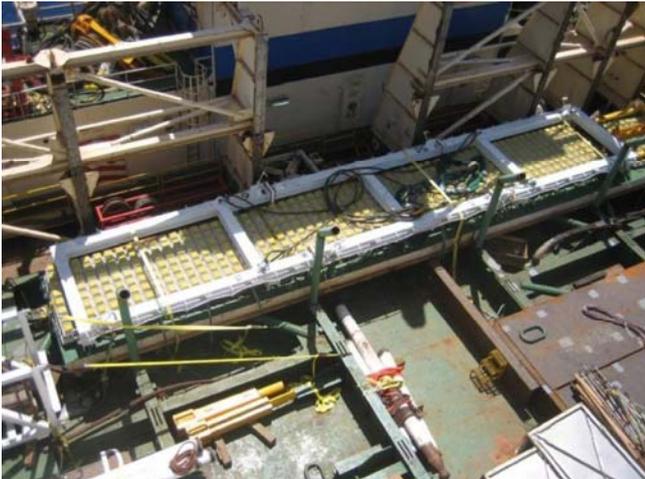
Mattress lifting frame

A member has reported an incident in which a webbing strop failed during a lifting operation onboard a vessel. The rigging crew found it necessary to reposition the mattress lifting frame which had been landed incorrectly. The lift was being carried out to reposition the lifting frame at one end, in order to square it up, as the forward section was not sitting correctly on the mats.

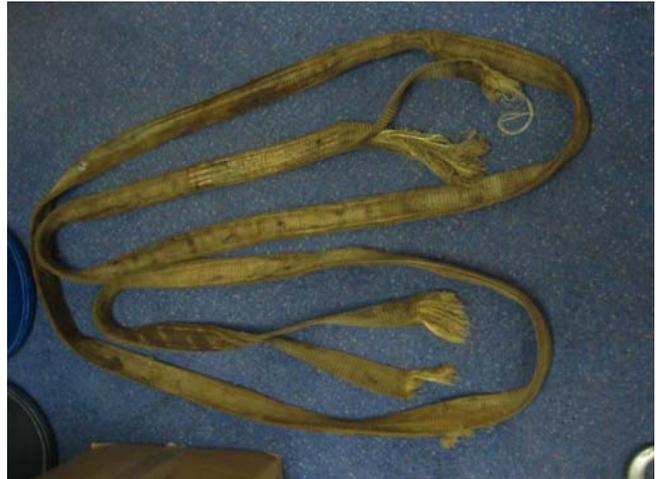
Example of worn lifting strop

- ◆ The sling was incorrect for carrying out this lift. It was not only an insufficient SWL but was also worn and in a generally degraded condition. There were no ID marks or colour codings on the sling;
- ◆ The sling was not subject to inspection prior to use and as such the wear and lack of ID was not observed;
- ◆ The intention had been only to lift up one end of the frame. However, with no adequate lift planning in place, the sling was connected to the central lifting point;
- ◆ An assumption was made that this sling would be of a sufficient SWL when basket-rigged to lift one end only.

- ◆ The need for an appropriate lifting plan for every lift, however small or routine, should be reiterated;
- ◆ All vessels should check their items of lifting equipment and rigging to ensure that they have appropriate and readable ID markings which are part of a vessel's itemised rigging, are free from defects and are included in regular planned inspection;
- ◆ Personnel should ensure they are familiar with the relevant lifting operation procedures including documentation and lift planning;
- ◆ Members should ensure that relevant information on lifting – including pocket safety cards, posters and procedures – is available at worksites and vessels;
- ◆ Use of generic lifting plans should be scrutinised to ensure their suitability.

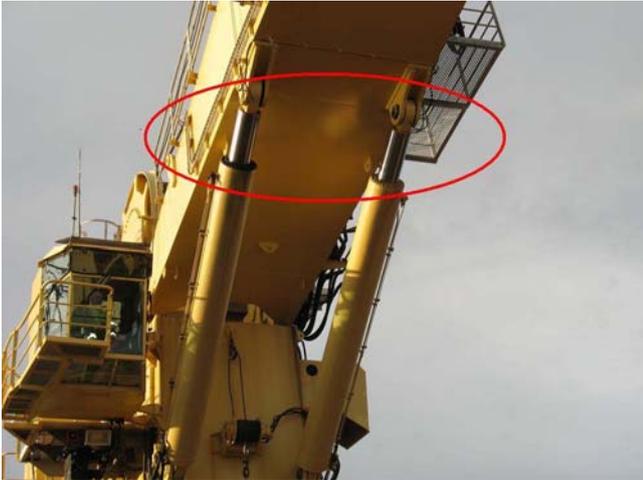
The hydraulic cylinders in the main boom were not fully closed when the crane was stowed in this position; therefore the weight of the jib was able to overcome the friction on deck and thus caused the movement of the knuckle head across the deck. At the time of the movement the inspector had been positioned close to the equipment in order to gain access on either side for a complete overview.

Main boom cylinders not fully closed

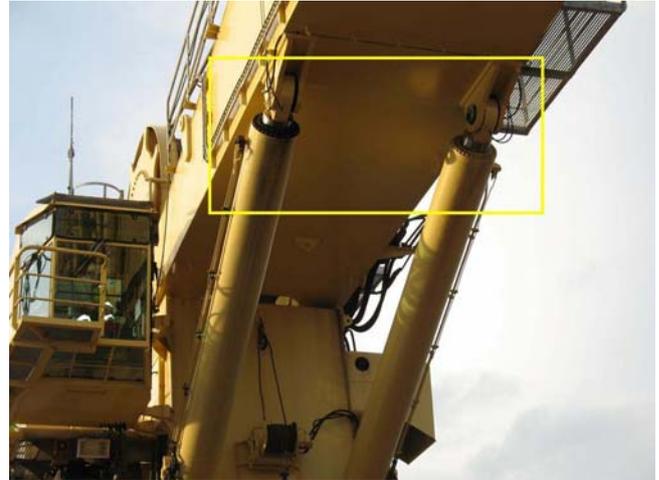
Main boom cylinders FULLY closed

- ◆ Conduct such inspections and routine maintenance with the crane stowed in dedicated parking position i.e. crane crutch;
- ◆ Ensure that the main boom cylinders are fully closed to avoid uncontrolled movement of crane jib;
- ◆ Follow approved procedures and always fully brief third party personnel during a toolbox talk prior to commencing the operation;
- ◆ Follow and adhere to the permit to work system, review and risk-assess specific tasks;
- ◆ Ensure that a complete and thorough shift handover is conducted at all times and strive to identify any hazards while the job is in progress;
- ◆ Barrier off work-site and ensure all personnel are aware of the potential hazards.

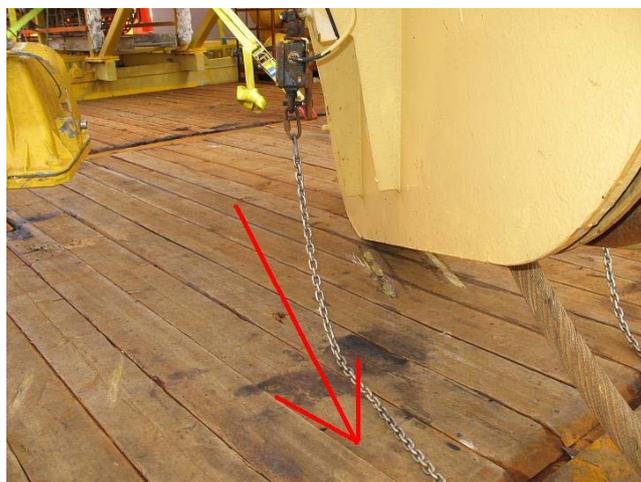
A member has reported an incidence of uncontrolled movement of a crane jib during inspection operations. The crane boom/knuckle had been lowered to deck to enable access to the main hoist sheave for inspection and maintenance purposes. The crane was powered down and the operator was not in the cab. During the inspection there was an uncontrolled movement of the knuckle section along the deck of approximately 30cm towards the crane pedestal.

Deck area where uncontrolled movement of the knuckle occurred

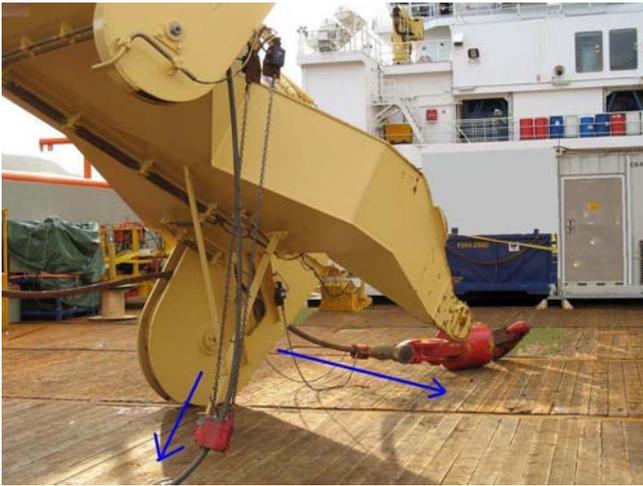
Showing correct angles and position of crane during the inspection operation

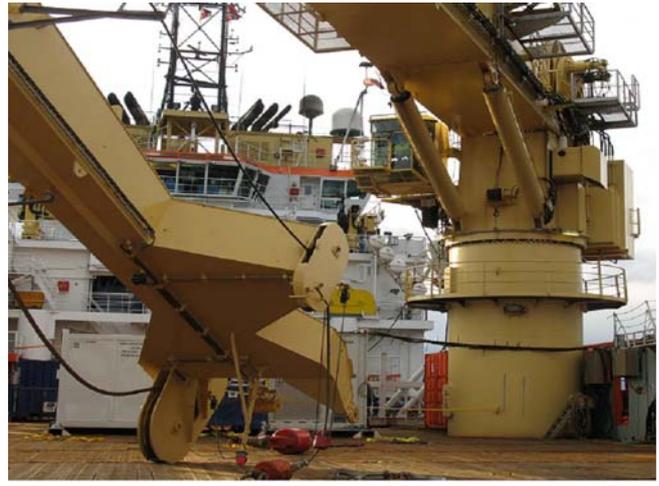
Showing correct boom position

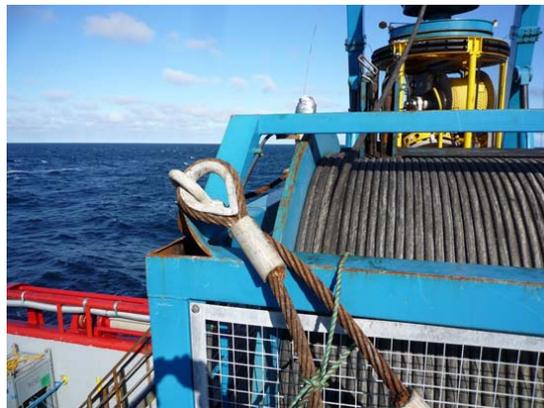
A member has reported a near miss in which a member of an ROV team spotted that one padeye on the tether management system winch was at an unusual angle. After closer inspection by the ROV pilot technician it became clear that the padeye had peeled away from the box section of the winch.

The cause of the incident is thought to be incorrect design. The 30mm thick padeye is welded directly to the top of a box section made from 5mm thick steel. The load on the padeye goes directly into the unreinforced top surface of the box section. Under repeated loading the padeye had peeled back the top surface of the box section as shown in the photograph.

- ◆ Personnel involved in lifting operations must always check the condition of the lifting lugs/padeyes and slings prior to and immediately after use. In this case the damaged padeye was not noticed until some days after the damage was caused;
