## IMCA Safety Flash 17/09

December 2009

### I Injury During Personnel Transfer Capsule Operation

## 2 Loading and Securing of Containers

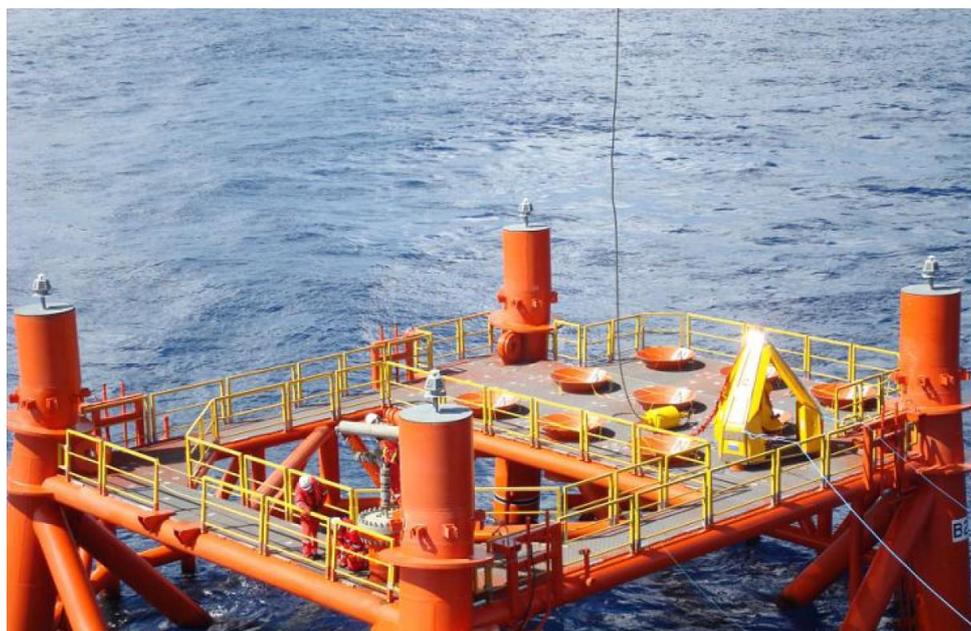
Prior to the actual lift, a swing developed on the crane's headache ball. The swing gathered momentum, despite the efforts of the crane operator to stop it, until it eventually hit one of the platform's legs and ricocheted into the capsule frame. A section of the crane rigging and headache ball hit the frame of the transfer capsule before sliding into the interior of the frame and impacting one of the three occupants.

*Jacket showing personnel transfer capsule and crane wire*

- ◆ The size of the area to which the capsule was lowered was not in compliance with the manufacturer's recommendations;
- ◆ On this occasion the crane operator did not lay the headache ball down on the jacket during the boarding of the capsule because of worsening swell conditions and restrictions on landing area (see picture);

- ◆ Risk management processes should be followed thoroughly for all high potential operations and repeated every time an operation is carried out. This is even more important when operations are carried out by different personnel;
- ◆ Actions identified during risk assessments should be fully closed out before operations begin. In this instance crane operator training had not been carried out;
- ◆ Management of change processes should always be followed whenever circumstances change during an operation. If necessary the operation should be stopped whilst this is carried out;
- ◆ All personnel involved in an operation should be fully briefed beforehand during the toolbox talk;
- ◆ Manufacturers' instructions and recommendations on the use of equipment should be followed;
- ◆ All personnel have a responsibility to intervene and stop an operation which is clearly unsafe.

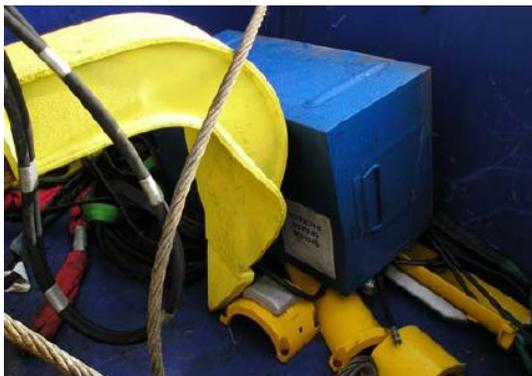
*The grab handle of this blue steel case has not been secured and the case is resting on top of other equipment*

- ◆ Use packing materials to prevent damage between items of cargo;
- ◆ Always lash down (and wedge if necessary) cargo to prevent movement in transit;
- ◆ Do not pack sharp items next to soft skinned drums;

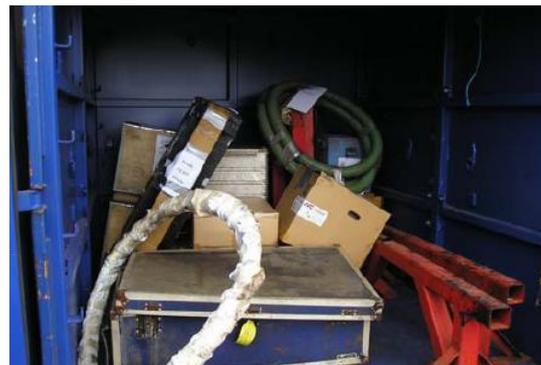
*The contents of a freight container are left unsecured. Some are labelled as fragile*

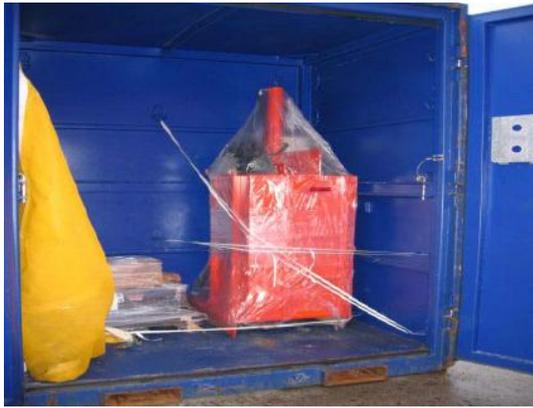
*This item is secured in an inadequate manner (nylon strapping) for its weight and value*

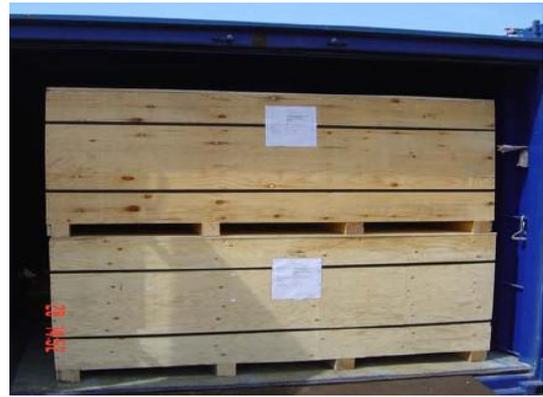
*This heavy item was loaded in closed container making it very difficult to unload offshore*

- ◆ Place contents in suitable containers, giving consideration to material handling capabilities of those receiving the load (i.e. forklift availability, access, container type);

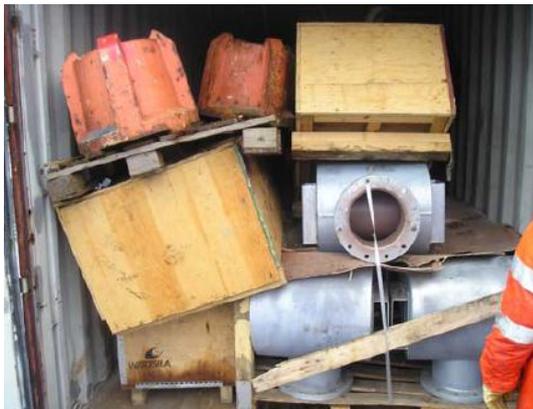
*Orange clump weights (500kg) unsecured and stored on top of lighter materials*

- ◆ Distribute the contents evenly over the floor to maintain balance;
- ◆ Place heavier items at the bottom with lighter goods on top – do not place heavy cargo on top of fragile cargo;

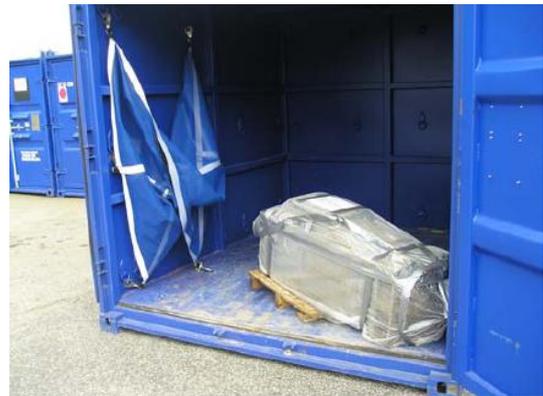
*Heavy and valuable motor left unsecured for transit*
