IMCA Safety Flash 17/13

November 2013

I High Potential Dropped Object

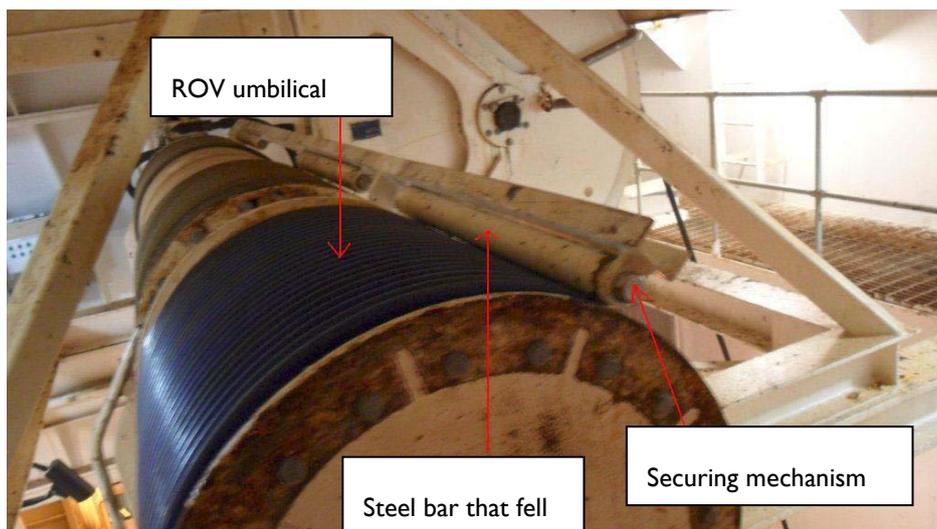
A member has reported an incident in which a heavy steel bar fell 10m onto the deck. The incident occurred during ROV deployment, when a round steel bar weighing approximately 20 kg became detached from above the cursor frame umbilical drum mechanism and fell approximately 10m onto the deck (moonpool doors). The object fell and struck the deck and then rolled under the ROV transfer plinth. There were no injuries or damaged caused, though at the time one member of the ROV deployment crew was standing in the moonpool area approximately 2-3m away from the point of impact and the ROV was approximately 1.5m off the deck.

Figure: Showing ROV umbilical winch drum from which steel bar fell

- ◆ The steel bar was identified as having come from above the cursor frame umbilical drum. It was used to stop the umbilical jumping on the drum;
- ◆ During a maintenance period (5 months prior to this incident), to upgrade parts of the existing ROV launch & recovery system, the manufacturer had fitted a guide above the drum as an improvement to the incumbent system. The function of this steel bar was to stop the umbilical jumping and fouling;
- ◆ The cause of the incident was found to be: three separate steel bars were fitted to a holding guide frame and held in place with bolts at each end. The ROV umbilical on the drum was rubbing against the guide causing the bolts to loosen over a 5 month period. This was due to there being insufficient clearance between the round steel bar and the umbilical when on the cursor drum.

- ◆ Weekly inspection checks on the steel bar guides, inspection interval to be reviewed, confirmed and included in planned maintenance system;
- ◆ Inspection to include confirming a minimum of 5mm clearance between the guide bar and umbilical;

- ◆ Ensure that the securing bolts are tight and torqued on all guide bars;
- ◆ A secondary securing device to be fitted to the round bars and this to be inspected during the planned inspection. Remedial hold back on all three guide bars as a temporary measure put in place;

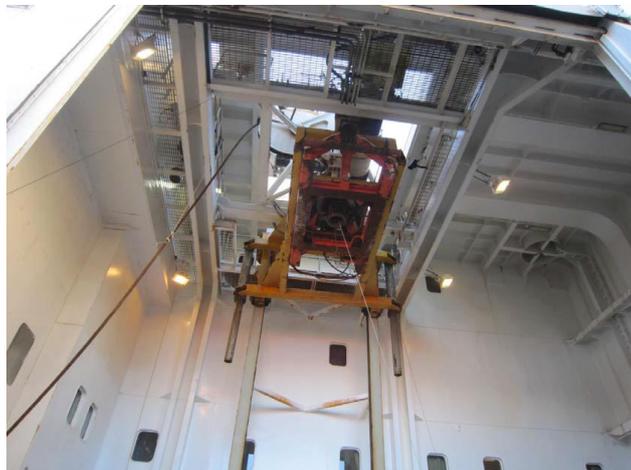
Figure: Looking to the top of the ROV hangar at the cursor and cursor winch

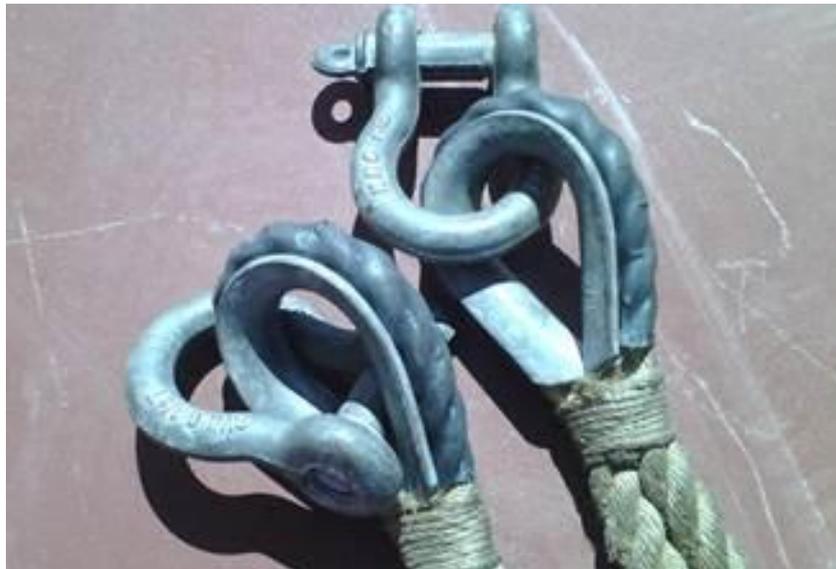
Upon boarding the ship, the inspector checked the damaged ladder and reported that, while the ladder generally appeared to be in good condition, the rope had parted at the upper end where an eye was formed around a thimble to allow for securing the ladder.

The rope around the thimble was covered with (heat shrunk) plastic, which did not allow that part of the rope to be inspected before use.

As it turned out, the rope under the plastic covering was completely rotten.

Figure: showing plastic covering under which the rope was rotten

These incidents highlight the importance of regularly inspecting every part of all ropes that are deployed on board, whether for safety equipment or for mooring operations.
