# IMCA Safety Flash 17/14

October 2014

## I LTI: Fall Overboard/Fall from Height

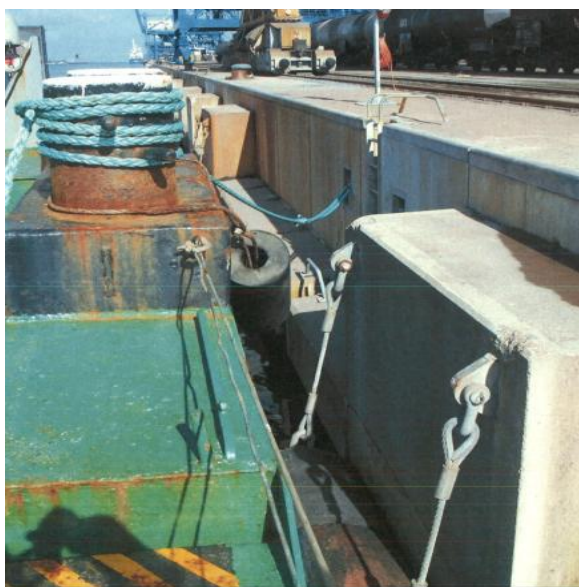
Figure: showing high position of bollard and low position of top hand rail

- ◆ The injured person was working alone;
- ◆ He found it necessary to lean overboard and used no personal protective equipment (PPE) or restraint mechanism;
- ◆ There was a mechanical jolt of barge against quay wall fender;
- ◆ The relatively high position of the bollard and the low position of the top hand rail;
- ◆ Poor weather conditions;
- ◆ The working conditions and the weather conditions had not been properly risk assessed.

- ◆ Never lean out overboard without first securing yourself – everyone is responsible for their own safety;
- ◆ In poor weather conditions always work on deck in pairs and secure yourself to the deck;
- ◆ Crew need to remain aware that they can 'Stop the job' no matter who they are;
- ◆ Increase due care level for routine jobs – be better informed about risk and control measures;
- ◆ As far as practical, use a capstan head or mooring winch to affix mooring lines;
- ◆ Improve the relatively high position of the bollard and the low position of the top hand rail;
- ◆ In case of suspected spinal injury do not move the injured person unnecessarily.

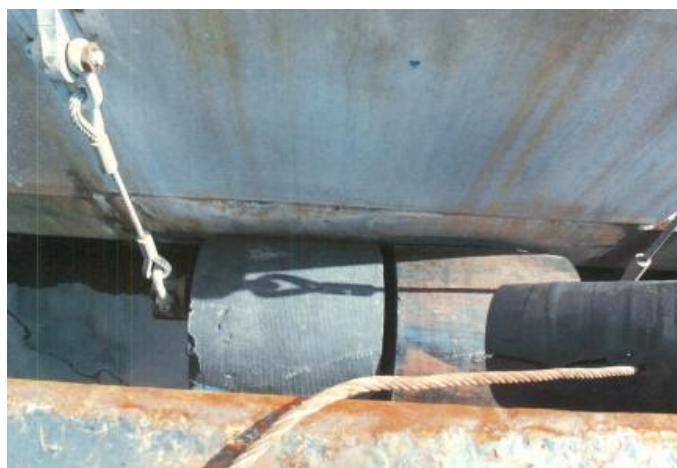
A member has reported an incident which a member of the crew of a hopper barge fell overboard onto a cylinder fender attached to the quay wall. He sustained serious injuries to his spine (twelfth thoracic vertebrae crushed and splintered). The incident occurred whilst alongside, during refitting a rope connection between the hopper barge and the quay wall. At the time of the accident the empty hopper barge was firmly moored at the quay wall, at one of the berths.

Figure: showing cylinder fender on quay wall, onto which the casualty fell

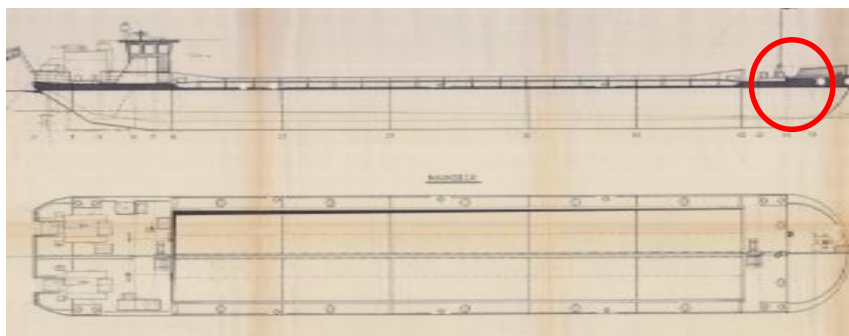
Due to adverse weather conditions (wind force 9, rain showers and swells in the inner harbour) and rising tide, the head line became slack. The injured person was on the foredeck to check the rope connection and to refit the rope. During refitting of the rope he had to bend slightly with his upper body overboard. When re-fixing the head line, the barge struck the berth fenders due to the wave motion in the harbour basin. As a result of this the injured person lost his balance and fell from a height of about 2m overboard onto the cylinder fender on the quay wall. He was rescued, using a ladder from the berth-fender and brought on board for transfer to hospital.

Figure: barge showing where incident occurred

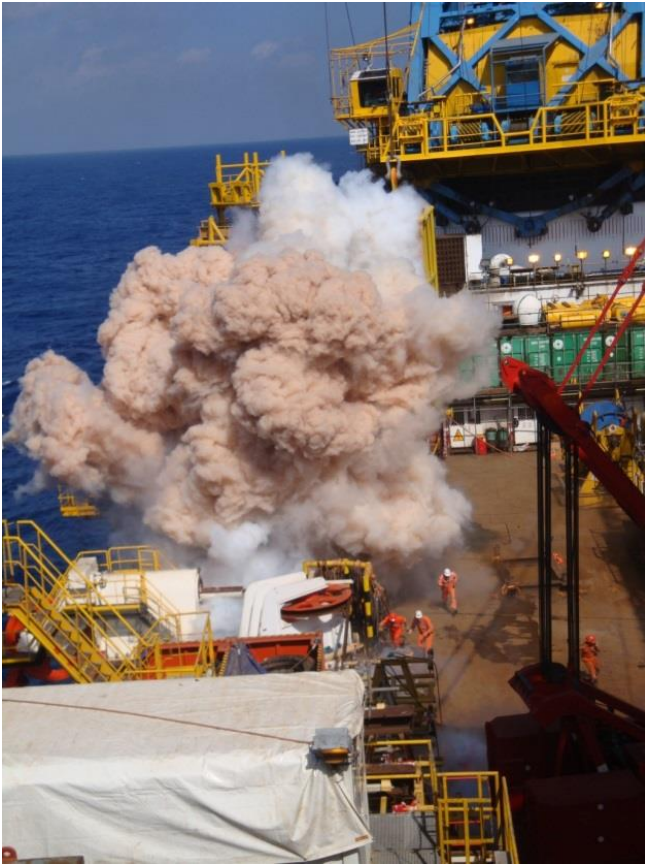
- ◆ The lithium battery pack exploded. There were no other energy sources in the area;
- ◆ The battery pack was thought to contain around 60 cells. A number of the cells were located in the debris field and were undamaged. The explosion was thought to be as a result of only one or two battery cells failing;

- ◆ Early indications are that the battery pack overheated triggering a chemical reaction resulting in an explosion. The cause for the overheating is not yet understood although all preservation requirements are thought to have been adhered to i.e. external temperature constraints;
- ◆ The manufacturer of the corrosion erosion monitor was informed, and the manufacturer took steps to find out what had happened, and to ensure that the incident could not recur.

Figure: showing Lithium battery explosion as it occurred

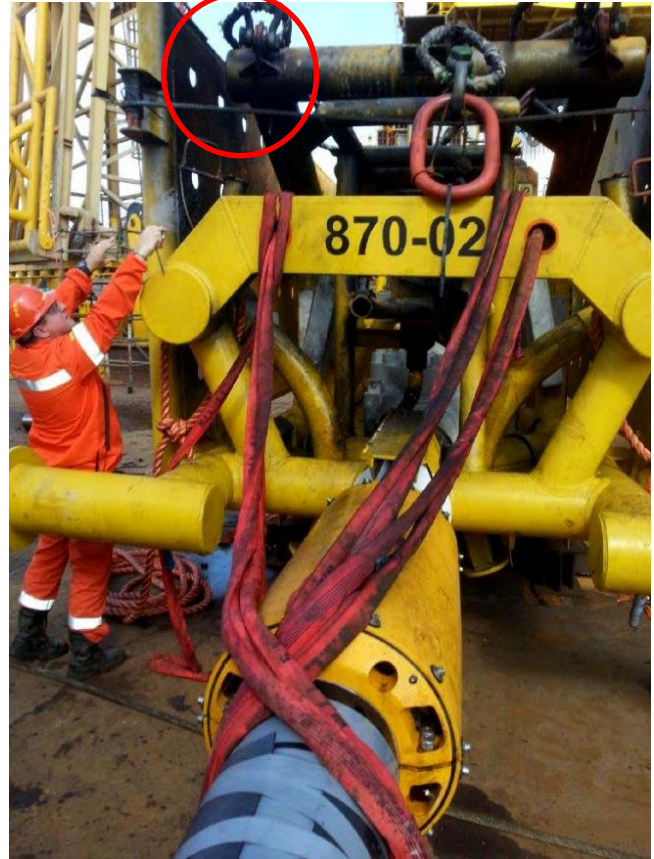
Four persons required medical treatment with one person requiring a number of stitches to the forehead as a result of flying debris. There was significant damage to the surrounding steel work of the Pipe Line End Termination (PLET), and subsequent installation delays while the remaining battery units were made safe and replaced with NiCd type systems.

Figure: showing damaged pipeline end termination (PLET) after the explosion (note blackened areas in red circle, and CEM sensor array in foreground)

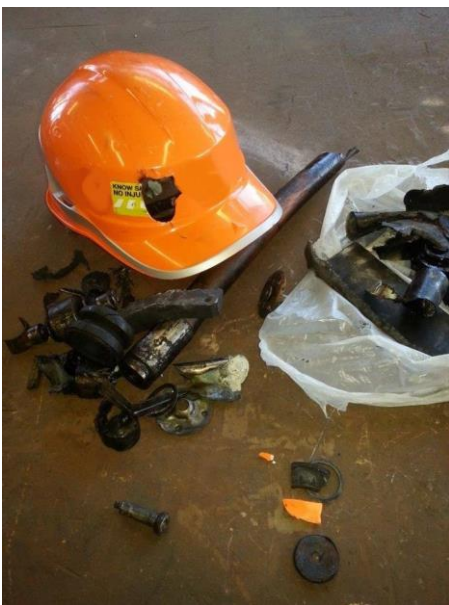
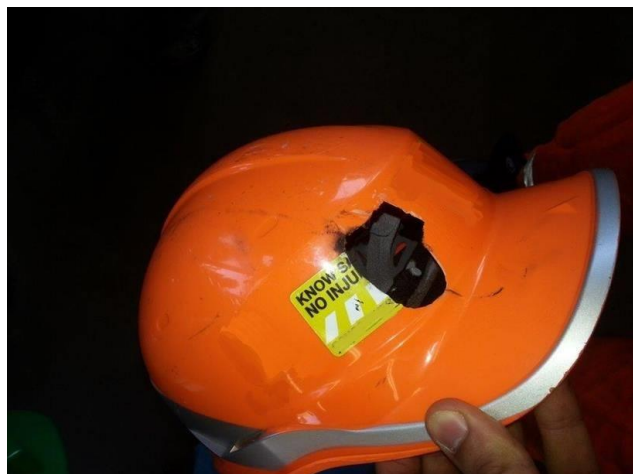
Figures: showing damage to helmet hit by flying debris from what is believed to be part of an ROV hatch close to the battery unit. The helmet and the person wearing it were 20m away from the area when the explosion happened.

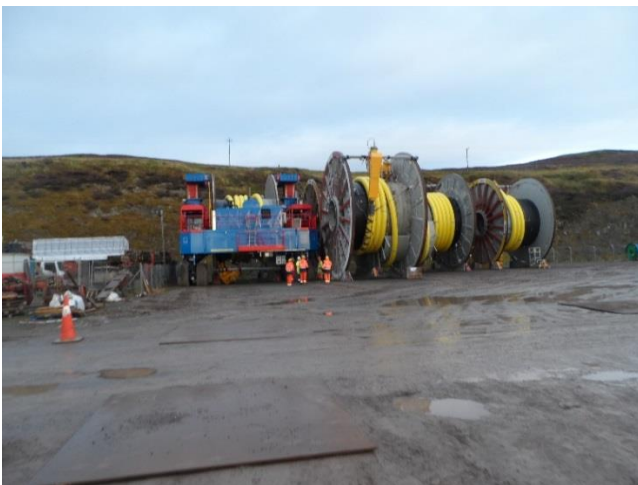
Figure: showing JRC (blue)

- ◆ The criticality of the position of the CoG of the loaded reel was not recognised;
- ◆ There was a lack of awareness that the JRC was not designed to lift and transport reels that are significantly off-balance;

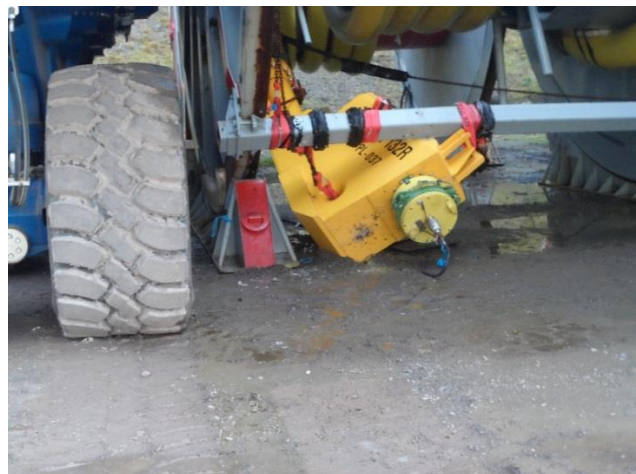
A member has reported a near-miss incident which a large hydraulic reel started rotating in an uncontrolled way. The incident occurred during onshore preparatory works for a vessel mobilisation. Two 9.6m diameter reels laden with jumpers and pullheads had to be lifted and transported from the storage area to the quayside using a 'Jumbo Reel Carrier' (JRC). The first reel was successfully transported to the quayside with its transport cradles attached as normal. It was then decided to transfer the second reel to the quayside without its cradles as they could land the reel onto the cradles from the first reel once it had been lifted onto the vessel. As the second reel was being lifted, it started rotating in an uncontrolled manner, until a pullhead touched the ground and was damaged.

Figure: showing cradle and damaged pullhead

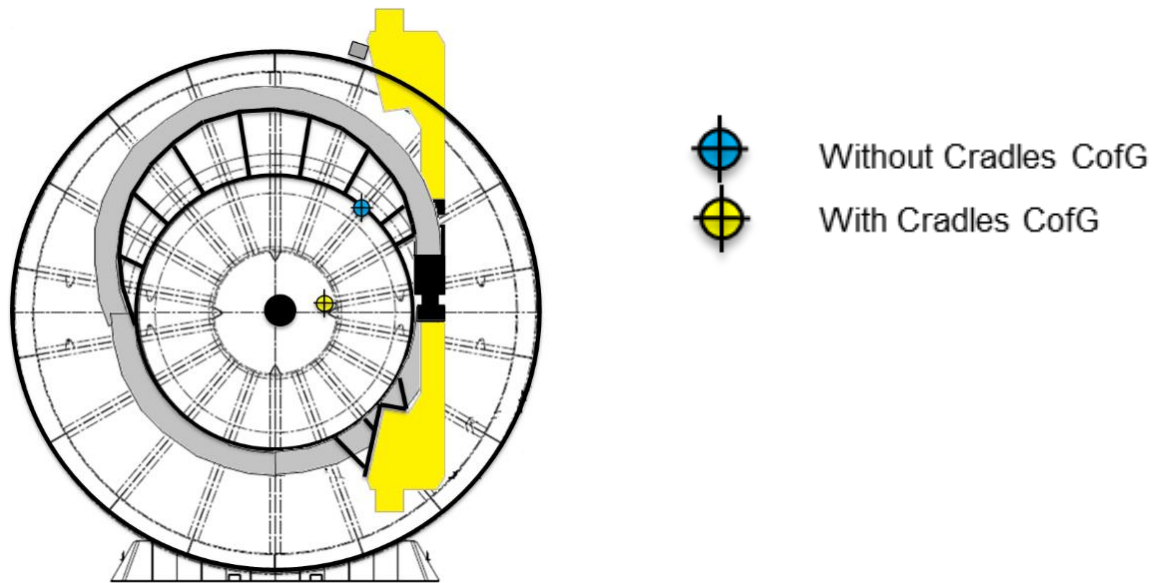
Figure: showing change of Centre of Gravity (CoG) with (yellow dot) and without (blue dot) the cradle

- ◆ The **immediate cause** of the incident was found to be the action of lifting the reels without the cradles (weight circa 3Te each) caused the CoG (Centre of Gravity) to be above the pivot points. This combined with the fact that the reel was already unbalanced owing to the position of pullheads and the snail caused the reel to overcome the friction at lift points and rotate;

- ◆ Consider the limitations of the JRC with regard to lifting reels containing additional components;
- ◆ Recognise that lifting without cradles was a change;
- ◆ Ensure method statements, risk assessments and procedures adequately consider the actual task and loads involved.

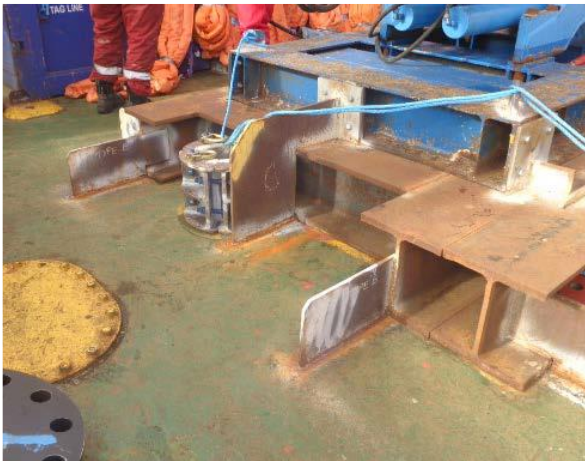
Figure: person tripped over Sea Fastening on right and banged his face on Sea Fastening on left resulting in a cut upper lip

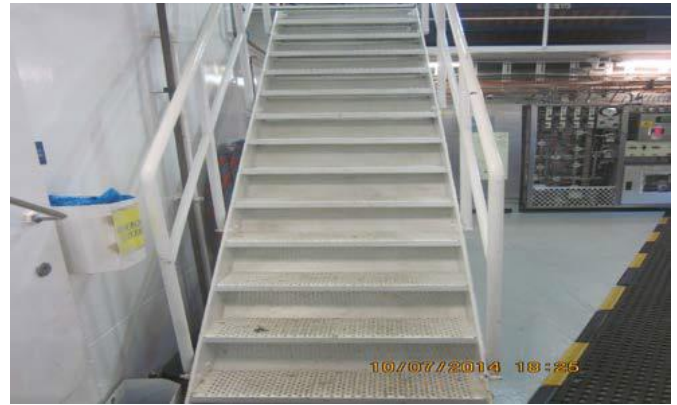
Figure: person slipped whilst descending the stairs bruising both his thigh and calf

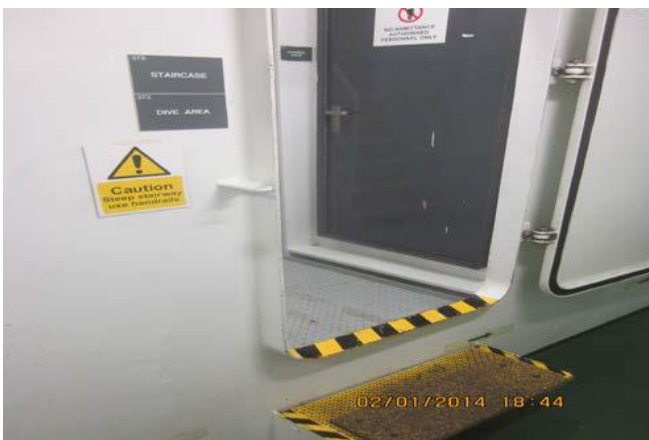
Figure: person slipped coming out of the door way, injuring his knee

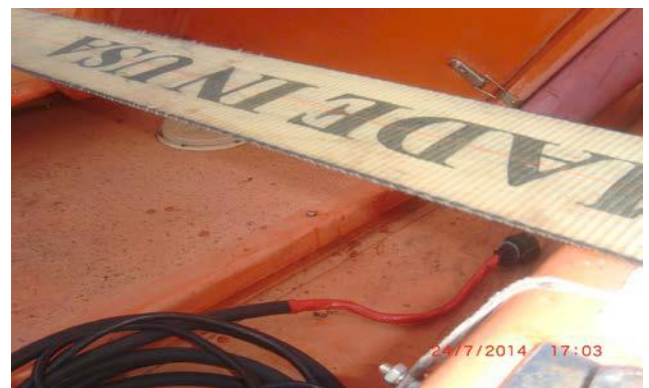
Figure: person tripped over the sea fastening strap on the Fast Rescue Craft bruising his knee

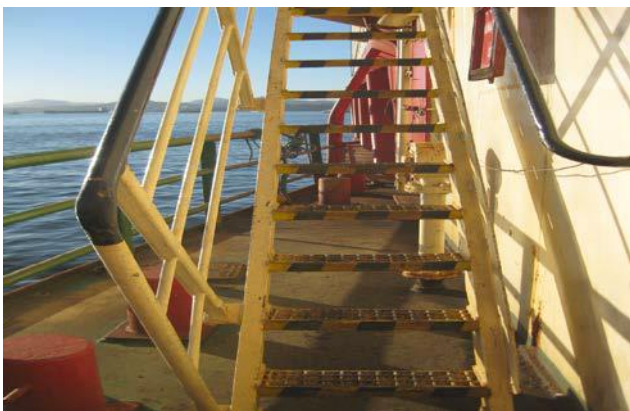
Figure: person slipped while descending the stairs, bruising his knee

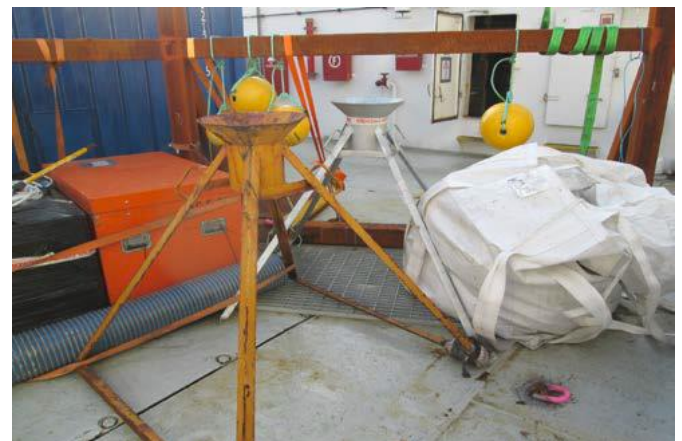
Figure: person's foot got caught in the bag handle; he then stumbled and fell twisting his ankle

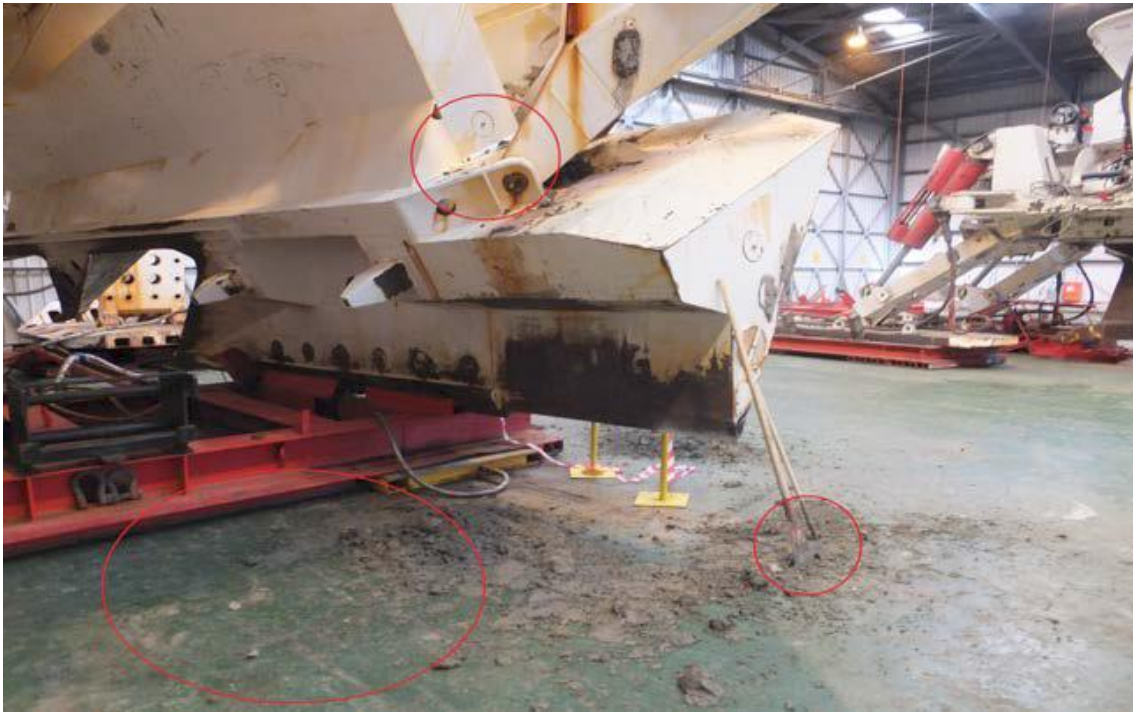
*Figure: here, the injured person was working between the ground level as well as the air skate frame (20cm high); he stepped down and slipped on the silt in the bottom of the dry dock during cleaning operations, and fell to the floor banging his head, he also cut his face and bruised his ribs and hip. Red circles indicate area being cleaned; area where injured person fell, and tools being used.*

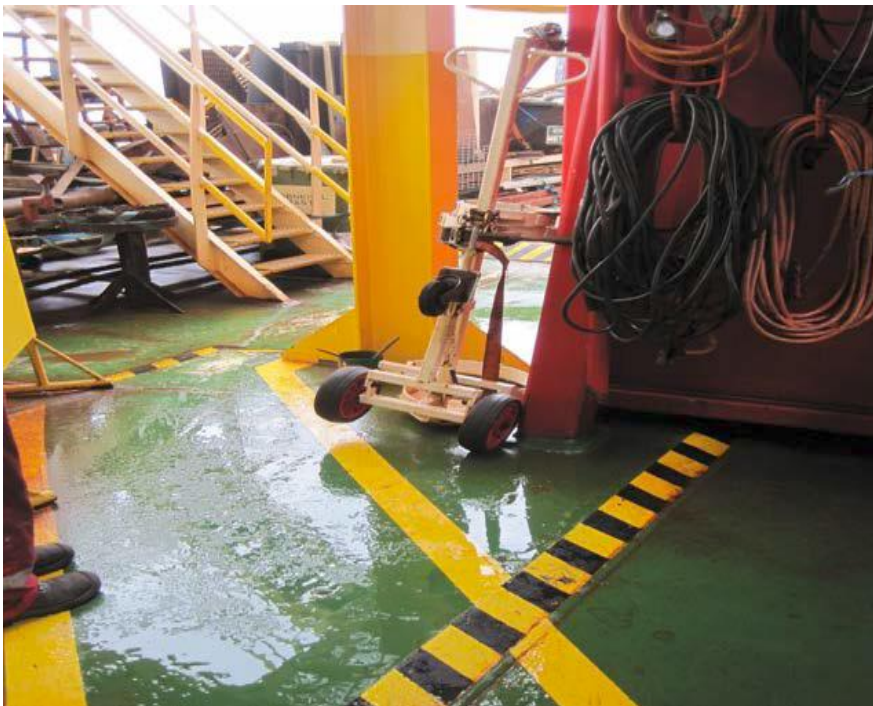
*Figure: injured person tripped over raised black/yellow warning line and fell, chipping one tooth and cracking another tooth when his face came into contact with the gas cylinder trolley*
