IMCA Safety Flash 17/18

August 2018

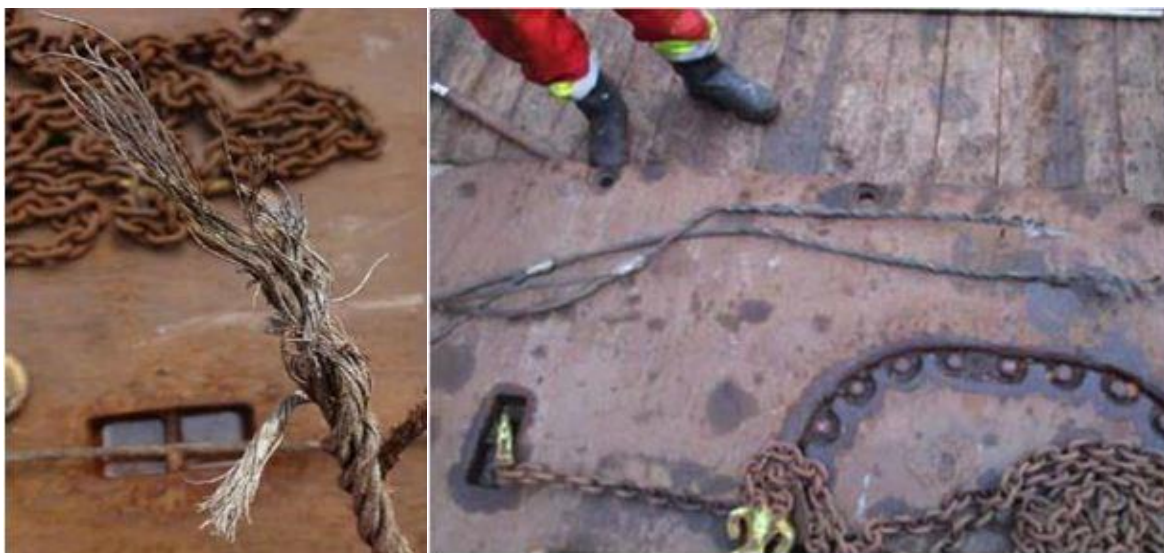
The crew were preparing a chain (76mm in length) for a decanting operation onto a semi-submersible mobile offshore drilling unit (MODU). Whilst recovering the chain, the starboard-aft tugger wire was connected to the chain, using a 6Te wire rope sling. The chain was recovered and was approximately a quarter of the way up the deck when the wire rope sling failed, causing the 76mm chain to fall onto the deck and into the AHV locker. No one was injured.

- ◆ The crew assessed the damage to the wire rope sling. After inspection, the sling was discarded;
- ◆ All the equipment used during the operation was inspected and no damage was found;
- ◆ A new 10Te sling was to be used, the chain reconnected and successfully recovered.

- ◆ Equipment inspections should be made before any operations are undertaken;

- ◆ Ensure all lifting equipment is suitable and fit for purpose.
- ◆ A clear deck policy was in place when this incident took place – it is important to make sure that you have a clear deck policy in place when undertaking operations. This will, as in this incident, prevent any injuries from occurring.

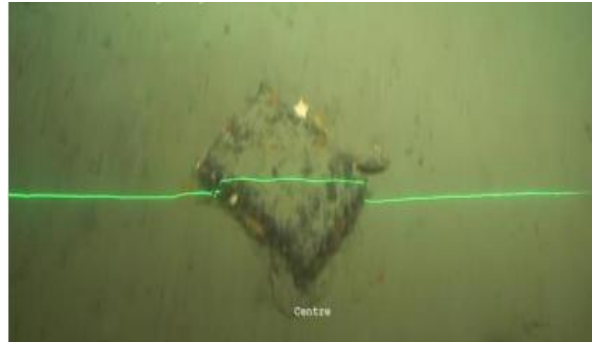
During the initial phases of the operation, several boxes previously classified as concrete debris were investigated and observed to be boxes containing dumped munitions. These boxes were left in place on the seabed. Later in the operation an item recovered, believed to be 'machine parts', was recovered to the vessel deck. The box was handled by vessel crew before they realised it was a WWII munitions box. Expert advice was obtained and the UXO was returned to the seabed.

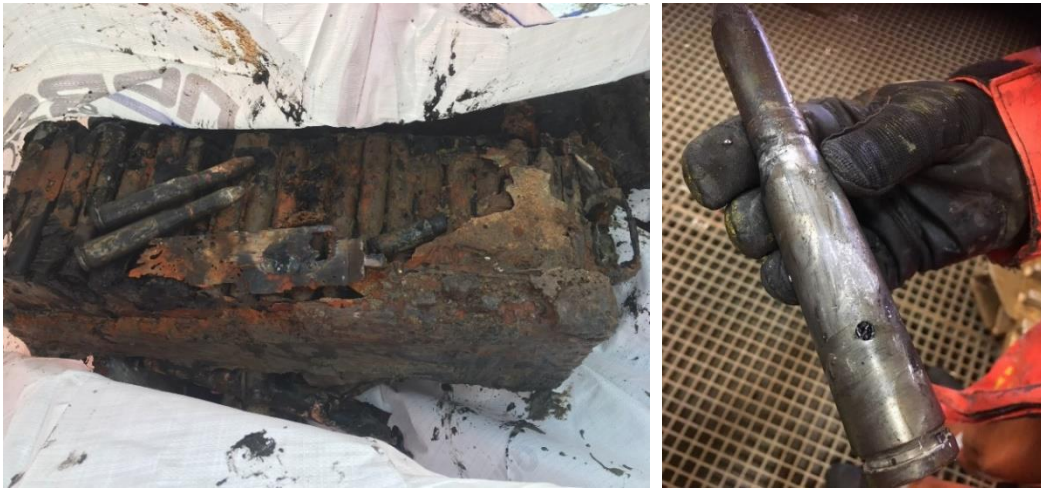
- ◆ Personnel handled dangerous items, bringing them to deck, and one person tampered with a piece of ammunition attempting to verify its condition. Personnel raised concern to on-board management;

- ◆ Immediate causes:
 - lack of valid information
 - lack of correct identification of debris
 - lack of management intervention
 - lack of adherence to procedures/lack of direction
 - complacency;
- ◆ Underlying causes:
 - failure to apply suitable management of change (MoC) and adequately assess risk
 - fundamental misunderstanding of key risks.

Items recovered to vessel deck

- ◆ Reinforcement required of stop work authority and MoC, specifically actions towards managers/leaders;
- ◆ Revision required for procedures covering actions to be taken in the event of discovering dangerous items such as UXO;
- ◆ Method of survey to be re-evaluated;
- ◆ Additional training and guidance to teams involved in debris clearance operations.
