IMCA Safety Flash 18/08

December 2008

I Mini Transponder Falling from Crane Wire to Deck

2 Failure of Pipe Handling System Causes Injuries and Fatalities

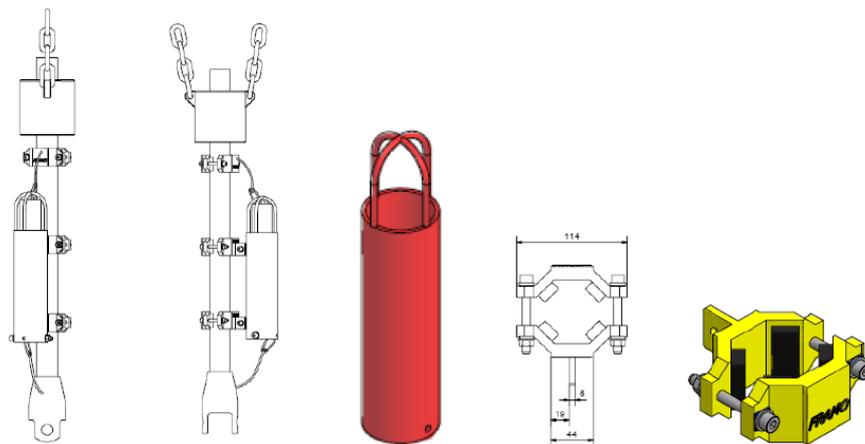
A 35m long pennant wire with a guide anchor in the end was being used to open/close hatches on templates. After closing hatches the wire was recovered to deck. A mini transponder was attached to the crane wire just above the crane hook, with two hose clamps. Due to the length of the forerunner the crane had to lift it as high as possible and the wire remaining outside the side of the ship had to be manhandled over the rail. Due to a failing end stop mechanism the crane was hoisted too far and the mini transponder was torn off the crane wire and fell to the deck, narrowly missing two members of the crew who were under the crane ready to manhandle the wire end in on to the deck. There were no injuries.

Transponder bracket design

- ◆ Deck personnel should not have been under the load or in the lifting area;
- ◆ Deck personnel should be reminded to always wait for a signal from the crane driver before moving into a lifting area;
- ◆ The practice of attaching the transponder to the crane wire should be identified as a risk and discussed appropriately at toolbox meetings beforehand;
- ◆ The faulty end stop mechanism on the crane was repaired – as this mechanism was the only barrier preventing the wire from being hoisted too far, the electrical switches on the end stop mechanism were replaced with switches of a better quality;
- ◆ A formal procedure was implemented for safely attaching the transponder to the crane wire;
- ◆ A purpose-designed transponder bracket was designed and fabricated for fastening these to the crane wire, such that the transponder itself cannot hit the end stop block.

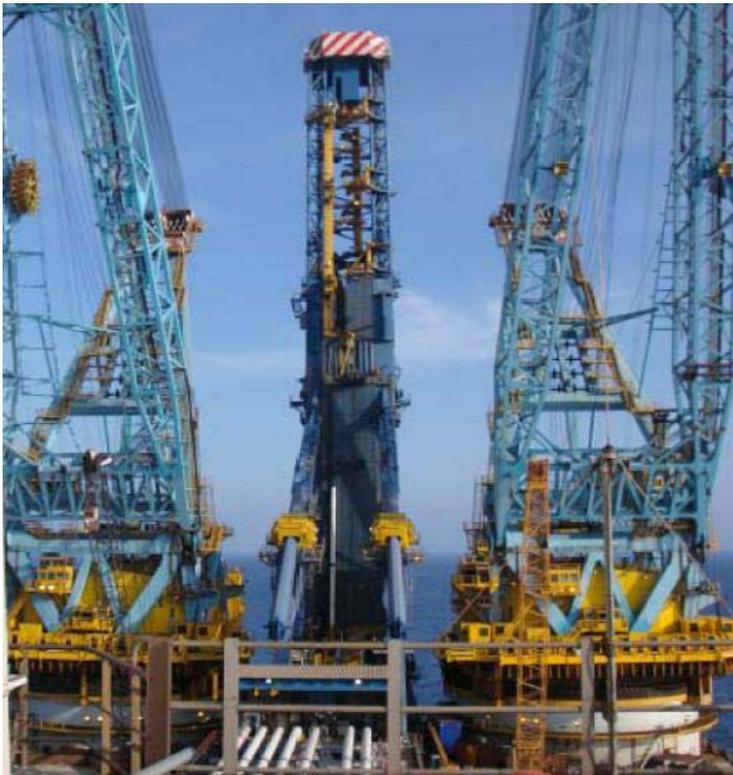
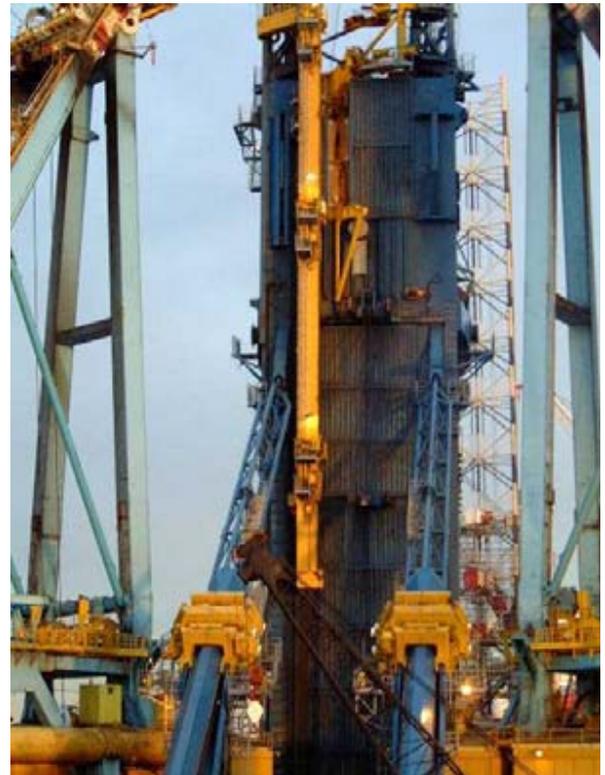
J-lay tower

- ◆ Sudden release of the two quadruple joints was caused by a failure in conceptual design of the control system software. The program relevant to the JLT initialising instruction was pre-loaded in the erasable programmable read-only memory (EPROM) of the programmable logic controller (PLC) with the instruction to open all clamps. **Members are**

- ◆ The unnecessary presence and uncontrolled access of working personnel on to the access platform destroyed by the falling pipe exposed personnel to suspended load/dropped object hazard.

- ◆ The first primary cause was resolved with the removal of the EPROM memories from the system;
- ◆ The second primary cause has been addressed by a revision of the vessel and JLT working methodologies; pipe handling activities have been reconsidered through a dropped object philosophy in order to identify mechanical and electrical barriers, additional controls, and new set of operational procedures;

- ◆ Electrical controls:
 - a number of clamp opening operations were prevented by adding electrical circuit breakers
 - all critical sequences will be called by PLC and must be confirmed by operator via electrical push buttons;

- ◆ Mechanical controls:
 - different systems have been and will be implemented to prevent the vertical pipe drop in any section of the JLT, to restrain lateral pipe movement and fall and to secure the pipe until the internal line up is completed in the upper welding station

- an additional public address system was installed for use during quadruple joint loader lift, and audible and visible alarms for elevator movements
 - a safety net was installed underneath the J-Lay tower platforms to guarantee protection against persons falling overboard;

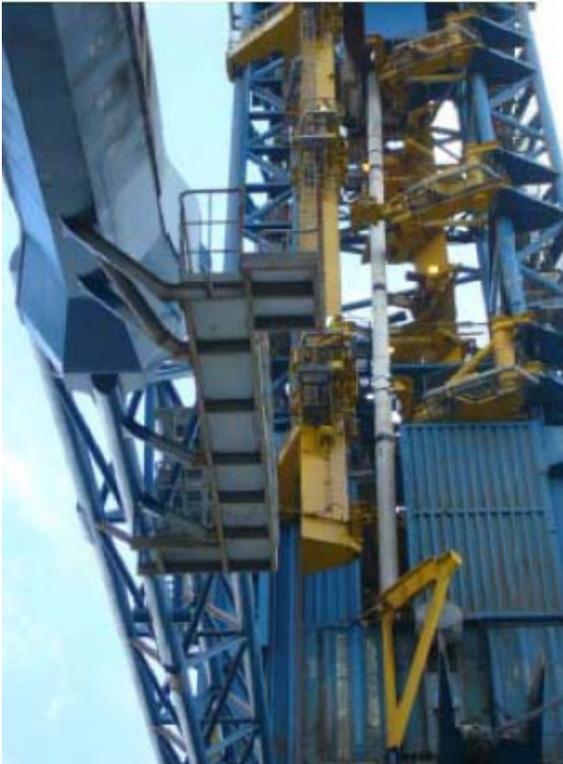
Pipe held in the clamps

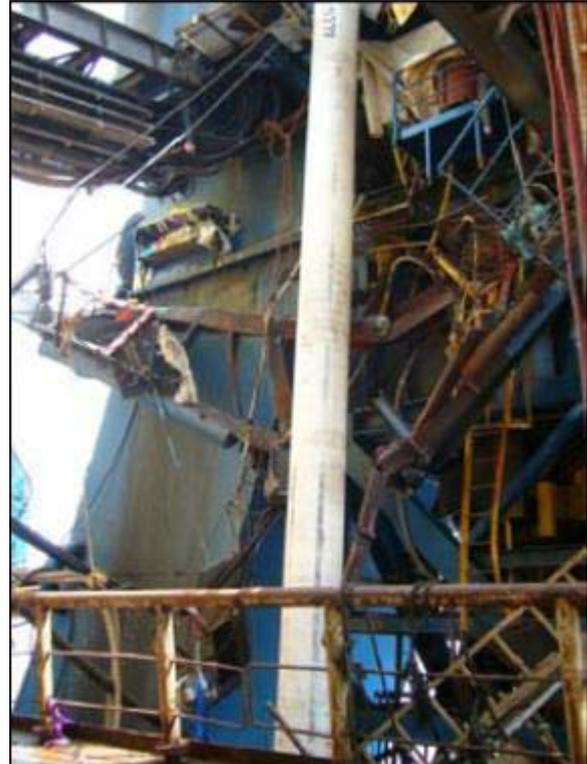
Only after all indications that everything was in order and all systems were up and running again was the instruction given to the operator to restart the hydraulic packs. As soon as the hydraulic power packs were started, a loud bang was heard along with the noise of the hydraulic systems. One quadruple joint within the J-lay tower, held by the transfer system, was released and fell about a metre to the upper welding deck. At the same time, the quadruple joint held by the pipe elevator at the top of the J-lay tower was also released from its clamps and the hydraulic safety stop swung away, allowing the pipe to fall the full height of the tower, smashing through the access platform located outside the non-destructive testing/coating station to the lower deck below.

All the people who were injured had been on the access platform which was destroyed. The force of impact caused some of the injured persons to fall down on to the lower deck at the base of the pipe-lay tower and some to be thrown overboard.

Pipe and wreckage after the fall
