IMCA Safety Flash 18/09

December 2009

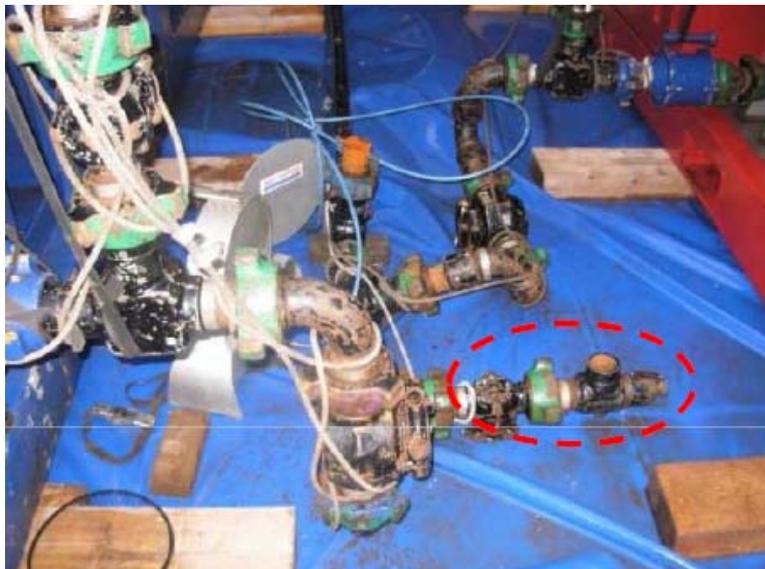
During a pressure test with nitrogen, a pressure relief valve in the treating line vented. The valve was rigged up in a vertical position approximately 60cm above the height of the line. As the valve vented, the assembly rotated through 90 degrees and hit the deck of the rig. During this rotation the assembly struck a crew member on the temple causing a fatal injury.

Valve equipment that moved following release of high pressure

- ◆ As the valve vented, the force caused the vertical stack to rotate through 90 degrees until it came into contact with the deck;
- ◆ The crew member was in the high pressure area while pressure was being applied in order to check the pressure on an instrument in the vicinity.

- ◆ Equipment that could move in reaction to the sudden escape of gas under high pressure should, as far as possible, be properly secured, anchored or immobilised. All fittings and connections on pressure test equipment should be rated for the test pressure and adequately secured.

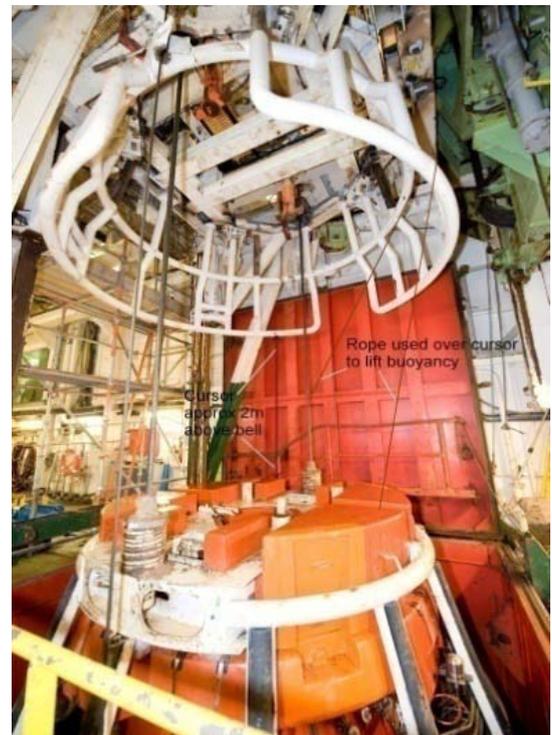
The cursor was suspended above the diving bell by the newly installed winch and it fell as a result of a failure of the hydraulic braking system for that winch. A rigger was working on top of the diving bell modifying some buoyancy units at the time of the accident. Although there were a number of other people in the vicinity and close to the worksite there were no other injuries.

The immediate cause of the winch failure was determined to be a faulty pilot valve in the cursor's winch control system. A technical failure in the pilot valve prevented the automatic brake application on the winch.

- ◆ A faulty pilot valve in the winch system failed, causing the brakes not to be applied in the stop position. This resulted in the hydraulic winch being unable to hold the weight of the cursor, which caused the winch to unwind and drop the cursor;

Diving bell with cursor above

- ◆ Measures should be in place to identify and mechanically secure suspended loads before passing beneath.

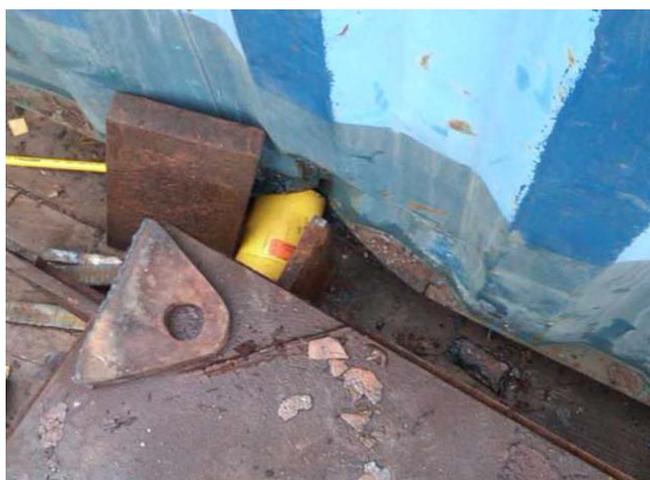
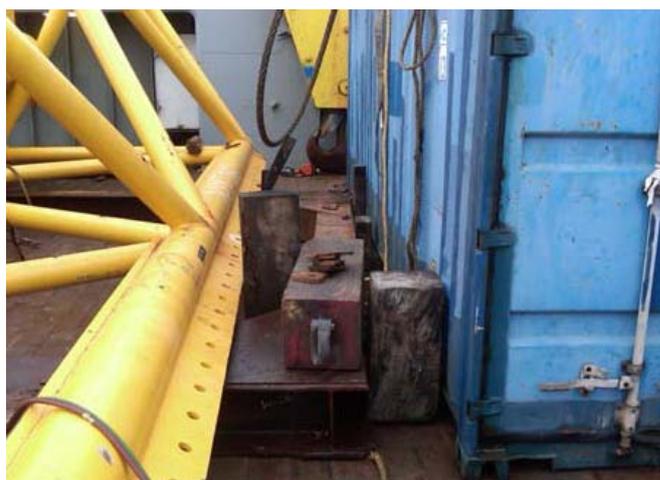
A member has reported an incident in which a sub-contractor's employee suffered a leg injury which was categorised as a lost time injury (LTI). Whilst working on offloading a vessel, the sub-contract employee's left leg above the ankle was pinned between a shifting spreader bar frame and a freight container located adjacent to the spreader bar frame. While one of the seven spreader bars was being lifted and in the air the remaining bars shifted, causing the frame to slide approximately one metre (40 inches) towards the freight container where the employee was standing. Hydraulic power packs were used to help free the trapped employee, who was taken to the local hospital. The employee suffered a hairline fracture of the left ankle and the incident was categorised as an LTI.

Injured person's ankle was trapped between yellow spreader bars and blue freight container

- ◆ Installation of clips to secure the load frames to the deck and installed additional safety stops on the load frames to hold the spreader bars from moving
- ◆ Audit of training records of all sub-contractor personnel in order to ensure that personnel without proven competence or proper training were not accepted for work;
- ◆ The sub-contractor was asked to provide full training for all contract personnel, which should be:
 - appropriate to the work being performed
 - compliant with local regulatory safety standards
 - fully verifiable through testing;
- ◆ Senior leadership would provide clear guidance to supervisory personnel that safety processes and procedures could not be cut short.

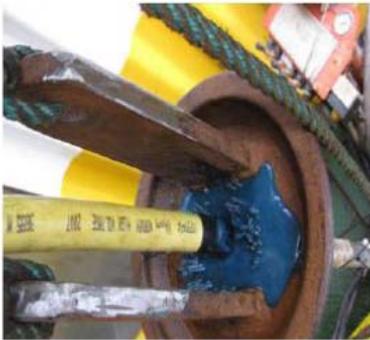
Picture of cast taken after re-termination

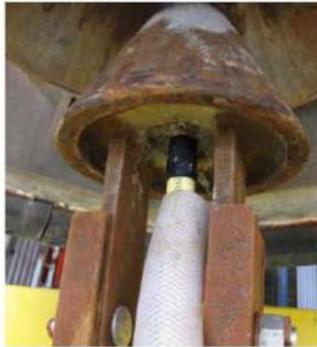
Two months after the cast was made. The strands show signs of being pulled into the cone. (Random picture available from system)

- ◆ The friction on the inner wall of the bullet was found to be greater than the combined friction of the strands, with the result that the cast was not able to be drawn down and wedged properly;
- ◆ During the investigation it also became clear that the relevant checkpoint in the maintenance programme was not detailed enough.

- ◆ A new maintenance checkpoint task was added for inspecting the armour strands for any signs of being pulled through the potting;
- ◆ Pictures of the cast structure of the company's entire ROV fleet were initiated immediately following this incident, for further review and technical analysis;
- ◆ Further pictures of the cast structure of every ROV system would be taken on a frequent basis;
- ◆ All bullets made of carbon steel would be changed out and replaced with a new type of bullet made of stainless steel. This would eliminate corrosion and friction to the inner walls of bullet.

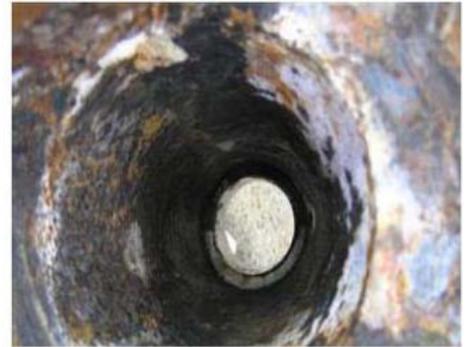
The surface of the inner cone was corroded and rough, although loose rust was removed

- ◆ Friction on the inner wall of the bullet was greater than the combined friction of the strands;
- ◆ An important quality control checkpoint lacked clear, and easy to follow, instructions.
