IMCA Safety Flash 18/13

December 2013

I Fatality During Lifting Operations

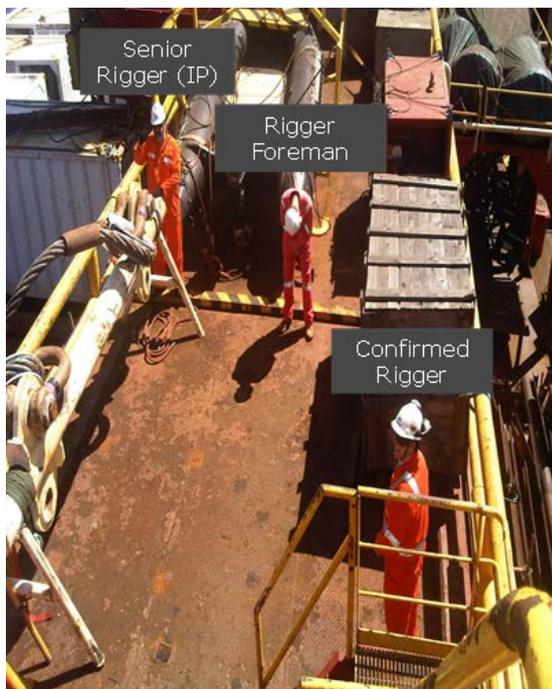
The rigger foreman, senior rigger (IP) and the certified rigger were located on the spar deck. They had already received and sea-fastened the spreader beam and were awaiting the next load to arrive. As the Heavy Lift Crane boom was located in its rest, the Manitowoc crane boom could not be positioned to allow a plumb lowering of the load onto the spar deck. The senior rigger (IP) was asked to move to a safe position by the rigger foreman.

Position of riggers on the spar deck

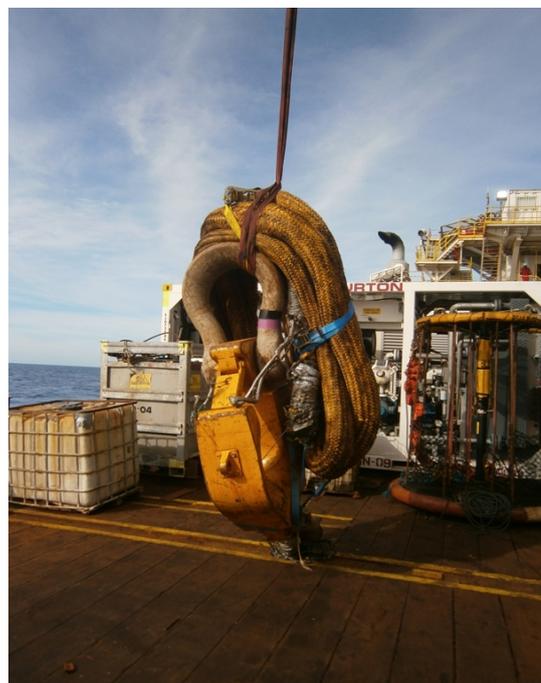
Dyneema sling and ROV reverse hook

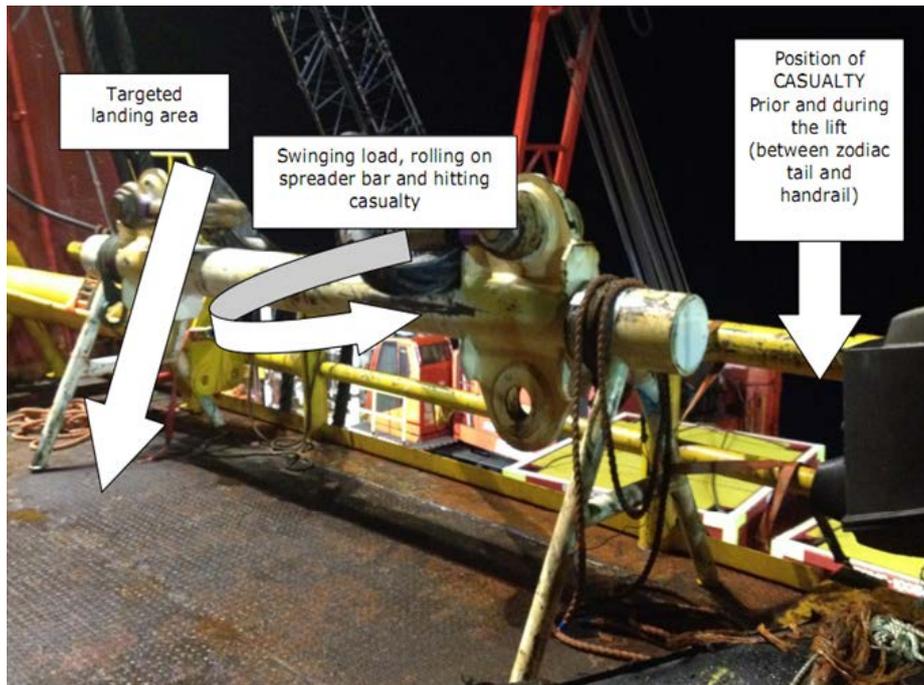
After confirmation was given to send the load it arrived suddenly at the spar deck; it landed inboard against the spreader. It then slid forward towards the senior rigger, who was struck twice by the suspended load. Due to his height the load made contact with his chest and crushed him against the cargo rail, at his back.

Illustration of load movement towards injured person

- ◆ Incident occurred in daylight hours;
- ◆ Wind was 20-22 knots ESE;
- ◆ Significant wave height 2.7m, with maximum wave height of 3.1m;
- ◆ The senior rigger may have felt he was already in a safe position, between the end of the spreader bar and the stern of the zodiac, not anticipated he was actually at risk;
- ◆ The slide forwards of the heavy load may have been caused by:
 - Induced momentum from crane swing
 - Contact with the parking leg of the spreader beam
 - Contact with the lifting eye, nubbins of spreader beam
 - Induced spin from offset of centre of gravity
 - Vessel motion from sea state;
- ◆ Or any combination of the above factors.

- ◆ Careful consideration should be given to all lifting operations. All lifts require planning whether they are routine or non-routine;
- ◆ Careful consideration should be given to the positioning of personnel – particularly riggers and banksmen, during lifting operations;
- ◆ Members may also wish to refer to IMCA SEL 019 *Guidelines for lifting operations*.

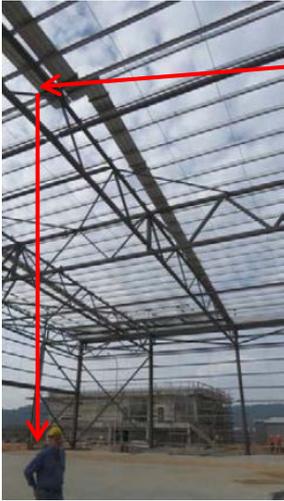
An employee of a sub-contractor slipped and fell 15m resulting in a brain haemorrhage and leg fracture.

The injured person and co-worker location with a fall distance of 15m.

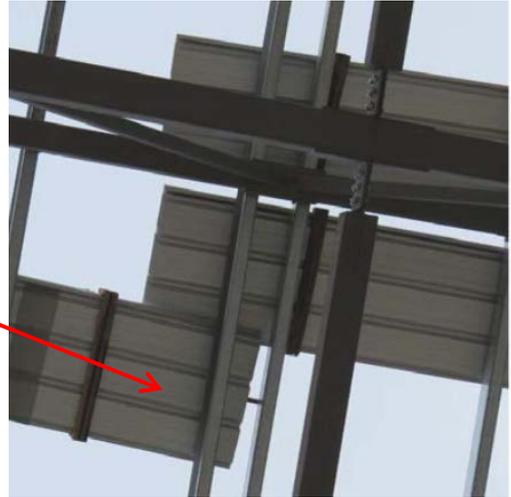
Roof sheets stacked on top of one another

Showing work area from which person fell

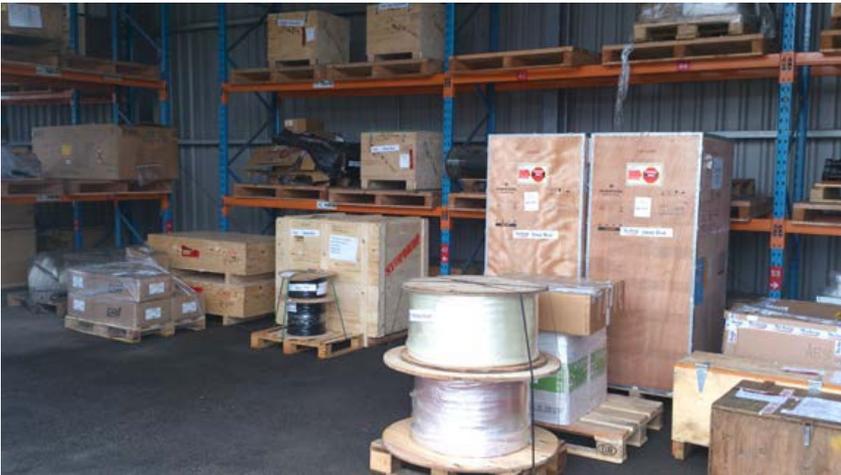
The injured person stood on a cardboard box to access the racking shelves in the storage area, of an onshore yard. Consequently, the injured person fell from the box and suffered a broken wrist and fractured elbow.

Internal storage area at onshore site

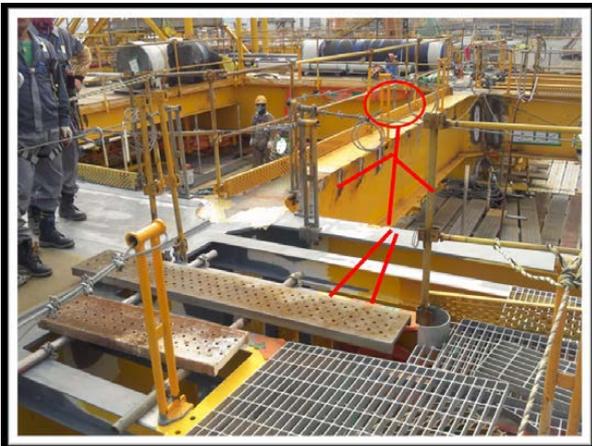
The injured person was attempting to transit an unsecured walkway and fell a distance of 1.7m. The person fell onto the scaffold structure below; the fall resulted in four broken ribs.

Showing from where and how injured person fell

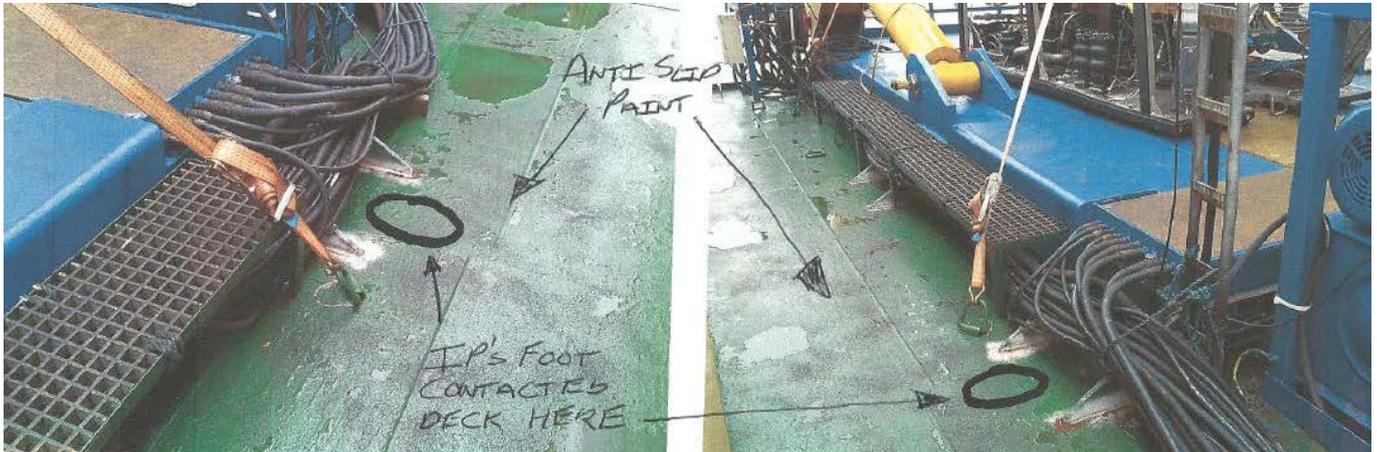
The injured person stepped down onto exposed hose-work from the ROV launch and recovery system (LARS). The person skidded onto the deck and slipped. The impact resulted in two minor fractures to the bones in right arm.

Showing worksite where injury occurred

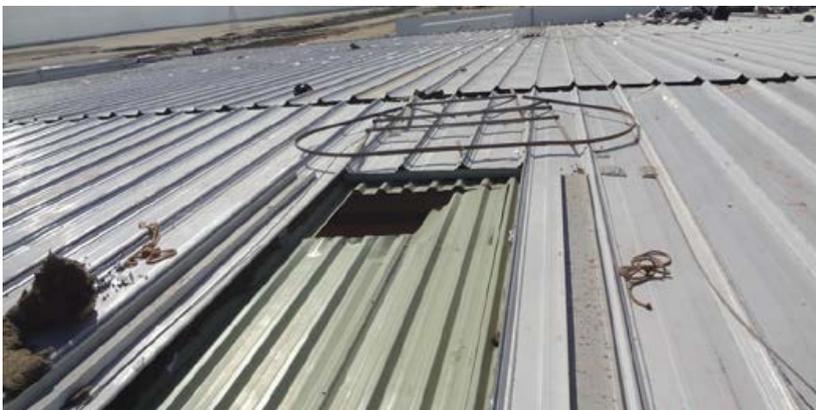
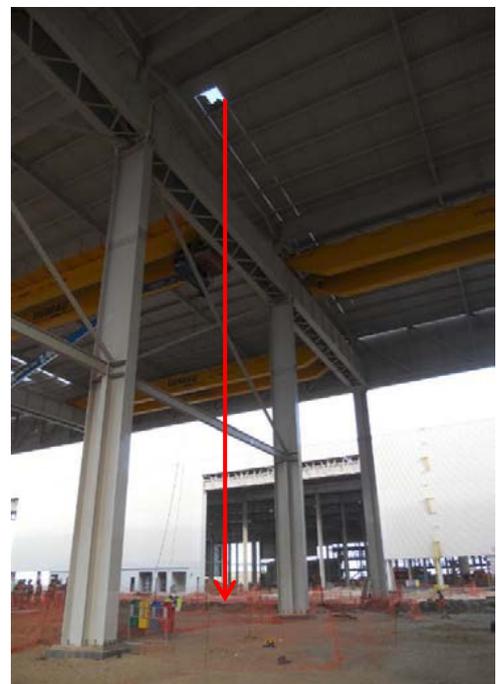
Height from ground: 22m

Whilst installing a ventilation system an employee of a sub-contractor, fell from the roof of a building. The person fell approximately 22m and died as a result. The employee was equipped with a safety harness; neither of the two lanyards had been attached to the adjacent life-lines.

Showing the hole through which person fell and the distance to ground

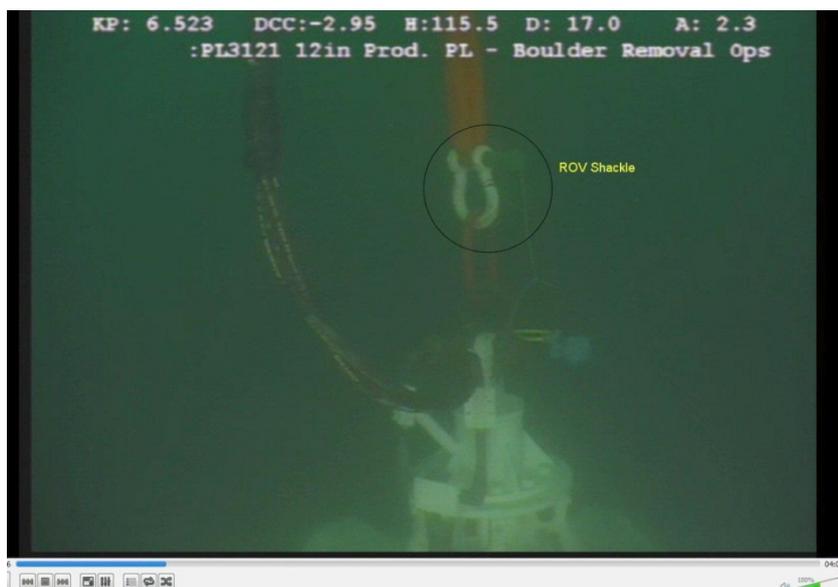
A member has reported a near miss incident in which an ROV shackle holding a boulder grab became loose and the pin partially disengaged. The incident occurred during a subsea boulder removal, along a pipeline route. A construction vessel had been working continuously for approximately 19 hours, conducting a boulder removal operation. The ROV operator spotted that the ROV shackle on the boulder grab had become loose and the pin was partially disengaged.

Showing shackle (white) and pin (green) partially disengaged.

- ◆ The positioning of the ROV shackle arrangement (just above the boulder grab), there was the potential for the 'R-Clips' securing the wire to become snagged, on other rigging or the boulder grab;
- ◆ Every time the boulder grab landed on the sea-bed to move a boulder, the rigging would slacken. This repeated action, over 19 hours continuous use, could have resulted in the 'R-Clips' becoming dislodged and the pin working loose.

- ◆ Lowered the boulder grab to seabed;
- ◆ Undertook a toolbox talk, management of change and further risk assessment, prior to recovery to deck of boulder grab;
- ◆ Altered the rigging: (25Te ROV shackle – 25Te anchor bow shackle c/w split pin);
- ◆ Considered (where possible) removal of the ROV shackles and replacing with 25Te anchor bow shackle (c/w split pin), connected straight to soft sling and boulder grab;
- ◆ Members are advised to be aware of the potential snagging risks and to re-assess the use of ROV shackles prior to their use.

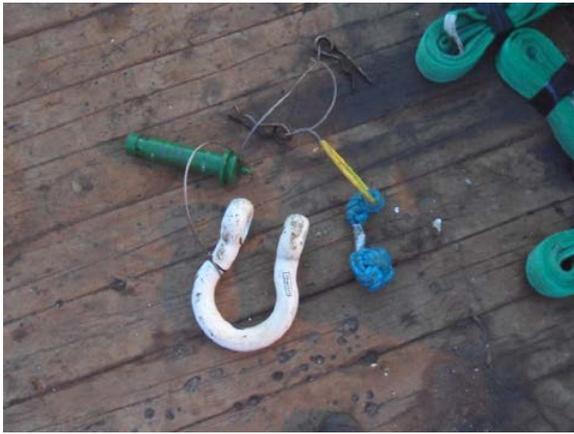
(Left): Shackle, pin and 'R-Clips' shown loose

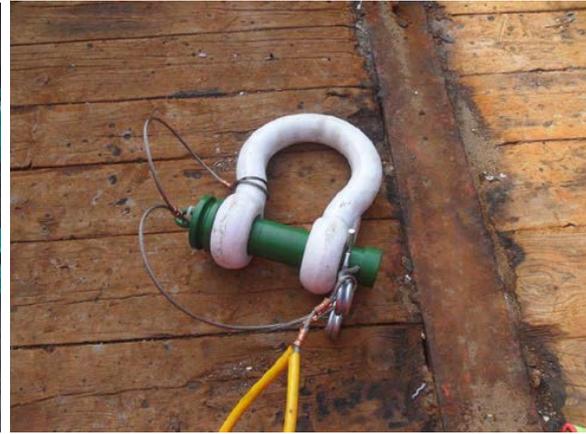
(Right): Shackle, pin and 'R-Clips' – complete arrangement

The replacement shackle and rigging arrangement, (25Te ROV shackle for 25Te anchor bow shackle c/w split pin) did not compromise the ability to abandon the boulder grab in any emergency situation.

The preferred option is to remove the requirement for ROV shackles altogether. The 25Te anchor bow shackle should be connected directly to the boulder grab (where possible) and the soft sling rigging arrangement. In an emergency situation, the ROV would cut the soft sling and release the boulder grab.

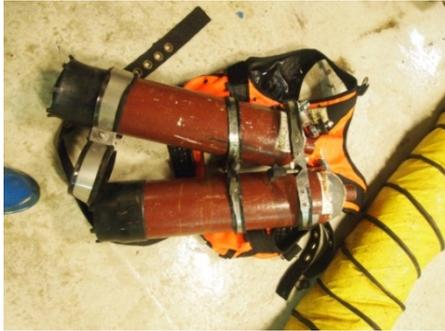
The third bailout to be charged was attached to the charging whip, secured and bailout opened. The Haskell supply valve was opened to decant the gas mix into the twin bailout set. The bailout was equalised to approximately 130 bar. The filling process was undertaken to fill the third twin set to the required pressure for diving operations. A small leak was detected at the charging whip connection to the bailout. This resulted in the repositioning of the bailout in the charge tank, so that the twin bailout set was submerged. This action was undertaken to assist in the cooling of the twin bailout and in the detection of leaks. Within less than two minutes there was a loud explosion/release of gas from the charging tank. The gas supplied was immediately isolated. Upon inspection it was identified that the pillar valve failed to hold the content of the cylinder.

Twin bailout after incident

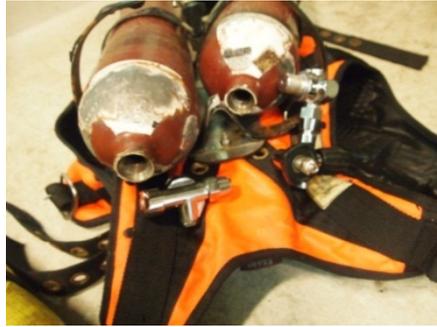
Broken manifold assembly

- ◆ Different types of cylinders (imperial and metric) were being used on the same job site;
- ◆ There was no management of change (MOC) process undertaken, to change pillar valve to twin manifold configuration;
- ◆ Additional force was applied to insert new pillar valve (no inspection undertaken as to why there was a resistance).

- ◆ Replacing bailout cylinders with metric only;
- ◆ Vessel technicians to be supplied with a precision measuring instrument (for measurement of thread patterns);
- ◆ Training to be undertaken by dive team / project department pertaining to the use of MOC;
- ◆ Implement system that ensures only metric thread cylinders and components used;
- ◆ Marking of all metric and imperial parts and cylinders to be undertaken for ease of identification.

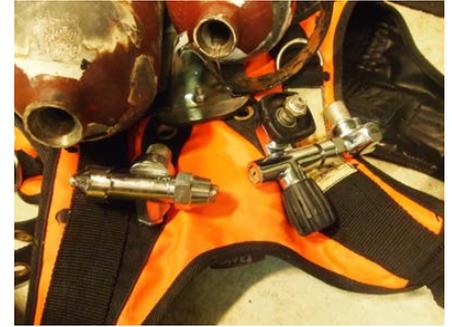
Broken assembly
