IMCA Safety Flash 18/14

November 2014

I Failure of Bell Winch Clutch Coupling during Bell Recovery

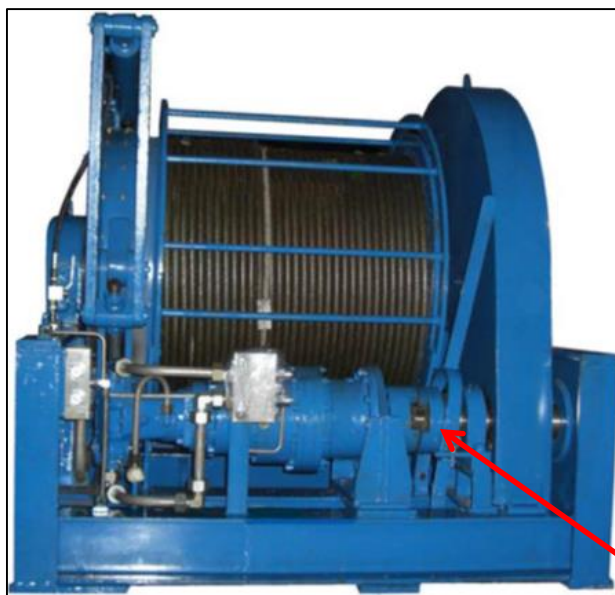
Excessive wear of the clutch components and their retaining device provided enough 'slop' in the assembly to allow space for separation of the coupling. The winch brake did not engage and prevent the free fall as the fail safe hoist lever was not immediately released upon descent (both the internal disc and external band brakes engage only when the lever is in the neutral position).

Figure: bell winch showing the clutch coupling mechanism in the undogged and locked position (LR).

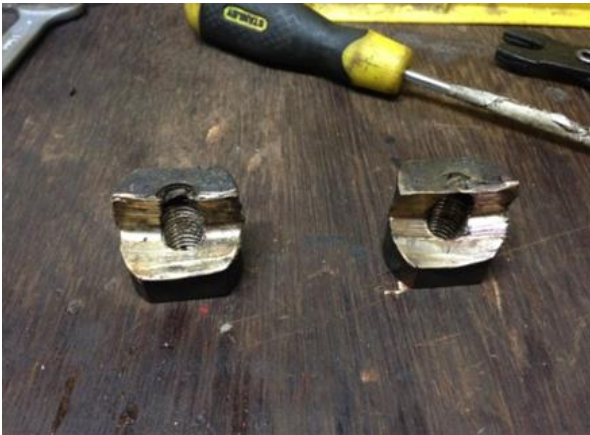
Figure: material loss on the bronze bushing

The leading edge of the clutch on the load bearing side pushed the pinion coupling outwards causing wear of both the bronze bushing and the engaging edge of the clutch cog, providing a gap which eventually allowed unintentional disengagement of clutch.

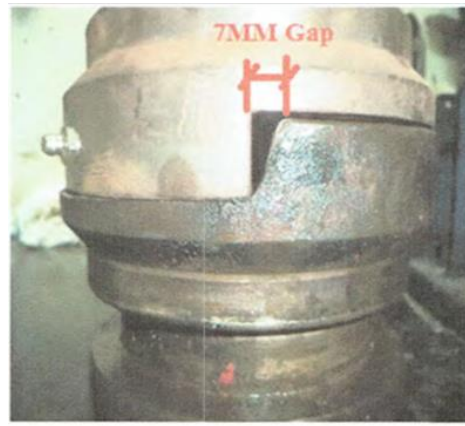
Figure: clutch cog wear showing $\frac{1}{2}$ the actual gap against the replacement clutch.

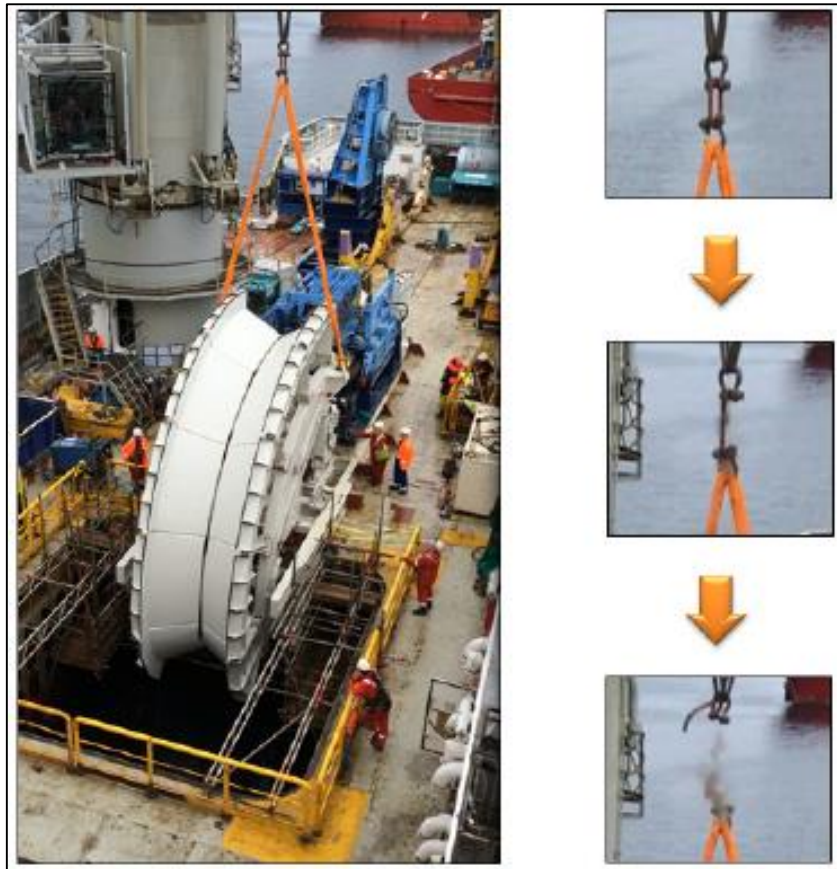
Figure: showing overboarding chute (L) and failure of master link (R)

- ◆ The requirement to closely monitor the load was not recognised;
- ◆ Analysis of the failed master link identified defects that could have caused failure below MBL. The process of establishing the cause of the defects was ongoing.

- ◆ Reviewed all master links onboard; quarantined any William Hackett 38.3Te master link with batch number H678/1-8;
- ◆ Management/Supervisory personnel to discuss alert with their teams and reinforce expectation that anyone can request further or challenge information that may compromise the safety of the task;
- ◆ Recognise the potential risks associated with moving loads that are attached to the deck (or similar) as part of reviews, and ensure an appropriate level of detail in procedures, lift plans and risk assessments accordingly.

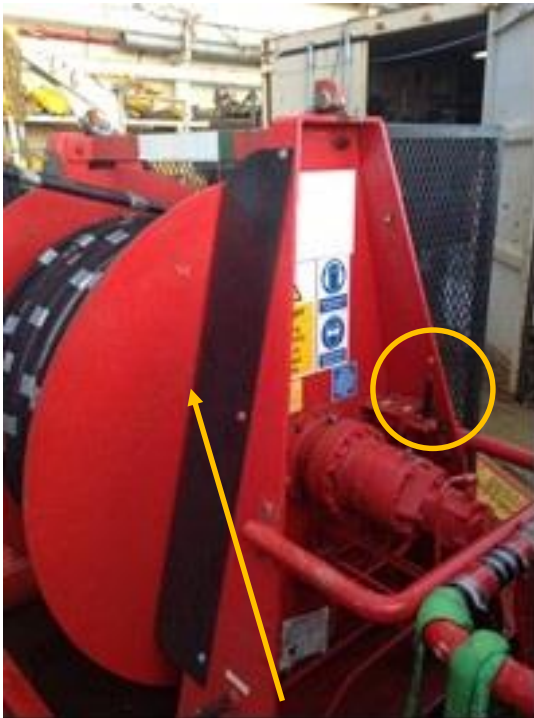
Figure: hydraulic winch showing control lever and the guard in which the operator trapped his thumb

- ◆ The operator was not in the correct location for operating the equipment. He was forward of the winch. The winch controls were located at the rear of equipment where adequate guarding was provided;

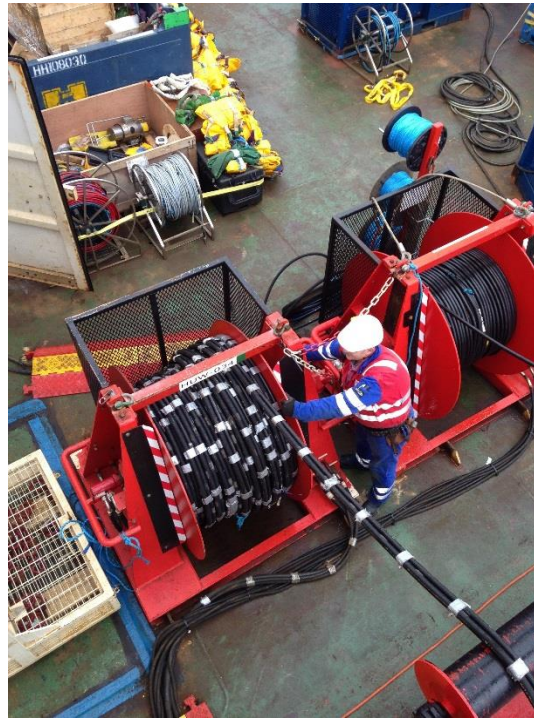
Figure: position of operator at time of incident (mock up) - hatched markings on the guards are post-incident

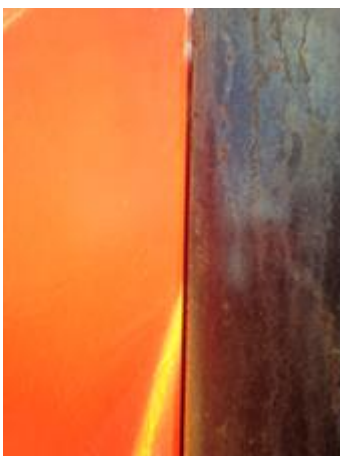
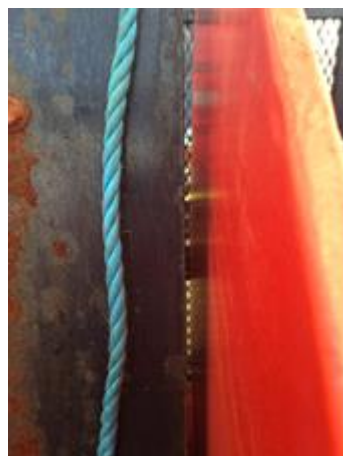
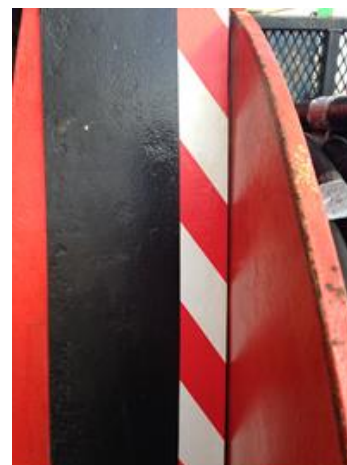
Figures: showing varying distance between winch drum and guards

- ◆ Gaps between the safety guards, located on the forward side of the winch, were found to vary in gap size ranging from 5mm to 15mm; it was found that the larger gap increased the risk of entrapment;

Figure: added strip of additional guarding and safety tape to highlight potential 'pinch' points to operators.

Our member reports that the crew have made suggestions as to how to improve the guarding and these will be implemented onboard. The improvements were to add a strip of additional guarding in an effort to close the 15mm gap and in addition to this apply safety tape (as shown above) to highlight potential 'pinch' points to operators.

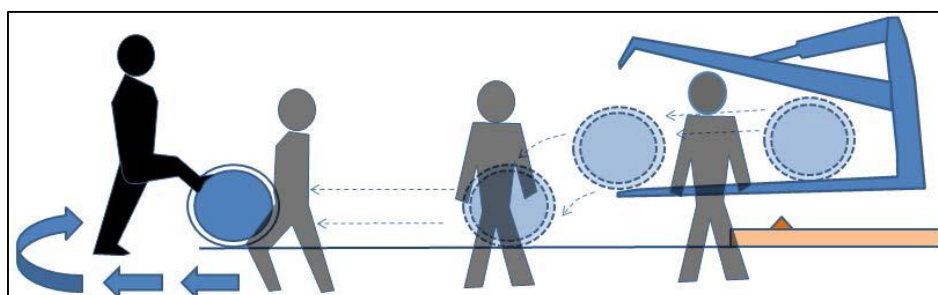
Figure: showing the sequence of events demonstrating his initial safe position (light grey) to his final position (black)

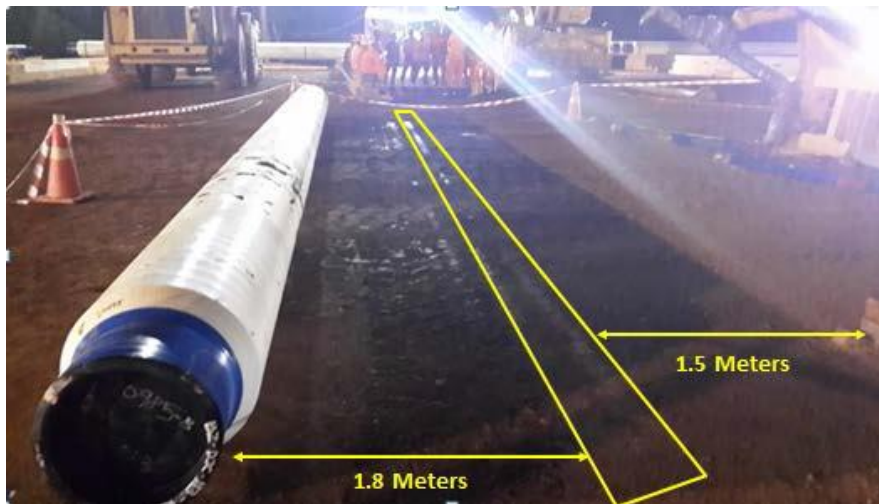
Figure: showing location where pipe dropped and rolled

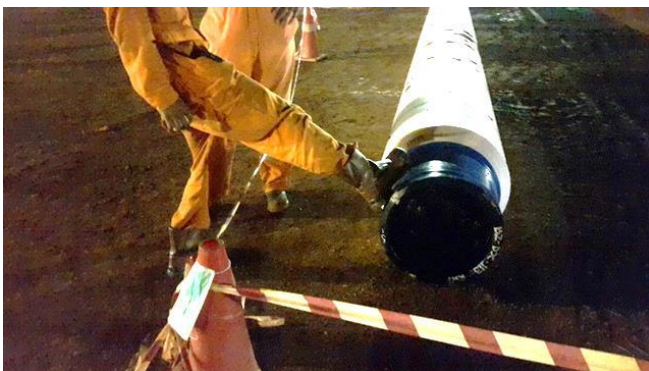
Figure: position of IP when attempting to stop the pipe rolling

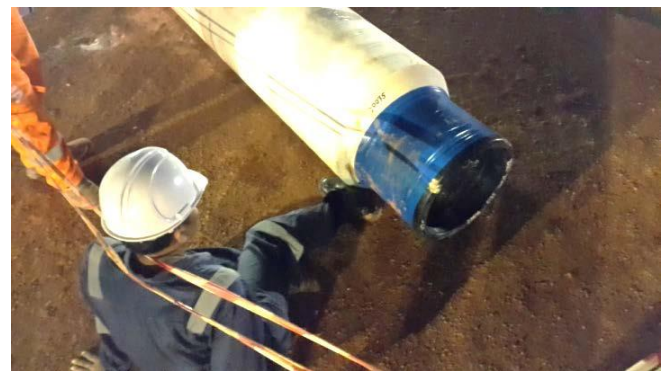
Figure: final position of IP

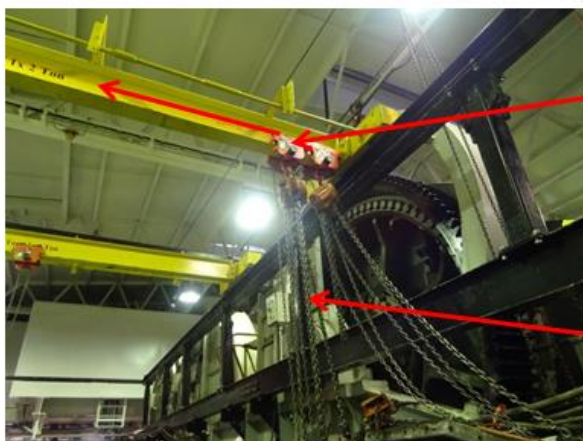
Chain hoist path of travel.

Chains that IP grabbed to prevent the load from moving away.

Figure: showing chain block location

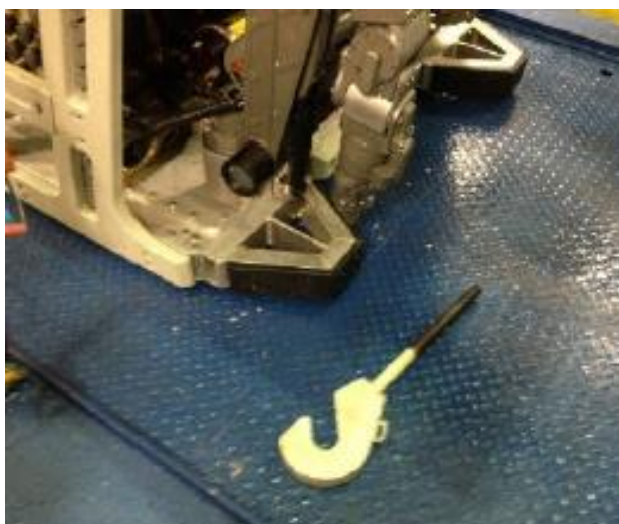
Figure: ROV hook on floor of ROV hangar

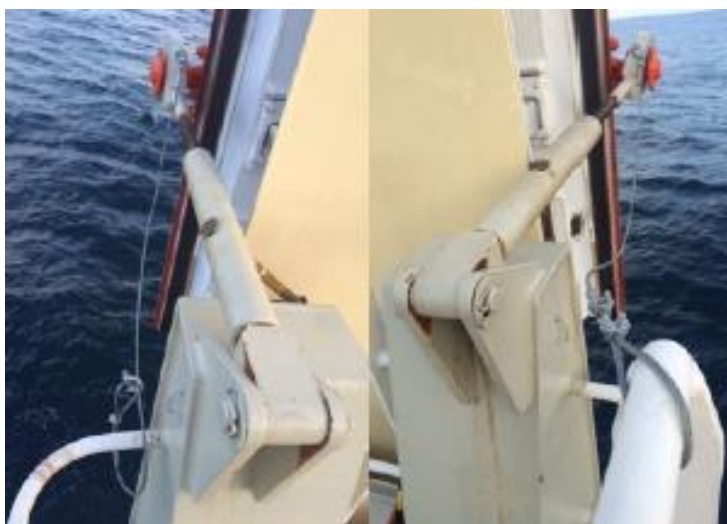
Figure: hooks in use, steel wire secondary securing in place

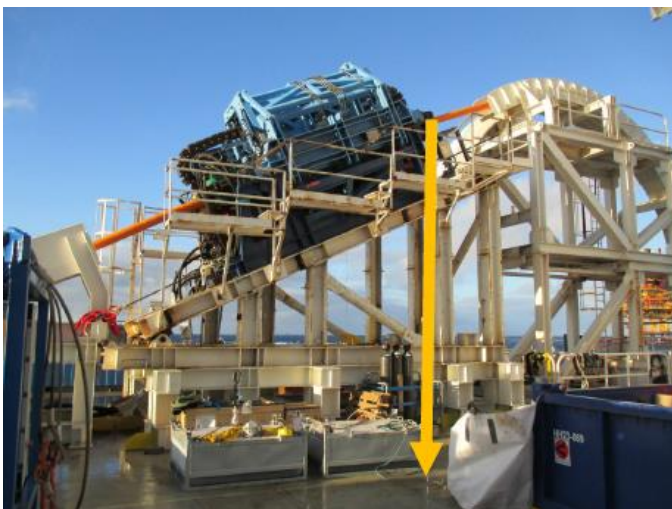
Figure: tensioner and height of fall (7m)

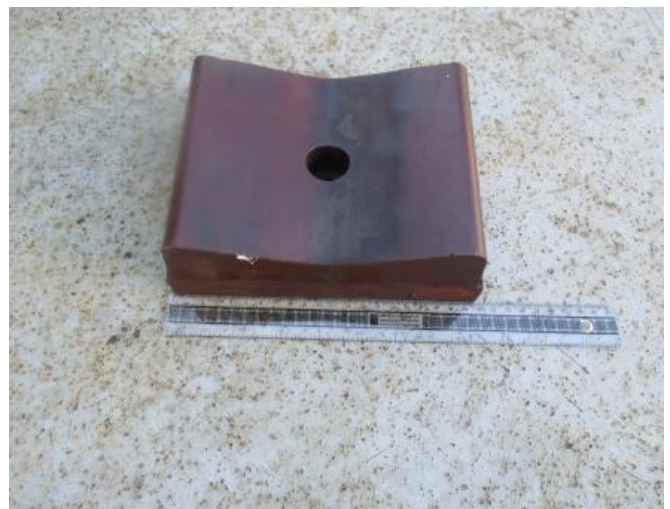
Figure: tensioner pad (weight 7kg)

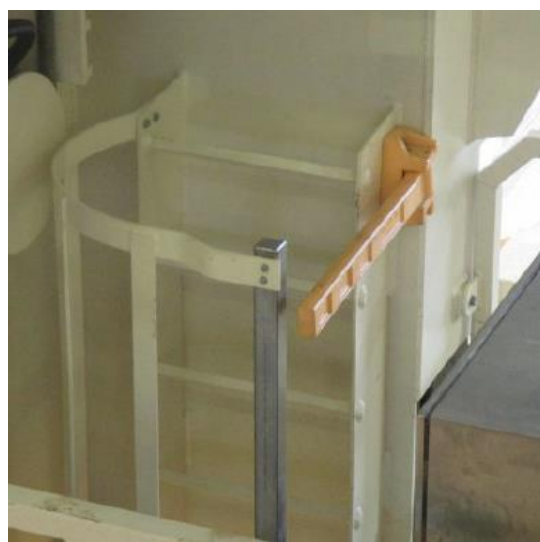
Figure: ROV LARS ladder guard (plastic) reinstated

On investigation, it is thought that the swing gate arm was not properly installed and the vessel vibration caused the arm to work loose. An inspection of the port side LARS swing gate arm showed it was in good condition with no issues observed.

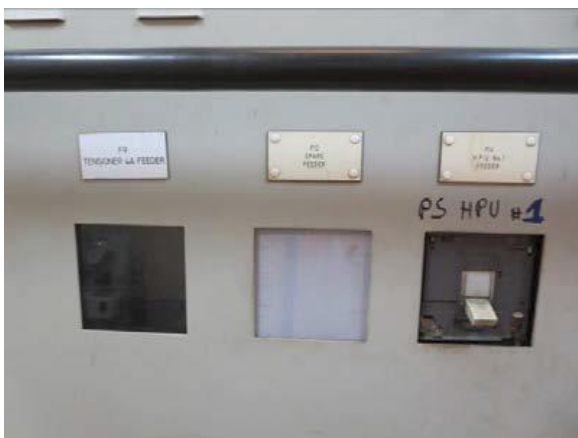
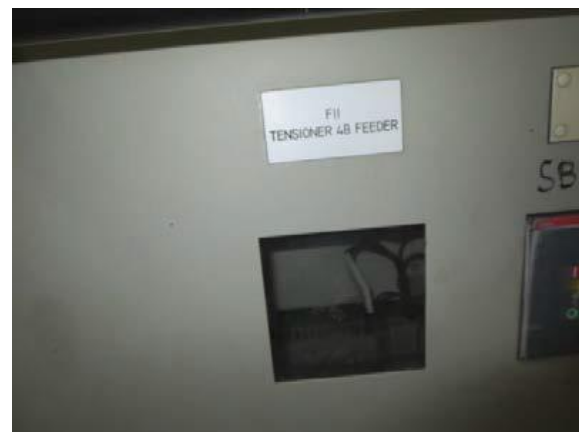
Figure: showing blanks on the switchboard panel where breakers had been removed.

- ◆ During this survey it was noted that there were blanks on the switchboard panel where breakers had been removed. The missing breakers supply power to a tensioner that is currently not installed. The unused tensioner breakers had been removed to be used in other areas as the vessel had insufficient spares onboard to replace all the breakers impacted by the breaker failure. They were relocated some time ago with the vessel technical management being aware of this;

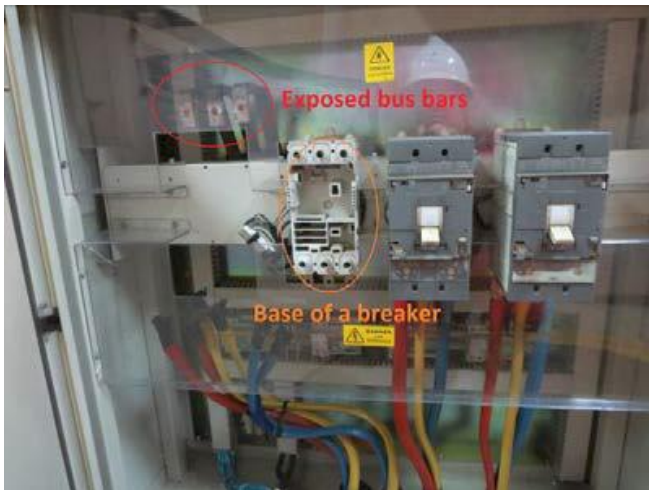
Figure: exposed bus bars

- ◆ Work standards in insulating the terminations and leaving the bus bars exposed were unacceptable;
- ◆ Management of spare parts stock was inadequate and should be improved;
- ◆ Management of change and technical oversight needed to be improved;
- ◆ Continuity of handovers and outstanding priority works needed to be improved, especially as the personnel involved with the original incident were no longer serving on the vessel;
- ◆ Third party contractors require robust supervision and verification of completed work.

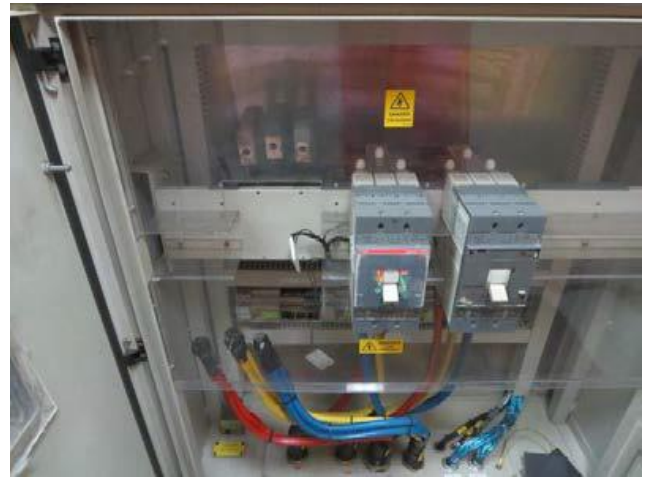
Figure: uninsulated wire terminals
