IMCA Safety Flash 18/15

November 2015

2 Maintenance of Automatic External Defibrillators (AED)

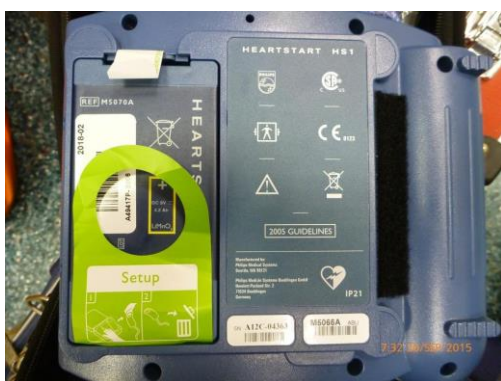
The battery had been removed or had been fitted incorrectly to the device. This was contrary to advice in the user manual for the item.

Our member considers this to be a significant issue. Inspection of other sites revealed that in some cases batteries were removed or detached from the units. Removing or detaching the batteries from these units will prevent the unit being used for an additional sixty seconds, and lessens the chances of survival for the patient.

- ◆ Confirmed that the battery was fitted in accordance with the manufacturer's instructions;
- ◆ Confirmed that all equipment associated with the AED was "in-date";
- ◆ Tested the readiness of AED in accordance with the manufacturer's instructions;
- ◆ Appropriately trained personnel conducted a familiarization session on use of the AED with all of the crew;
- ◆ Ensured that the maintenance of the AED was added to the appropriate planned maintenance system.

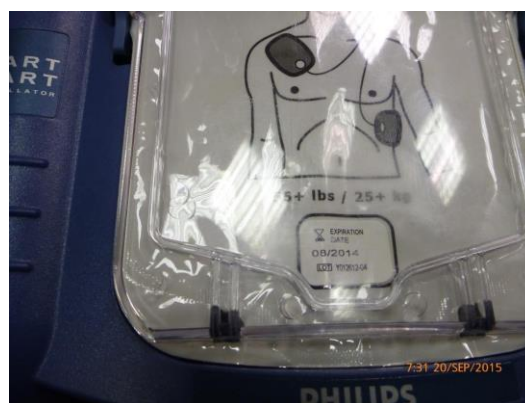
The pads on the AED were out of date;
