# IMCA Safety Flash 18/18

August 2018

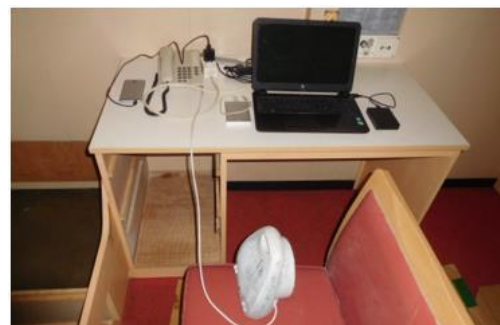
The crew member emerged from his bathroom to find his cabin filled with smoke and a fire on the desk; both the cabin telephone and extension cable were burning. The crew member attempted to extinguish the fire by hitting it with a pillow, at this point the cabin telephone exploded and fragments fell onto the mattress, starting a second fire. The crewmember left his cabin.

*Layout of the desk within the cabin.*

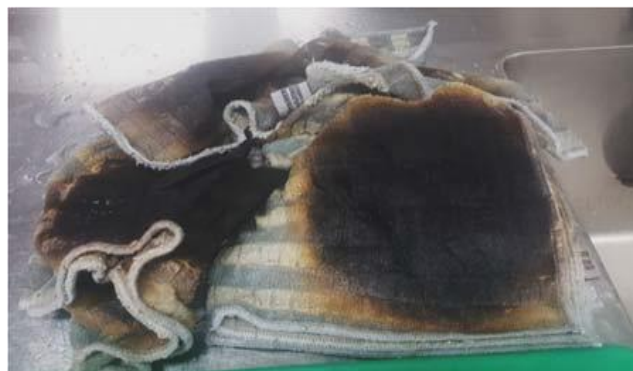
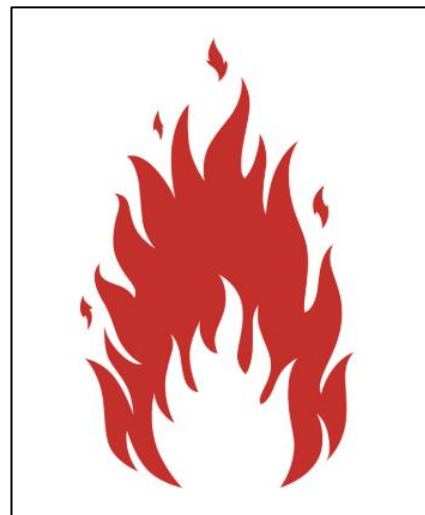
Cloths used for general galley cleaning were removed from a tumble dryer, immediately folded and piled in a steel bucket. Three hours later they were stowed in a cupboard. After a further three hours (six hours after removing the cloths from the dryer) a burning smell and the presence of smoke were reported. Upon investigation, the cloths were found smouldering. Immediate action was taken, and no further damage was noted.

- ◆ Following the fire, it was discovered that the cloths were still contaminated. This indicates that the items had been washed at the wrong temperature (40° instead of 90°) to reduce the wash time. This was not sufficient for them to be fully cleaned;
- ◆ Either the cloths were removed from the tumble dryer prior to completion of the full cool down cycle or the wrong temperature setting was used (too high). As a result, the hot contaminated cloths were not cooled before being stowed. This led to them starting to smoulder.

- ◆ Ensure items are washed at suitable temperatures to remove residue;
- ◆ Ensure that the correct temperature setting is selected and that cool-down cycles are completed when using tumble dryers;
- ◆ Hot laundry should never be folded and stowed. Allow suitable time for cooling down;
- ◆ Discard cloths that can no longer be cleaned;
- ◆ Reiterate these lessons to all catering crew.

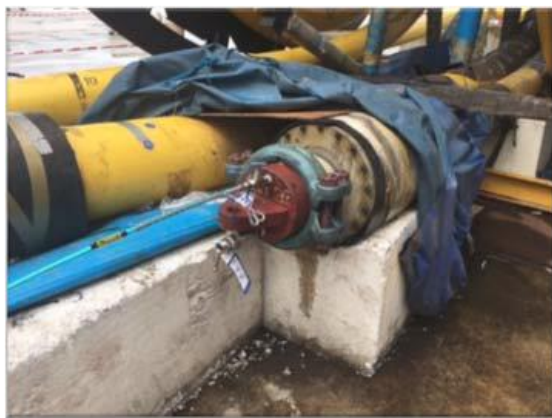
During the dewatering of a 6" flexible jumper, a near miss incident occurred when the pull head was removed whilst it was still under pressure. This resulted in a foam pig that was inside the flexible jumper being unexpectedly ejected by the residual pressure. The pig narrowly missed personnel in the immediate vicinity and landed on the ground approximately 2m away from the jumper end.

*Showing 6" pull head that was removed for inspection of the foam pig*

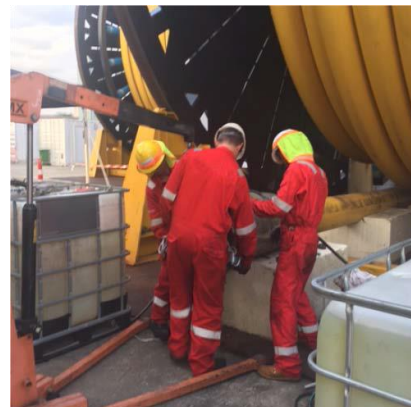
*Position of personnel before removal of the 6" pull head.*

- ◆ The approved procedure for the pressure testing and dewatering activities was not followed correctly (a vent valve that should have remained opened at the other end of the jumper was closed);
- ◆ A 'working copy' of the approved procedure was not available at the task location for reference by personnel;
- ◆ There was no on-going sign-off being conducted as each task was completed;
- ◆ There was no check conducted for positive confirmation that the system was at ambient pressure before starting to remove the pull head to access the foam pig;
- ◆ There was no requirement for formal sign-off/handover of system control from the pre-commissioning services company to our members' personnel who were required to remove the pull head for the foam pig inspection.

- ◆ When lines have been pressurised, isolation and venting processes should be in place, which ensure the ambient pressure is verified before breaking pressure containment;

- ◆ Supervision on worksites should highlight safety critical points within the procedures and ensure that they are strictly followed by personnel;
- ◆ Where stored pressure or energy is involved, ensure approved procedures contain requirements for formal sign-off/handover of system control, particularly when third party sub-contractors are involved.

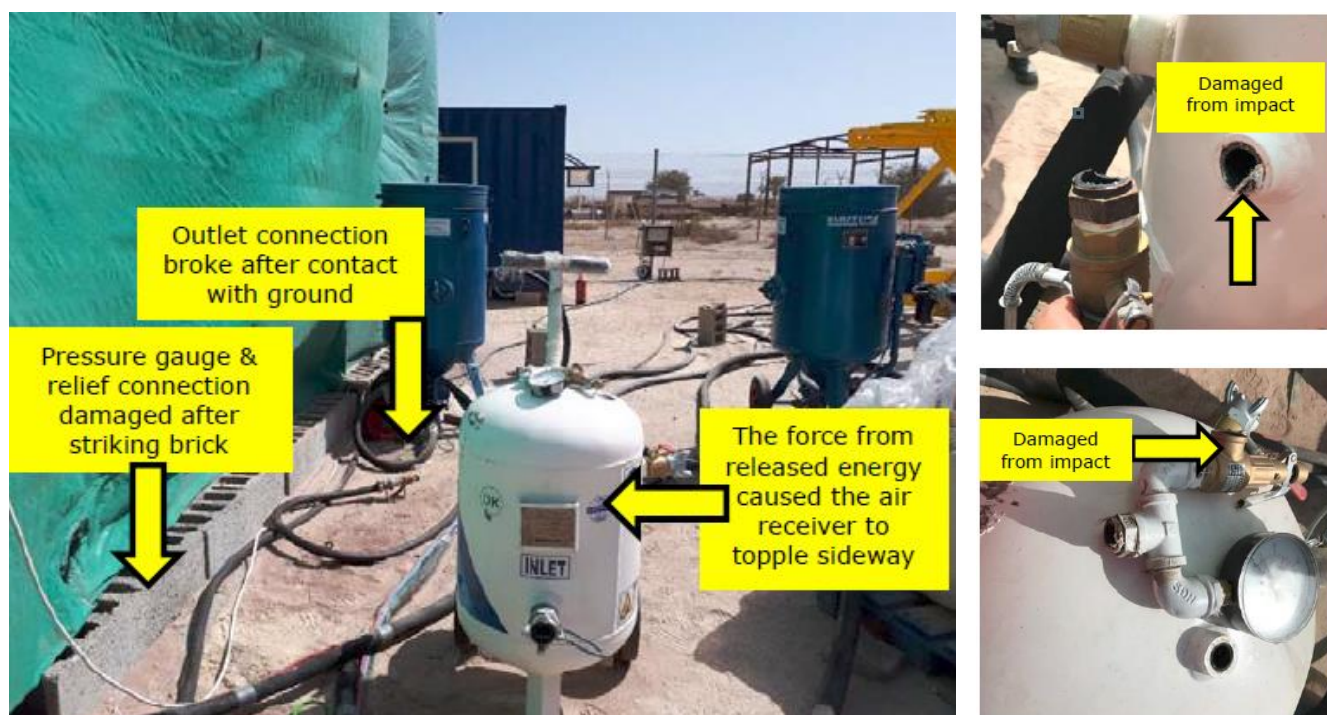
During blasting and painting operations conducted at an onshore worksite, a near miss incident occurred when a 2" blasting hose outlet released from the coupling clamp connected to an air receiver. The 2" hose was arrested by the hose restraint. The force from the released energy caused the air receiver to fall sideways striking the ground and adjacent objects, resulting in equipment damage. No personnel were standing in the immediate area or line of fire when the incident occurred.

- ◆ The 2" hose dislodged from the hose shank due to an improperly tightened Chicago connector;
- ◆ The air receiver was placed on sand and was unstable and contributed to the air receiver tank falling sideways.

- ◆ Ensure that risk assessments are carried out. Implement controls to ensure that equipment is appropriately placed on suitable stable footings (hard standing) and that appropriate restraints are in place;
- ◆ Assess the application of Chicago connectors with a view to replacing them with alternatives when high pressure applications are identified;

- ◆ Regularly review and inspect all pressure related connections to ensure that they are correctly assembled and fitted with adequate whip checks/restraints;
- ◆ Assess that barriers are in place to ensure an effective safe distance is achieved to protect personnel from any unplanned pressure release or equipment failure.

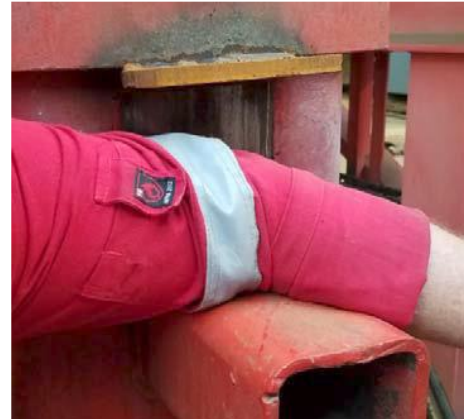
A yard worker was cleaning debris from underneath a hydraulic pipe. Whilst performing this task, the worker placed his forearm on a hydraulically operated pipe stand. This put the forearm in the line of fire between a lift pocket and a recently modified plate. A serious injury occurred to the worker's forearm when the pipe stand (see photograph) was lowered by another worker operating the hydraulic lowering mechanism.

- ◆ There were no energy isolation routines to prevent the lowering operation from occurring inappropriately, though this was covered and required by our members' permit to work (PTW) system;
- ◆ There were simultaneous operations (SIMOPS) taking place and these presented risks which had not been properly assessed;
- ◆ There had been modification of this equipment and this had not been fully risk assessed;
- ◆ The task plan was not detailed enough to define all of the hazards in the work area;
- ◆ The injured person did not notice that his task placed him 'in the line of fire'.

- ◆ All activities require a risk assessment. Where simultaneous operations have the potential to expose a person to harm, the PTW and isolation process should show that a higher level of control, communication and mitigation is in place;
- ◆ Use the MoC process to ensure that modifications to equipment are assessed and do not introduce a new hazard.
