IMCA Safety Flash 19/15

November 2015

All the incidents in this Safety Flash involve the Crew Transfer Vessels used by members in the offshore renewables industry.

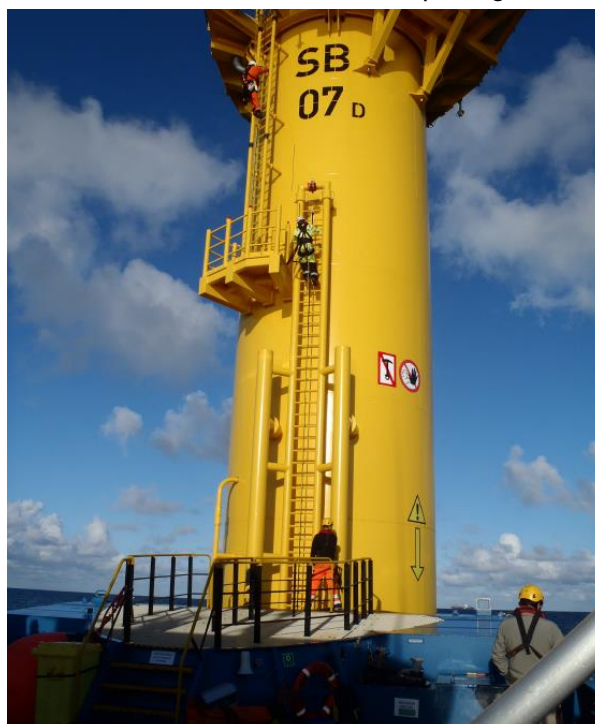
A member has reported a near miss incident during transfer operations between an offshore renewables industry CTV and a turbine tower. The incident occurred during the pick up of crew from a tower – a crew transfer vessel was pushing on to the tower and started transferring crew. The weather was workable but there was a long high swell which was considered manageable. When the high swell came the transfer was stopped, and restarted when safe to do so. The swell caused the vessel to go up and down for five rungs on the ladder. As it did so, a person was briefly left suspended by his fall arrest equipment when the boat moved suddenly under the influence of the swell. There were no injuries.

After pushing on with maximum engine power and monitoring the swell, the first person was asked to come down. The person was transferred to the crew vessel with his fall arrester still attached to the tower. This person stepped back too fast and the inertia reel mechanism in his fall arrester temporarily locked. The deckhand tried to help this person with unhooking from the fall arrester. Unexpectedly the swell came in and the vessel moved down, causing the person to be lifted into the air and temporarily suspended by his fall arrester. As the deckhand was holding on tight to the fall arrest equipment, he too was lifted off his feet. When the vessel came up again the deckhand jumped back on deck, while the person remained on the ladder. The vessel moved up and down but no-one was hurt as the fender of the boat and boat landing were designed to leave space between ladder and persons.

The fall arrest equipment was checked and found to be in good condition. The root causes of the incident were found to be incorrect work procedures, and insufficient awareness.

Further personnel transferring from that tower to the CTV were asked to disconnect the fall arresters at the last five rungs of the ladder. All further transfers took place safely.

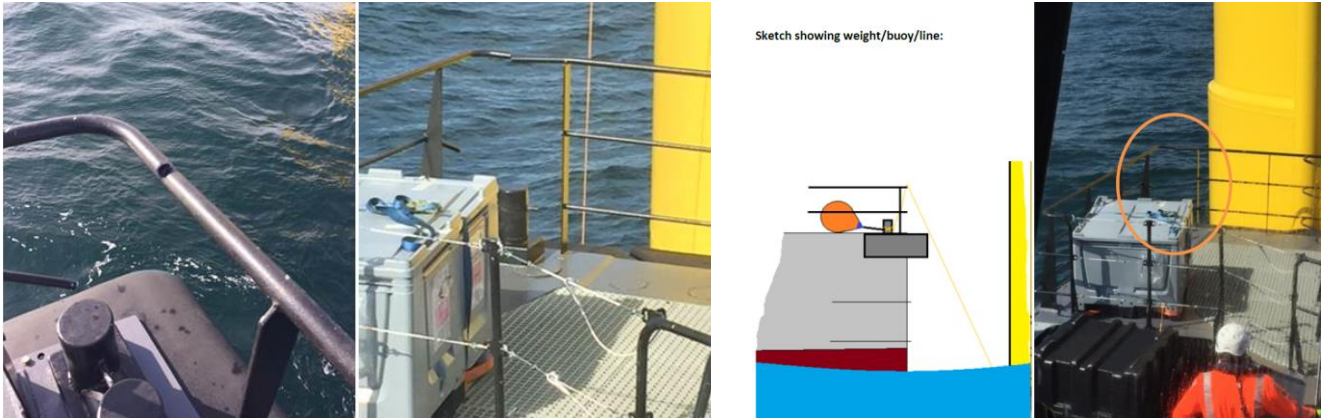
Once the buoy had been lifted on-board, two riggers quickly began retrieving the loose line until it became taut against the weight on the seabed. As they began to pull the weight up from the seabed it became snagged. The riggers fixed the line to the forward cleat so that they could reposition themselves to pull harder. Unknown to the Master, as his vision was very restricted with a large grey storage box on the foredeck, the riggers had pulled the line over the top rail and made fast to the bollard below. The rope drew tight and personnel positioned themselves away from the bow to avoid the snap back zone. The rope did not snap but it cut through the top rail and broke the middle rail off completely.

Showing damaged bow rail on CTV.

Sketch showing weight, box and line, and photo.

- ◆ A toolbox talk had been held on-board, including the Master and superintendent before the work took place, and at no point was it discussed that the line would be tied to the forward cleat;
- ◆ The incident was discussed on-board after its occurrence and it was highlighted that in the event of snagging, the line should never be tied to the vessel and nothing should ever be tied over the handrails;
- ◆ The handrail was repaired on the next maintenance day.
