IMCA Safety Flash 19/17

August 2017

Focus: Hand and Finger Injuries

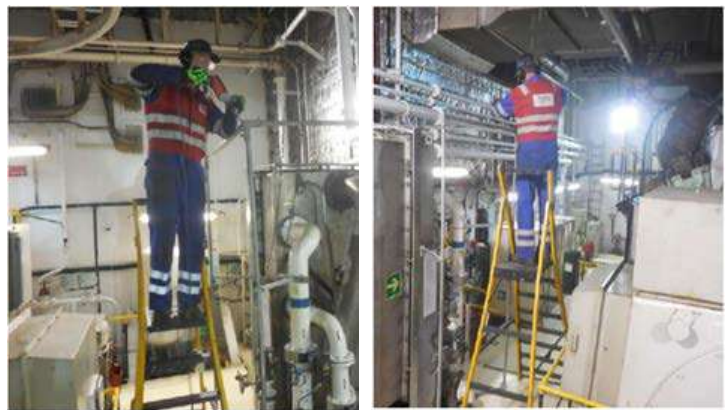
Someone using a power tool suffered a serious injury to the right wrist when the drill got out of control. Vessel engineers were installing a support frame for spray protection curtains around the evaporator in the engine room. The task required the engineers, whilst working at height, to drill three 10 mm holes in the frame and add the splash curtain to the support frame.

To access the support frame, a step ladder with a designated working platform was used. The injured person was working on the platform with a power drill. He was directing the drill with his right hand with his left hand on the supporting handle on the left-hand side of the drill. It is estimated that during the drilling of these holes, the drill was at an angle of approximately 45°. During the drilling of a 10 mm hole, the drill bit snagged within the metal tubing of the supporting frame, causing the pistol drill to kick back and spin in a clockwise direction. As the drill spun, the pistol grip was pulled from the engineer's right hand. The pistol drill continued to rotate, then contacted his right wrist/forearm, causing a lost time injury (LTI).

- ◆ There was a lack of active supervision. Supervisors should have a full understanding of safe systems of work, and thus be able to ensure that if the circumstances of an operation change, the team is able to respond correctly and recognise any new requirements in each situation;
- ◆ A causal factor was the fact that the task was being carried out at height, which made it difficult to drill the hole in the correct position. To attain this position the employee had to work in a position which caused the drill to snag;
- ◆ There was poor procedural and risk awareness surrounding the activity:
 - Whilst a toolbox talk was conducted between the engineers carrying out the task, and this highlighted potential hand injuries and slip/trip hazards, no consideration was given to the increased height of the task or the use of power tools whilst working from a ladder/platform

- No permit to work (PTW) or job risk assessment (JRA) was considered necessary, as a similar task had been conducted previously. The engineers did not identify the difference in height between the previous task (180 cm) and the task in hand (293 cm);
- ♦ The work was incorrectly planned and did not have to be done at height. Personnel failed to recognise they were working at height. Had the task been correctly planned and classified as work at height, the decision could have been made to pre-drill the holes at deck level, thus allowing the work party to attain the correct working position and potentially mitigating the snagging of the drill.

- ♦ Correct tools and equipment used in the wrong conditions can still result in an incident;
- ♦ Routine tasks can become hazardous when changes are not correctly managed;
- ♦ The step ladder with designated working platform should have had the handrails and securing chain in position (they were previously removed due to space required to store the ladders);
- ♦ Tasks requiring ladders, working platforms or alternate access solutions should be reviewed to determine if the appropriate level of work control is applied. Risk assessments and routine duties should be updated accordingly.

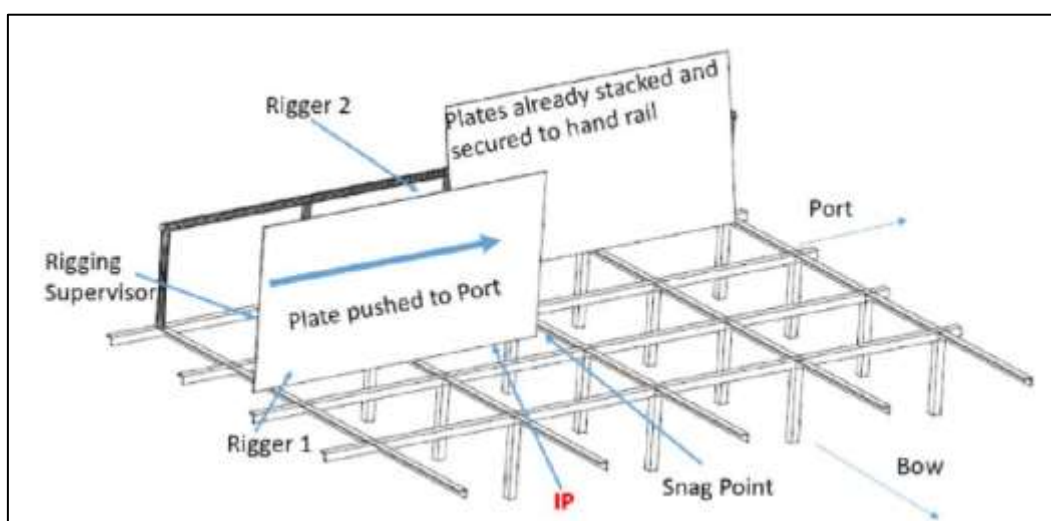
While moving one of the plates and turning it through 90° onto its long axis, to be slid over the angle beam foundation, the leading corner of the plate caught on a section of angle beam and stopped sliding. A rigger (the IP in the sketch below) attempted to rectify this by lifting the corner, enabling the rest of the team to push the deck plate. Upon setting down the deck plate, his middle and index finger became trapped between the angle beam foundation and the deck plate, causing a serious injury.

- ♦ The incident occurred as a result of 'scope creep'. There was no proper Management of Change;

- ◆ The size and weight of the deck plates did not allow for a safe and ergonomically friendly means of moving them, especially over the angle beam foundation;
- ◆ The injured person placed his hand beneath the deck plate despite being instructed not to do so by his supervisor;
- ◆ The injured person was wearing welding gloves, rather than the impact gloves required in the JRA (job risk analysis);
- ◆ Pinch points had been discussed in a task-specific toolbox talk held just before starting the job.

- ◆ The change of job scope ('scope creep') should have triggered a stop, leading to the change being properly managed. A new permit should have been raised with a task specific JRA;
- ◆ Members may wish to use this example to highlight the issue of 'scope creep' and appropriate Management of Change – particularly where manual handling is involved.

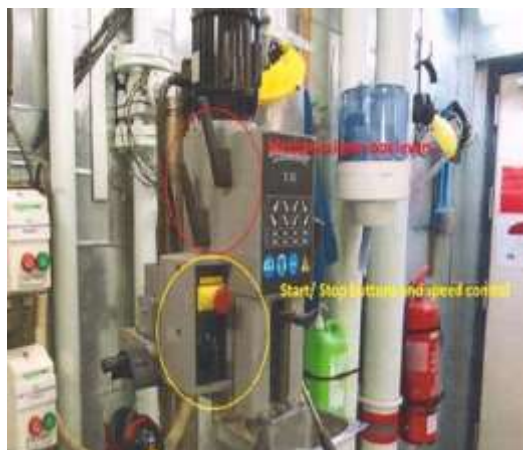
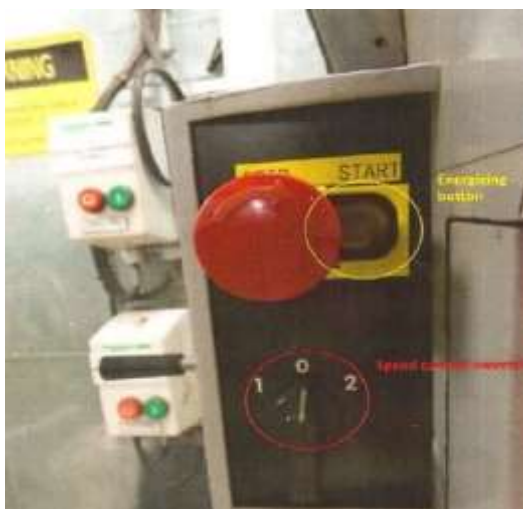
The Marine Safety Forum (MSF) has published an alert in which someone was injured whilst using a pillar drill. An experienced engineer was changing out a drill bit on a tower drill in the engine room workshop. While doing so he inadvertently operated the wrong handle and started the drill. The engineer was wearing gloves to carry out this task and as the drill turned the glove caught and turned with the drill bit, trapping his hand inside and causing a hand injury.

- ◆ The drill had multi-function controls (including clutch speed, gears, slow and fast operation, on/off switches) none of which were actually marked to indicate their purpose;
- ◆ By its design, the emergency stop button for the drill did not clearly identify to the operator when it was engaged or deactivated;
- ◆ There was no 'green light' (or similar indicator) to show when the equipment was 'energised'.

- ◆ The company reporting the incident introduced 'drill familiarisation' to the engineers' induction;
- ◆ A full and comprehensive risk assessment should be carried out for the use of all engine room equipment;
- ◆ Engineers intending to use the equipment should be fully familiar with those risk assessments and comply with their requirements;
- ◆ IMCA notes that in many countries there are regulatory requirements (the Provision and Use of Work Equipment Regulations (PUWER) in the UK) which should have been applied with regard to equipment control markings.

Note: A more recent model of the same drill incorporates a safety feature where the drill cannot be operated if the drill guard is in the open position. Such safety features should be function-checked to ensure they are fully operational before carrying out any drill changes.
