IMCA Safety Flash 19/19

August 2019

1 Fire in Incinerator Exhaust Gas Manifold

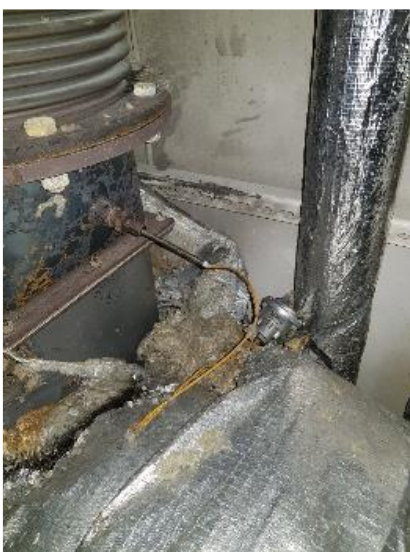
Exhaust sensor was tampered with

- ◆ It was discovered afterwards that a set point value on a control resistor was set too low, such that the equipment was not able to detect a flame failure;
- ◆ The exhaust sensor had been tampered with.

Have a full, detailed and comprehensive understanding of what happens to incinerators and other similar equipment when the **EMERGENCY STOP** button is pressed, and/or when power fails and restarts. This applies not only to incinerators but to all complex machines. Ensure that incinerator flame failure devices are tested as part of the vessels’ planned maintenance system.

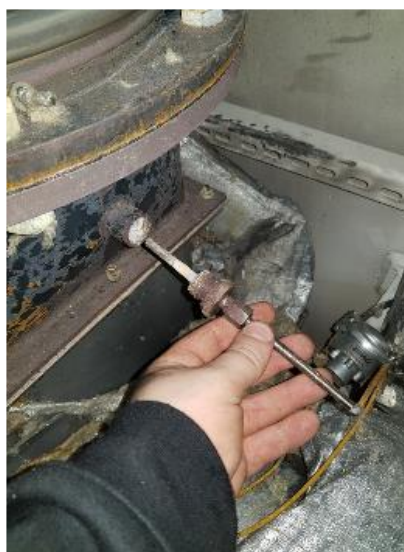
Exhaust sensor

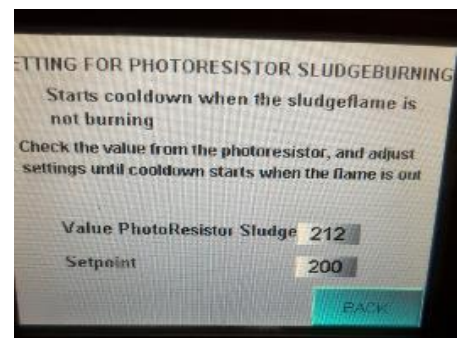
Setpoint on sludge resistor is set to low

- ◆ A set point value on a control resistor was set too low, such that the equipment was not able to detect that the flame had failed, and so kept pumping sludge into the combustion chamber;

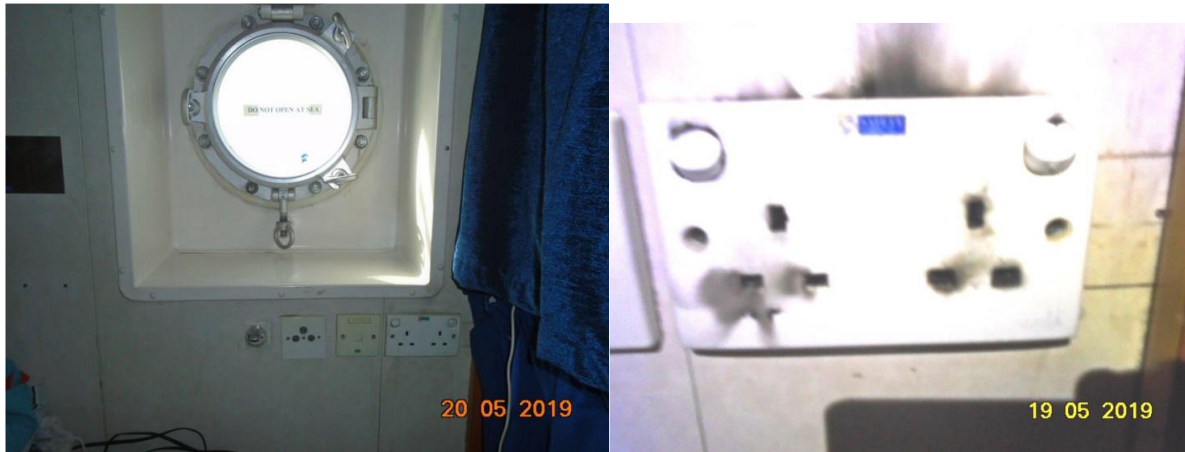
During vessel operations, a porthole in a passenger’s cabin was left untightened and slightly ajar. This allowed for seawater to enter the cabin and seep into the electrical socket under the porthole causing a short circuit resulting

in burnt wiring and smoke in the cabin. A passenger observed the smoke and raised the alarm; the response team attended the scene and immediately isolated the supply.

- ◆ Cabin occupants failed to ensure that portholes were closed during vessel transit.

- ◆ Ensure all are given full and appropriate vessel induction when boarding, and that all are aware of the need to maintain watertight integrity at all times;
- ◆ Ensure full and effective watertight integrity inspections are made and confirmed when leaving port.

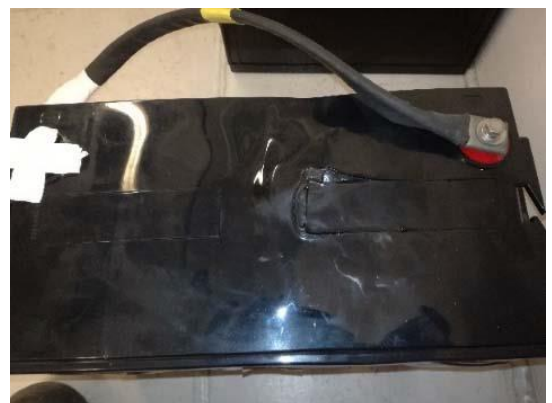
An overheated and swollen lead acid battery was found on-board a vessel.

When charging, the temperature inside the affected battery rose beyond the critical level. As the heat was unable to dissipate fast enough, the chemical reaction inside the battery accelerated and led to an even higher charging current and heat generation.

- ◆ The battery in question was found to be at the end of its design life and vulnerable to thermal runaway;
- ◆ Due to the heat generated within the battery, the battery became pressurised and deformed;
- ◆ In addition to design life, overcharging, internal physical damage, internal short circuit or a hot environment are all potential causes for battery fires or explosions.

- ◆ Depending on the battery configuration; isolate the battery or string of batteries, or shut down the charger;
- ◆ Cool the battery and ventilate the room.

- ◆ Ensure all batteries are subject to periodical inspection and maintenance; consideration may be given to inspection by infra-red camera to look for hotspots;
- ◆ Report any sign of external damage;
- ◆ Ensure that battery chargers and procedures are correct for the battery type;
- ◆ Consider the installation of a “thermal runaway monitor” on battery packages (UPS);
- ◆ Batteries should be in rooms suitable for batteries with the required ventilation, fire detection and fire-fighting capabilities;
- ◆ Ensure there is a specific risk assessment and transport/disposal plan relating to the removal of faulty batteries, with specific care being taken to identify the correct personal protective equipment (PPE) to be worn, and any transportation necessary.

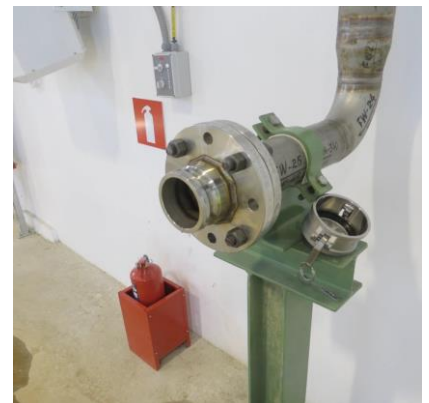
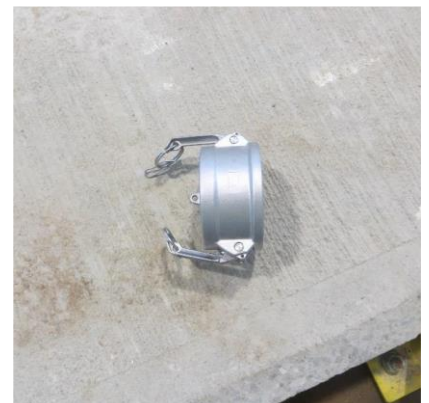
A fire main dust cap was blown off by pressure from the line and hit the wall 10m away. The incident occurred when a fire team were checking the firefighting water line filling point connection. The filling point had a camlock fitting and the blank end steel dust cap was in position. The fire team proceeded to release the dust cap by disconnecting the clasps. When the clasp was released, pressure from behind the dust cap blew it off, causing it to hit the wall approximately 10 meters away. This caused minor damage to the wall. There were no injuries to personnel.

Work was stopped immediately. A thorough inspection of the site was made which identified a few fire ring main lines where the same scenario could occur; these were carefully checked, and any trapped pressure was released. Consideration may be given to the fitting of a drain cock which would allow the release of any residual line pressure prior to cap removal.

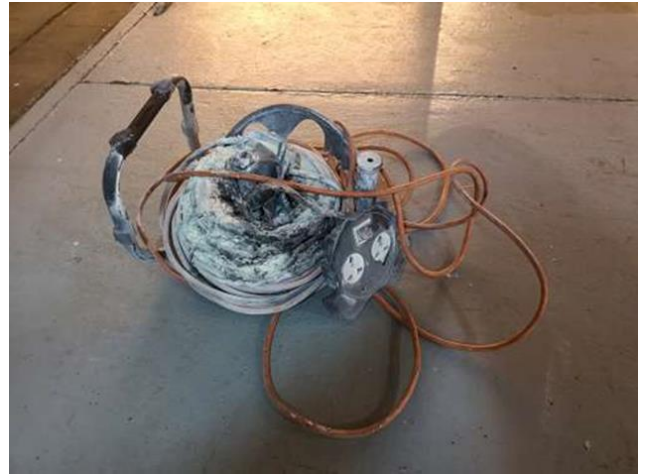
While ventilating a manhole in the engine room, the fire alarm was triggered when an electrical extension lead overheated, melting the insulation and started smouldering.

Investigations confirmed that the electrical extension lead was not laid out in the correct manner and was still around 80% coiled. Also, the extension lead was the incorrect specification for the task of providing power to the blower.

- ◆ Seafarers were unaware of the need to run out all the extension lead when using them;
- ◆ The extension leads available on board were not of an appropriate or correct specification.

- ◆ Provide correct, fit for purpose specification extension leads;
- ◆ Ensure coiled electrical leads are unwound totally prior to use and include such instructions in safety management system (SMS) and on coil casing;
- ◆ Positive: all fire systems were operational, checked, drilled and crews reacted immediately alarm sounded.

- ◆ Thorough audit of all extension leads to ensure correct specifications, and removed all non-approved leads;
- ◆ Add electrical lead management to power and hand tools procedures, training and challenge tests in vessel SMS.
