IMCA Safety Flash 20/15

December 2015

Focus: Slips, Trips and Falls

I Recent Slips, Trips and Falls Involving Stairs

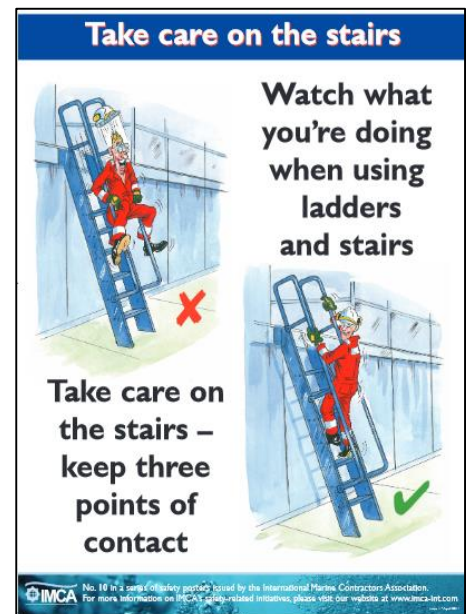
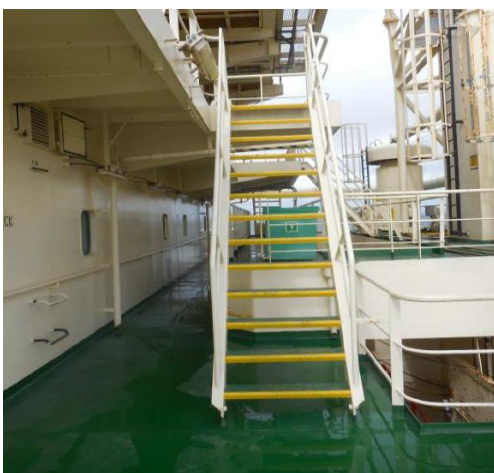
On these stairs, someone slipped on the second step whilst descending and came to rest at the bottom of the stairs, injuring his elbow.

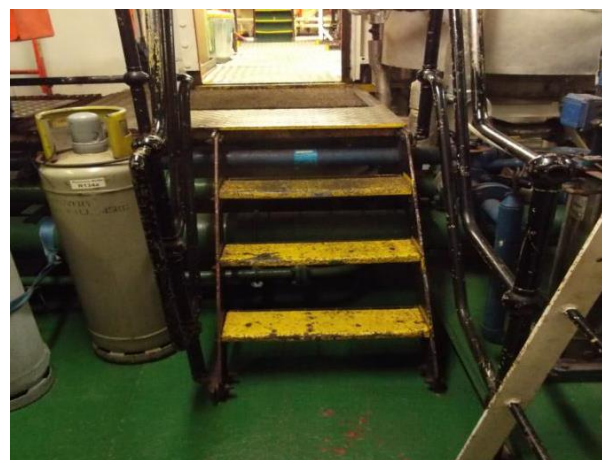
On these stairs, a person reached the bottom step, and his left foot slipped from the tread, landing heavily on the deck injuring his foot.

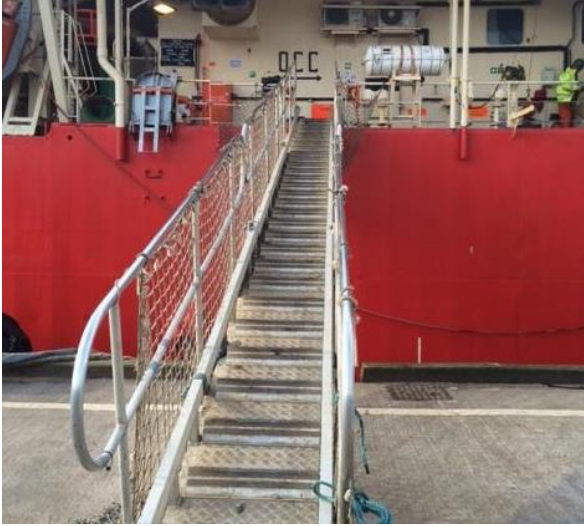
On this gangway, a security guard missed a step when making his way up the gangway. He then experienced pain and swelling to his left leg.

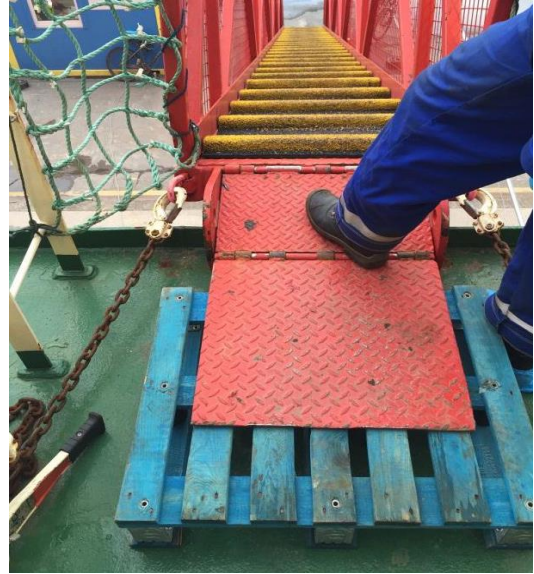
Here an employee stepped on the hinge of the gangway access ramp when it buckled.

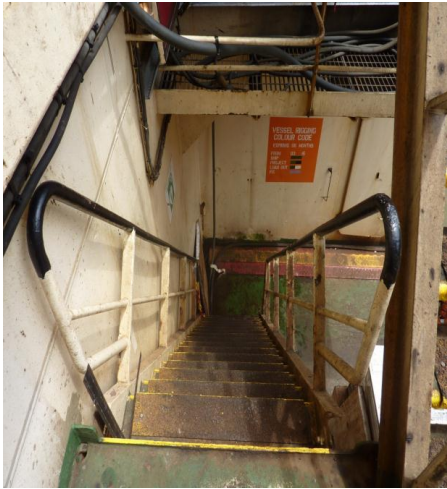
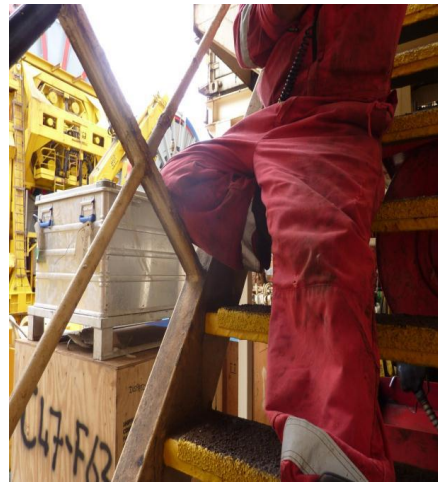
A crewman lost his footing and slipped down an entire flight of stairs (illustrated). As he neared the bottom his right knee struck one of the stanchions of the hand rail, causing the knee to dislocate and fracture.

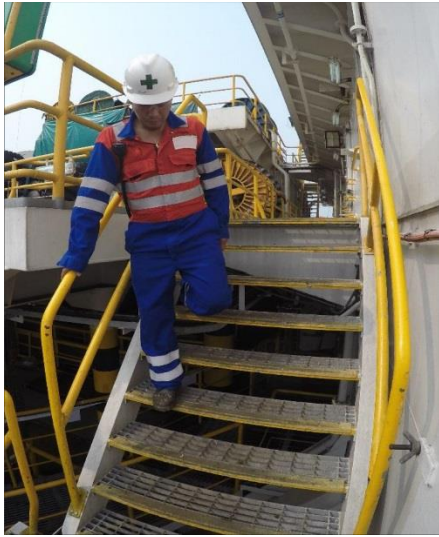
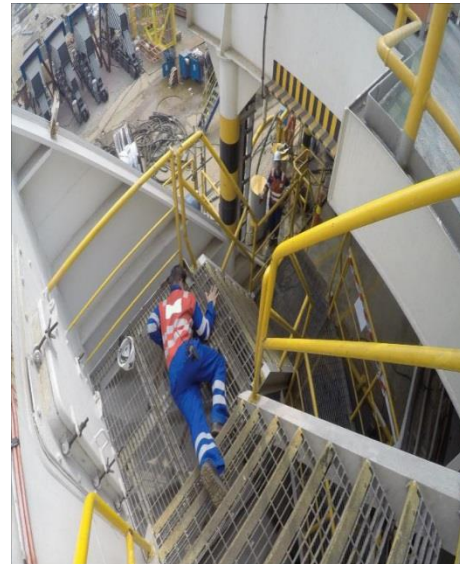
Whilst descending a flight of stairs a crewman lost footing and slipped, fell forwards and landed face forward on the deck below, suffering a compression injury to the right knee. The right-hand image below shows (staged) the position of the injured person after the incident. This incident was a Lost Time Injury (LTI).

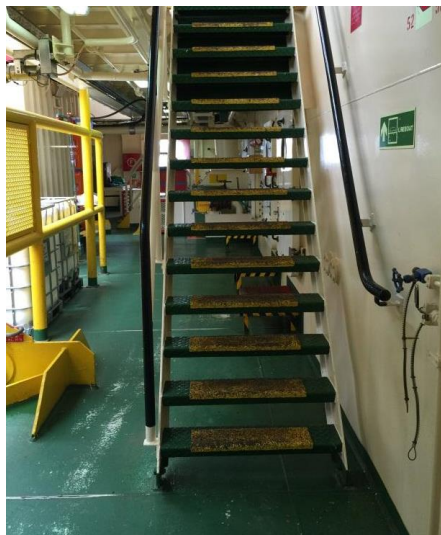
Someone was coming down these stairs when their foot slipped on the fourth step up from the main deck. This caused the person to slip down the stairs and land on their bottom on the deck bumping the left arm in the process.

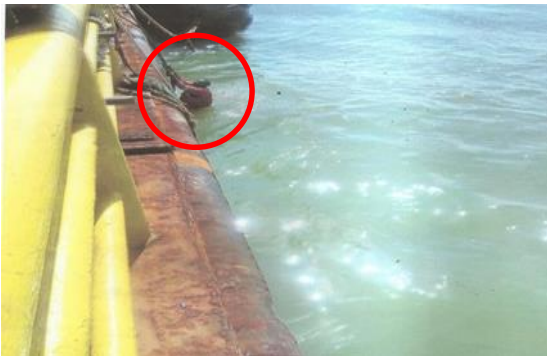
Person who fell overboard

A member has reported an incident in which a crewman fell overboard during mooring operations. The incident occurred whilst an Offshore Support Vessel (OSV) was casting off from a barge after completing a delivery of groceries. Whilst retrieving the forward mooring rope from the sea (which was stuck between the forward Yokohama fender and the barge at the time), the crewman assigned to this activity lost his balance and fell into the sea. He was recovered unharmed.

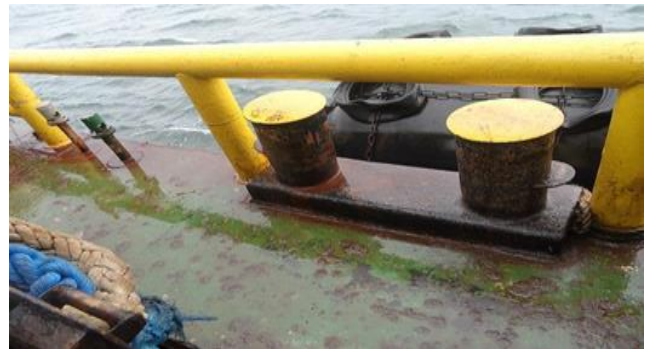
Place from which he lost balance

- In the wrong place (between the space under the railings) while pulling the mooring rope to free it from the fender. This led to his falling overboard when he lost his balance;

- ◆ **The mooring rope was:**
 - Trapped or entangled on the Yokohama fender which was positioned directly by the fairlead
 - Relatively old and fitted with a bowling eye

- ◆ Adjust position of Yokohama fender to prevent tangling or entrapment of mooring lines;
- ◆ Review MOB drill;
- ◆ Review of mooring operations to include:

- ◆ Fabrication and installation of mid-rails to prevent recurrence of incident;
- ◆ Post incident drug and alcohol test kits should be provided on board the barge;
