IMCA Safety Flash 23/16

September 2016

Focus: Dropped Objects

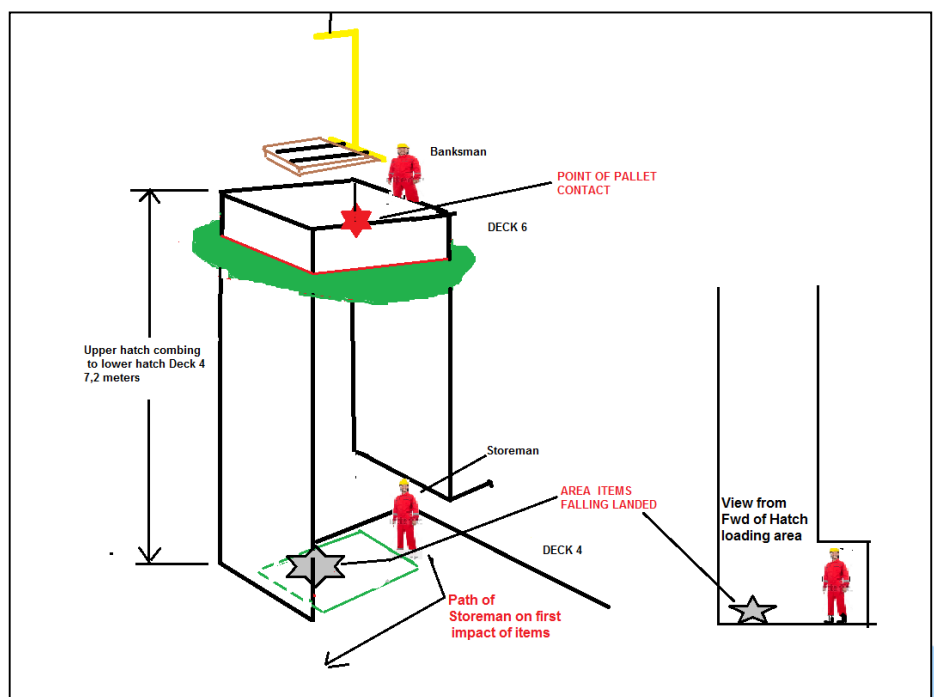
A member has reported an incident in which a pallet shed its load during lifting operations, resulting in 900kg of groceries falling 7m to the deck below. The incident occurred during a routine lifting operation from quayside to vessel. Whilst attempting to lower a pallet laden with stores through a deck hatch, the load contacted the corner of the hatch, damaging the pallet. The cellophane wrapping split near the bottom, and the majority of the 902kg contents fell 7.2m to the deck area below. The front right corner of the pallet was hanging off but did not fall.

- ◆ The risk assessment did not make reference to the practice of a staged progression;
- ◆ As a result of the above, the load had a sufficient degree of freedom to contact the side of the hatch and damage the pallet, resulting in the contents dropping to the deck below.

The **root cause** was found to be **complacency** during "routine" tasks.

- ◆ Ensure all personnel involved in an operation attend a toolbox talk (TBT) before taking part in the activity;
- ◆ The TBT should sufficiently outline roles & responsibilities of those involved;
- ◆ Reinforce the 'STOP THE JOB' philosophy to work teams prior to conducting an operation;
- ◆ Review lift plans and task risk assessments for routine lifting operations, ensuring they are up to date and there is sufficient detail surrounding:
 - control of loads
 - roles & responsibilities of personnel involved
 - securement of loads

- lifting of pallets
- “Line of Fire” and confirmation of clear areas during blind lowering;
- ◆ Review the method for securing pallet loads ensuring it is adequate for the proposed lift;
- ◆ When lowering through a blind hole, adopt a staged progression to the lift allowing for the load to be stabilised and centralised before lowering;
- ◆ Communicate with your work team that time constraints should not impede the safe progress of an activity. If there are concerns regarding time constraints and the viability of completing a task, this should be raised with the offshore management team or supervisor.

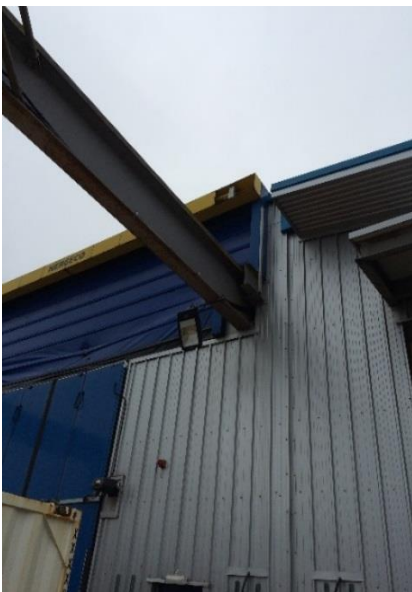
A member has reported a high potential dropped object near miss incident. The incident occurred in a workshop location ashore. A section of metal panelling, which weighed 5.6kg, came loose from the hood of a large industrial automatic rolling door and fell 7-10 meters to the ground. It landed right in front of the fire exit of the workshop.

Item dropped approximately 7-10 meters from above the main roller shutter door

- ◆ Fallen panel was replaced and appropriate secondary retention (self-tapping screws) installed;
- ◆ The remaining panels were all examined and self-tapping screws were fitted as secondary retention;
- ◆ A preliminary dropped object survey was carried out, and annual checks on the hood panel were introduced.

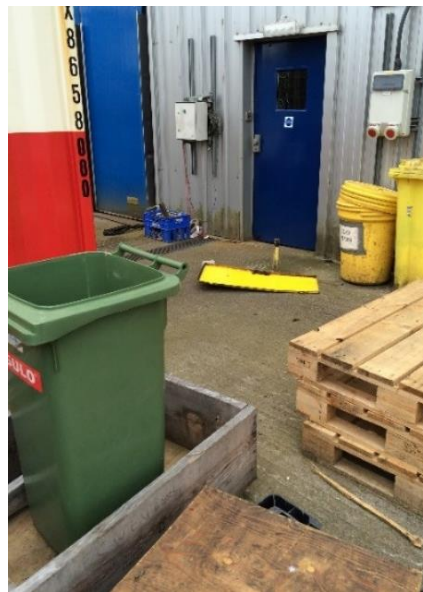
Hood panelling had dropped in front of the main fire exit

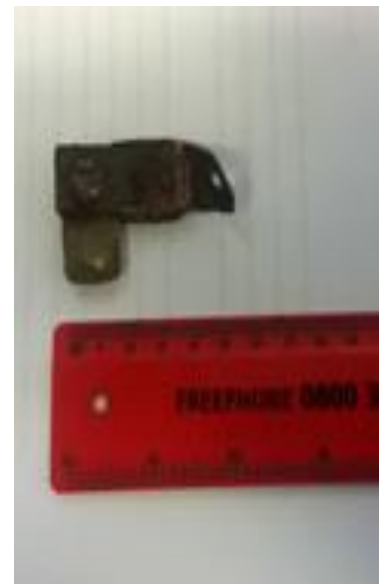
One of the rusted fastening brackets

- ◆ Fastening brackets were rusted; this rusting was caused by water ingress;
- ◆ There was no secondary retention fitted - a practice advocated by DROPS;
- ◆ Whilst the rolling door itself was subject to planned maintenance and inspection, the system did not extend to the hood above the door, which had not been inspected since its installation approximately 15 years before;
- ◆ No dropped objects survey had taken place, which could have identified the actions required to ensure the safety of the item.

The **root cause** of the incident was found to be **failure to identify the requirements** to ensure the safety of this large automatic rolling door – including maintenance, inspection and secondary retention.

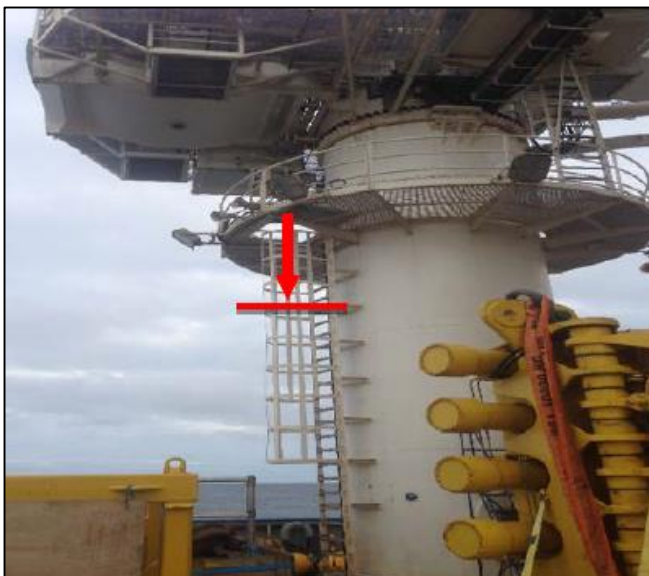
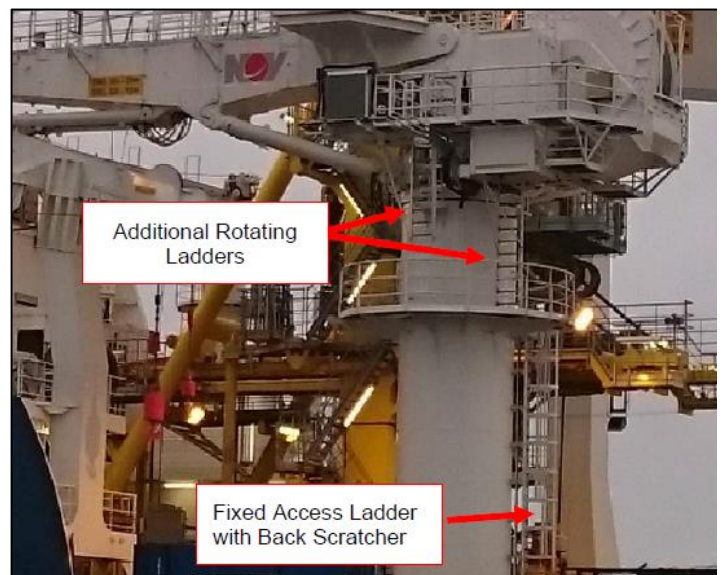
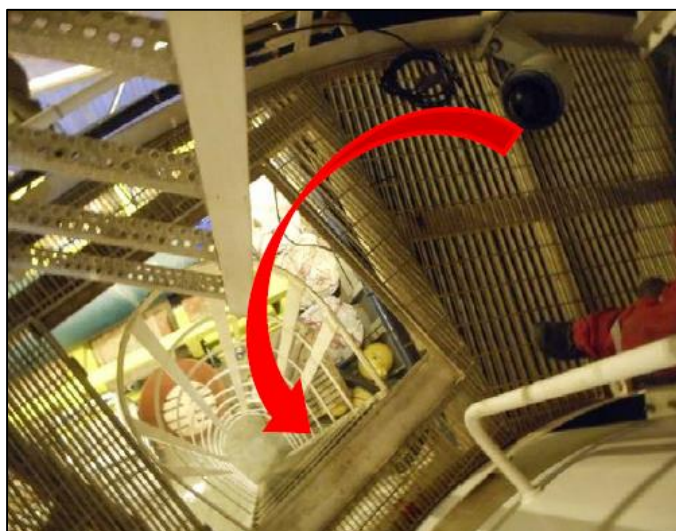
As the crane was rotated, one of these ladders caught the CCTV camera that had been secured to the walkway following maintenance during the previous shift, pulling it approximately 1 meter to the access hatch, where it fell before being arrested by the data cable.

- ◆ The faulty camera could not be repaired at the time and as such, was secured to the crane walkway using tie-wraps;
- ◆ The access hatch located on the walkway was left in an open position while crane operations were ongoing. This is common practice and is done to allow suitable access/egress to and from the crane in the event of a crane breakdown or if a rescue operation is required. The crane design prevents the hatch from being opened when one of three ladders are positioned over it, restricting access/egress;

- ◆ The work conducted on the camera and the status in which it was left was not communicated to the crane operator or the project construction crew at shift handover/TBT. The on-shift crane operator was not made aware that work had been conducted on the crane pedestal and did not identify the CCTV camera during the pre-use inspection;

- ◆ There was a lack of awareness and risk perception of the hazard presented by the rotating ladders;
- ◆ A more thorough pre-use inspection of the walkway would have discovered the potential dropped object;

- ◆ Improved communication – particularly at shift handover – between all parties would have raised awareness of the operation;
- ◆ Had this operation been conducted under a permit to work (PTW) or the correct process followed for routine duty activities, awareness of the operation would have been greater. It is important to highlight that control measures had been implemented by those conducting the work to ensure safe execution of the task and that these were removed when the worksite had been deemed safe;

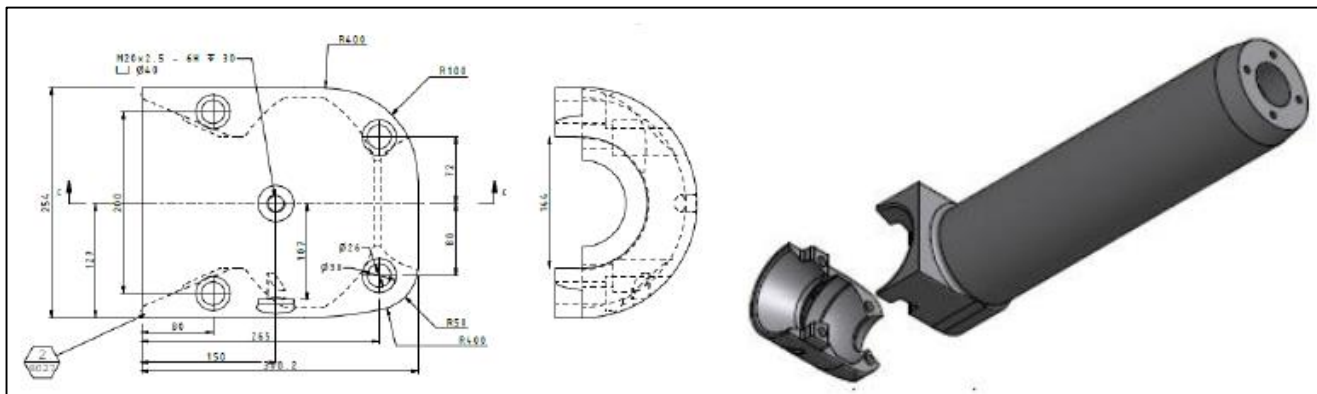
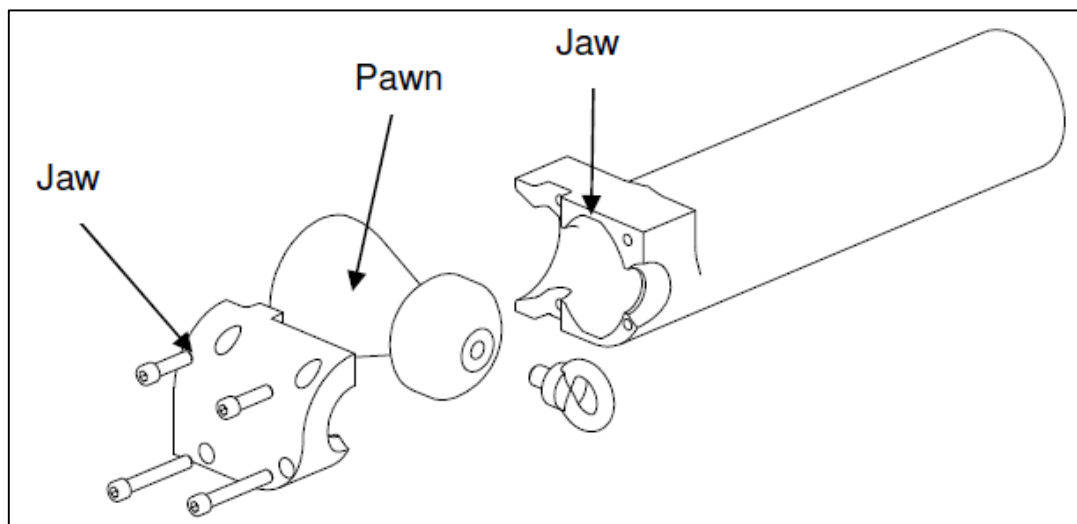
During pipelay operations, the split head elbow is assembled around the pipeline pawn head for attachment of the product (pipe) to the storage reel. The elbow is a two-part socket bolted equipment that is fitted by the construction crew on deck before being pulled in to the reel insert and secured.

These bolts have failed on a number of occasions during spooling or laying operations resulting in dropped objects. One contributing factor being considered is the suitability of these bolts for the activity.

- ♦ Use of a brand new set of bolts for each spooling operation;
- ♦ Careful checks to be made to ascertain that all bolts are new and inspected for defects before each assembly operation;

- ◆ Further close attention to be paid to the engineering details of the bolts and the torque settings of the split head elbow.
