IMCA Safety Flash 23/18

September 2018

1 Electric Arc Incident

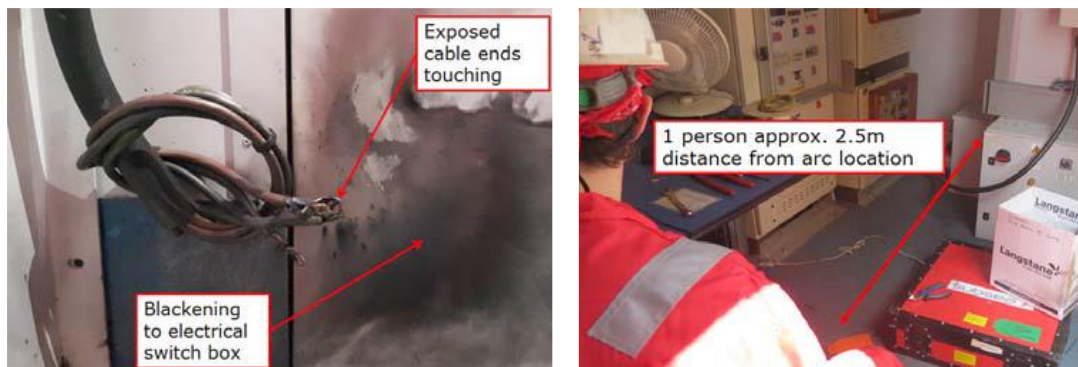
During a vessel mobilisation a control cabin for an electric ROV was being installed and commissioned. The cabin's internal main electrical power cable arced, tripping the vessel's power circuit breaker. The arcing, witnessed by an ROV technician, came from a coil of electrical cabling which had been left hanging from trunking in close proximity to the cabin's internal transformer. This cable was the main electrical power feed from the external power source socket to the internal transformer and had been supplied disconnected and with exposed conductors. The cable's conductors had arced when the cabins electrical system was energised, producing a bright flash and audible bang.

Although there was no actual injury or equipment damage, there was serious potential for both.

- ♦ There was no external power socket available at the workshop base for powering the control cabin during testing and preparation. The work team developed a workaround disconnecting the control cabin's main electrical cable and hardwiring the power supply from the base directly into the control cabin's transformer;

- ♦ There was no management of change (MoC) process conducted as this operation was seen as a temporary change to the equipment. The change to the transformers electrical input was not formally documented or communicated to the personnel that would be working on the system;

- ♦ A combination of inadequate supervision, instruction and experience resulted in the failure to recognise that the main power cable had not been correctly reinstated prior to shipping;

- ◆ Ensure power supply requirements are adequately identified before the job starts;
- ◆ Worksites should ensure they have an appropriate selection of electrical sockets on site for correct equipment connections;

- ◆ Ensure an MoC process is applied to control all temporary equipment modifications;
- ◆ Reiterate to work team leaders the importance of effective job briefings, which confirm job expectations and responsibilities in sufficient detail of the work to be undertaken;

- ◆ Review pre-mobilisation checklists to ensure they include the requirement for adequate checks for loose or hanging cables, exposed conductors and unsafe electrical conditions before the appropriate testing of the main electrical system is carried out;

- ◆ Mobilisation procedures should include checks prior to electrical hook-up for the appropriate testing of electrical cables and inspection for unsafe conditions;

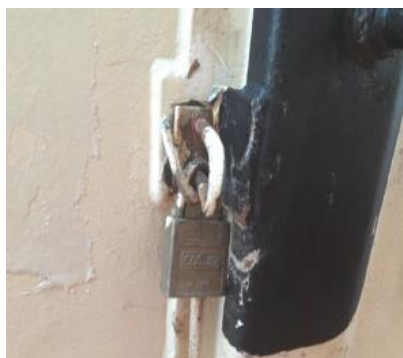
Padlock eye cut open

Onboard investigation established that the intruders had boarded via the poop deck from a small boat, cut open the padlock securing the engine room entrance watertight door, and thus gained access to the engine room.

- ◆ Pre-arrival security briefing should include anticipated threats and planning;
- ◆ Vessel management should remain updated with world-wide maritime security concerns;
- ◆ A deck piracy watch in locations known for piracy.

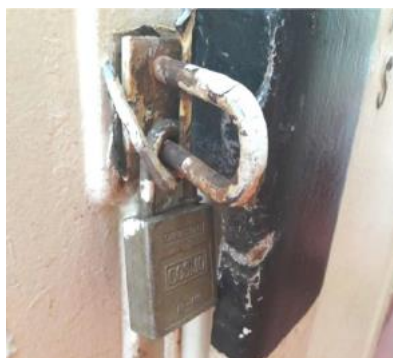
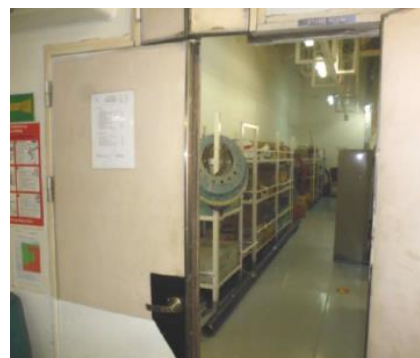
Engine room store

On noticing that the crew were alerted and active, the intruders (5 in number) lowered some bags into boat, jumped overboard and escaped. A thorough search of the vessel was carried out for further unauthorised persons and for items lost. It was discovered that auxiliary engine spares to the value of around 12,000 USD, were missing. No crew were injured.

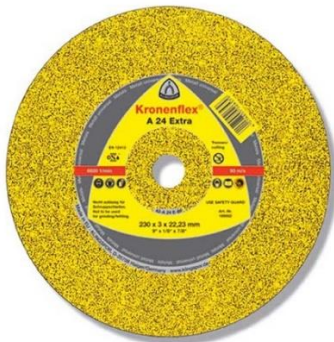
Klingspor A24Extra Flat Cutting Disc

Seamen were grinding sea-fastening spots in the hold, and one of them made a complaint to the Chief Officer about the quality of the grinding discs, they could only grind one spot away before the disc disintegrated and pieces were flying everywhere. The Chief Officer ordered them not to use these discs anymore pending investigation.

- ◆ Investigation revealed that the marking and appearance of the disc led to misunderstanding as to proper use:
 - the discs looked like a normal grinding disc, but also bore the text 'cutting', leading to the conclusion that they were cutting discs
 - none of the officers or crew on board had ever seen a cutting disc this thick before, so that is probably why the mistake was made
 - the discs were clearly marked 'Not to be used for grinding';
- ◆ Further investigation showed from this particular brand (Kronenflex) there is type A24Extra as both a grinding disc and as a cutting disc.

- ◆ There was no check of the disks on delivery, or before use;
 - inadequate attention and awareness of the crew, failing to spot the wrong kind of disc before use.
 - supplier asked to deliver grinding discs and instead delivered cutting discs – but no-one noticed.

- ◆ Ensure crew are thoroughly aware of what happened; a safety moment was planned to show this disc and to demonstrate that it is not a grinding disc, although it looks like one;
- ◆ Ensure equipment and tools are carefully selected and inspected before use;
- ◆ When ordering these items, the purchase department should ensure the grinding wheels are of good quality and marked with an expiry date.

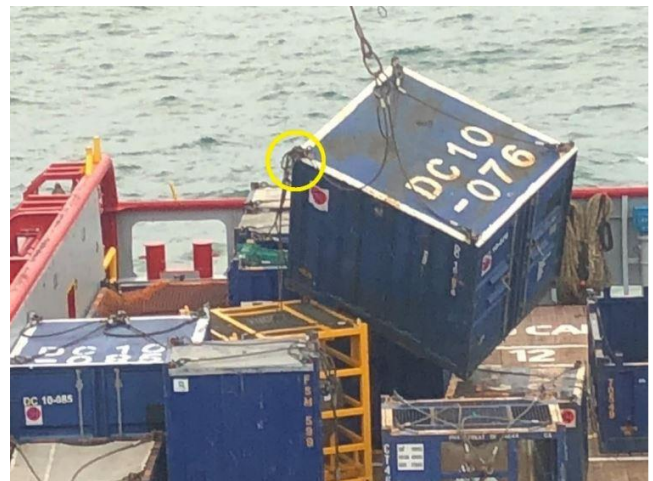
The Marine Safety Forum (MSF) have published [Safety Alert 18-19](#), in which a hoisted 10ft container became snagged on the bridle of a backloaded tote tank. A 'stop stop stop' order was given and the crane operator immediately halted operation; the containers remained suspended 3m off the deck.

The crane operator attempted to free both containers, but the space on deck was too restricted, and he was forced to land the containers on top of a nearby tubular stack.

- ◆ There was limited space to manoeuvre the containers due to lack of deck space;
- ◆ Whilst on location, the number of lifts declared for offload and backload changed significantly;
- ◆ The snagged bridle could not be seen from deck level or from above by the bridge team or the crane operator;
- ◆ The corners of the 10ft container were fitted with guiding pins, which prevented the snagged bridle from slipping free;
- ◆ The snagged bridle was not 'tucked away' or secured when the tank was backloaded.

- ◆ The deck crew removed the bridle once it was safe to do so;
- ◆ The containers were safely discharged, and the deck items were securely re-stowed;
- ◆ The charterer was informed in accordance with company procedures and this helped contribute to an effective and conclusive investigation taking place.

- ◆ A toolbox talk (TBT) took place prior to the start of the operation – this TBT included the subject of checking for potential snag hazards. The vessel owner highlighted the need for all vessels to continue this practice and to continue searching for potential snag hazards both prior to and during operations;
- ◆ The deck crew were safe and clear of any risk during the operation. Crew members should remain in a safe place whilst lifting operations are taking place;
- ◆ The bridle of the tote tank could have been tucked away after disconnecting the hook – these actions would not have prevented the incident from taking place, but may help prevent future similar incidents;
- ◆ The bridge team should take time to research reporting requirements when going on hire and before a potential incident could occur.
