IMCA Safety Flash 23/19

October 2019

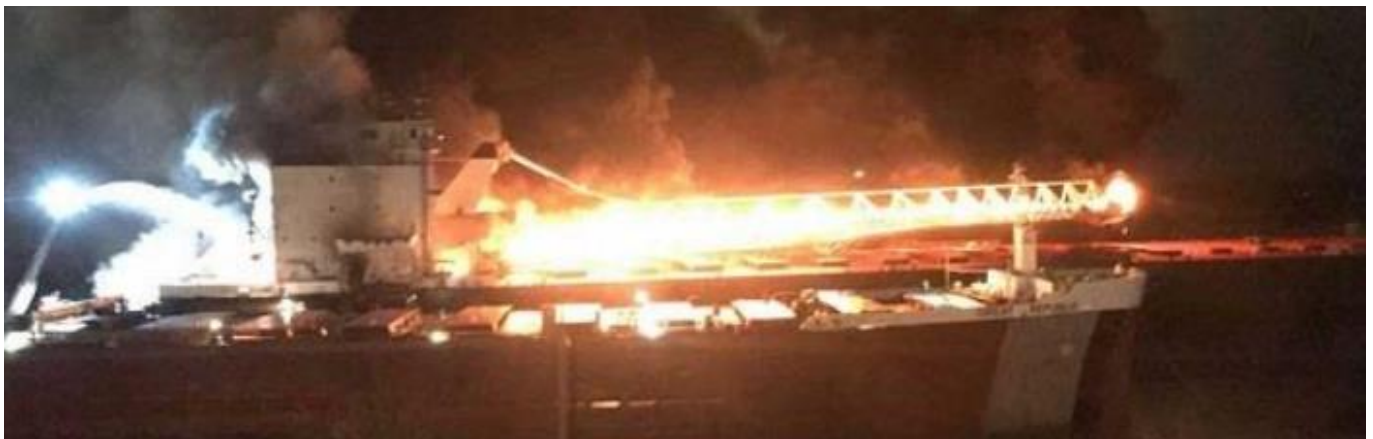
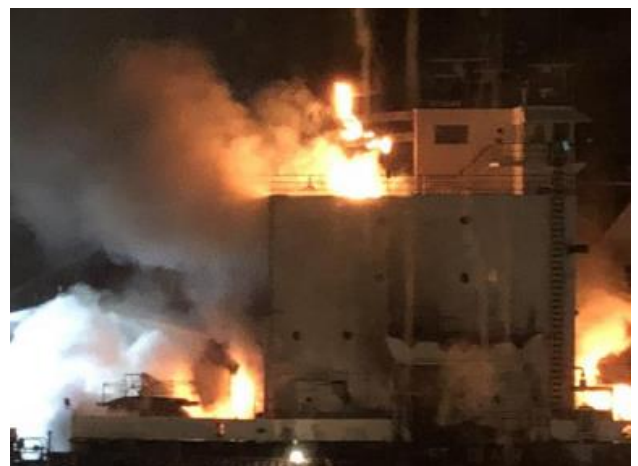
The United States Coast Guard (USCG) has published [Marine Safety Alert 07-19](#) entitled '*For want of a watchman the ship was lost*'. It tells the story of a Great Lakes bulk carrier laid up for the winter suffering a catastrophic fire that caused major cosmetic, machinery, and structural damage. The vessel was unmanned and vacant at the time the fire was discovered. There were no injuries.

The fire appeared to have originated in the machine shop on the gangway deck, above the lower main engine room space. Numerous possible sources of ignition were identified; propane heaters, electric heaters, and heat lamps were being used in the machinery space.

Fighting the fire was hampered by cold weather causing frozen water hydrants. As a result, the fire burned for over 35 hours within the upper engine room spaces, moving up into the entire superstructure. While the fire was being fought, the electrical shore power supply to the vessel failed. Within the machinery space, a number of valves had been opened for maintenance and to drain various systems. During the fire and due to the power loss, the system used to prevent freezing around the machinery space area of the hull failed. As a result, and because of the several days of freezing weather, various piping systems failed and allowed water to flood the machinery space. The flooding continued until divers were able to secure the flow from the sea chest.

- ◆ **Ensure that continuous fire, safety, and security watches are maintained** and that the watchmen are provided specific written instructions regarding their duties in the event of a fire or other emergency situation;
- ◆ **Ensure that persons with vessel engineering experience and knowledge of engine room systems** are used during lay-up preparations to prevent unintended circumstances – such as, in this case, the flooding of the machinery space.

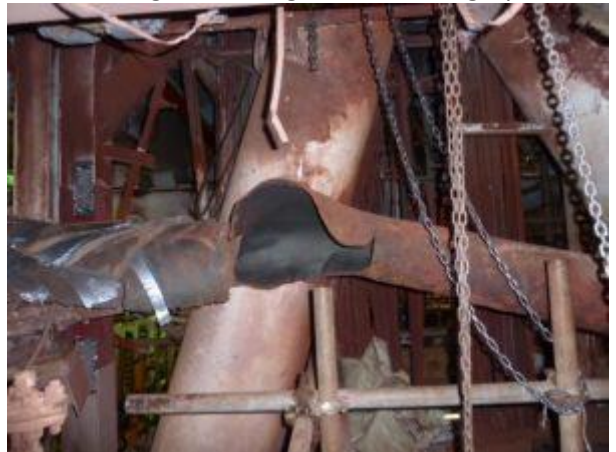
The UK HSE has fined Marathon Oil UK LLC (Marathon) £1,160,000 following an investigation into a high-pressure gas release on the Brae Alpha offshore platform on 26 December 2015. Eight-inch (20cm) diameter high pressure pipework in Module 14 on the platform suffered a catastrophic rupture as a result of 'Corrosion Under Insulation' (CUI), allowing over two tonnes of high-pressure methane gas to be released almost instantaneously. The force of the high-pressure release caused significant and widespread damage in Module 14. Fortunately, owing to the timing of the incident, there were no injuries.

Investigation found that Marathon Oil had failed to undertake any suitable and sufficient inspection of the pipework that would have allowed the company to identify the risk and prevent the hazard from materialising. These failures resulted in personnel on-board the Brae Alpha platform being exposed to an unacceptable risk of serious personal injury or death from fire and explosion, and also led to the UK HSE serving an Improvement Notice on Marathon Oil in January 2016, requiring the company to implement an effective hydrocarbon pipework inspection and maintenance regime.

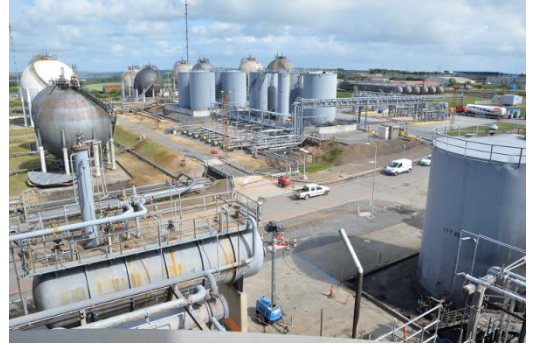
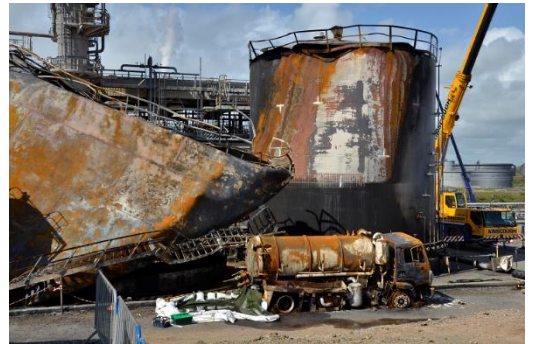
The UK HSE has prosecuted two companies after an explosion killed four workers and seriously injured another at an oil refinery in Pembrokeshire in 2011. Five workers were emptying a tank using a vacuum tanker when the explosion and subsequent fire took place. The explosion resulted in a fireball which severed the 5-tonne tank roof, and this was projected 55 metres to impact against a butane storage sphere. The roof narrowly missed a pipe track where a range of flammable materials were carried.

Investigation found the explosion was most likely to have been initiated by the ignition of a highly flammable atmosphere within the tank, during **what should have been a routine emptying operation** [IMCA emphasis] in preparation for further cleaning and maintenance. The investigation also found there had been longstanding failures within the refinery safety management systems (SMS) and as a result **the risks posed by flammable atmospheres ...were not understood or controlled.** [IMCA emphasis]

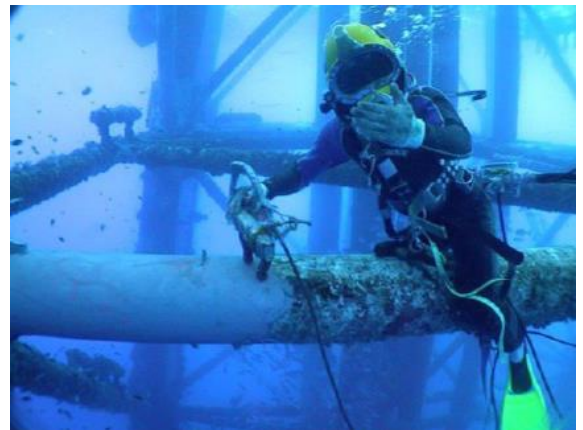
A vessel main engine was started while the divers were in the water, and the engine was immediately shut down again by the bridge. The diver was able to exit the water and was unhurt in the incident. The incident occurred during diving operations in a dockyard to remove debris from a bow thruster.

- ♦ Engine room to bridge communications procedures were not followed. The engineers started the engine without consulting the bridge;
- ♦ There was a failure to follow the diving permit to work (PTW) procedures;
- ♦ There was a failure to implement lockout/tagout (LOTO) procedure;
- ♦ There was no risk assessment conducted.

- ♦ Only the vessel Master should have the authority to start the vessel's engines;
- ♦ Sometimes, isolation tags (LOTO) are not enough, and physical isolations and barriers should be put in in place;
- ♦ Our member recommended the following specific actions:
 - before divers enter the water, all subsea equipment should be physically isolated including the auxiliary engines and HVAC system
 - lifting operations on the main deck are to be stopped while divers are in the water

- control of work documentation to be completed in full before any tasks are started, including any associated documentation from the diving teams
- do not sign off on the control of work unless you have physically checked to ensure that the control measures listed in the risk assessment and associated PTW have been put in place
- any mistakes in any official logbook should be corrected by placing the mistake in brackets or a single line through it so that it is still eligible – scraping out and use of correction fluid not to be permitted.

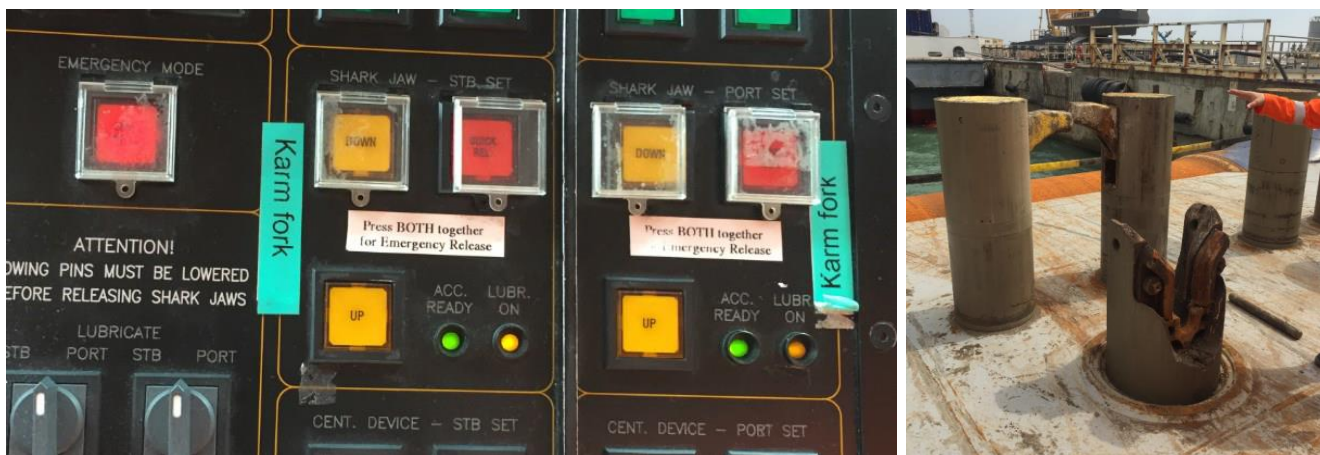
There was an unplanned retraction of the Karm Fork on an Anchor Handling vessel, leading to an anchor tow wire and chain to be dropped. The incident occurred during a rig move. The Anchor Handling vessel was following the rig with the anchor line secured in the Karm Fork on deck with 300m of wire and 150m of chain between the rig and vessel. During the transit to the new location, the vessel accidentally retracted its Karm fork, allowing the wire and chain between the vessel and rig to slip over the vessel stern roller into the sea. Water depth at the time was 370m. No subsea assets were in the vicinity, no personnel were in the line of fire.

- ◆ The Chief Engineer raised the port side Karm Fork with no command from the Master – the company procedure states "All instructions for operation of the anchor handling plant will be disseminated directly from the Master";
- ◆ Ignoring the Masters' request and lack of attention — even after the Masters' second command to lower the port side Karm Fork, the Chief Engineer delayed the task implementation and then in a rush accidentally pushed the emergency release buttons of the wrong Karm Fork.

- ◆ Revision of operations manual and task risk assessment;
- ◆ Relocation of CCTV camera to cover deck area;

- ◆ Reiteration of need for strict compliance to manual requirements and specifically, the need to follow the requirement that such commands or actions should come from the Master only.
