IMCA Safety Flash 24/16

September 2016

Focus: Fire

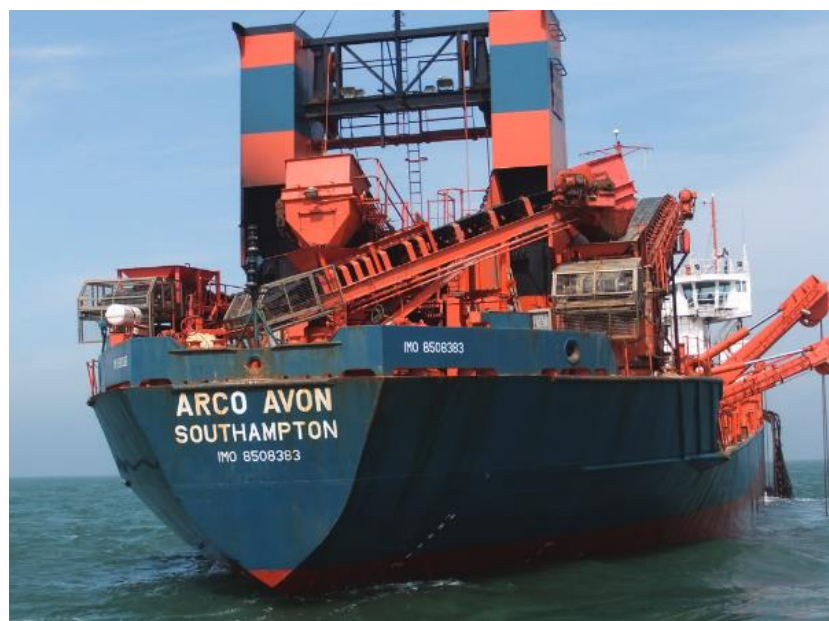
A fire broke out in the engine room while the vessel was loading a sand cargo approximately 12 miles offshore. The vessel's third engineer was badly burned in the fire and later died as a result of his injuries. As a consequence of the fire, which was extinguished following activation of the CO₂ smothering system, the vessel lost all power and remained at anchor with its dredging equipment partially deployed for 9 days until it could be taken under tow and delivered to a repair facility.

- ♦ The third engineer was attempting to repair a failed fuel pipe when fuel, under pressure in the pipe, ignited;
- ♦ No one else on board was aware of a failed fuel pipe or that the third engineer had apparently decided to repair it;
- ♦ The third engineer was using a portable angle grinder to access the repair site and had underestimated the risk of doing so;
- ♦ Possible contributing factors to the third engineer's underestimation of risk were that he had neither carried out a formal risk assessment nor sought a permit to work before starting the repair.

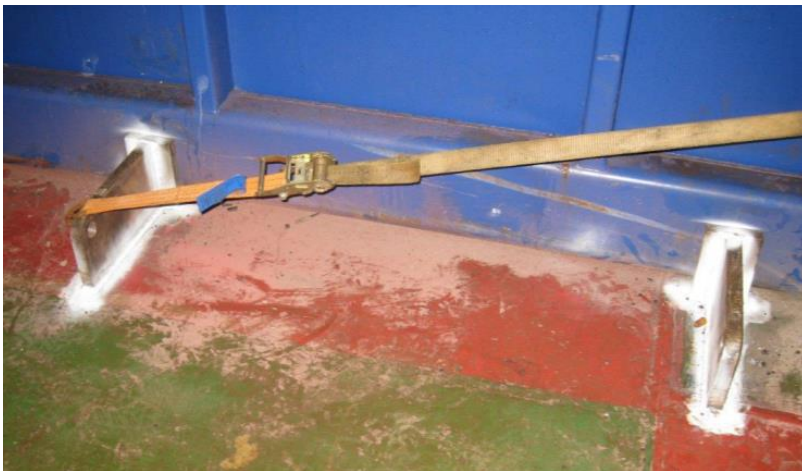
A member has reported a near miss incident in which welding was discovered which had clearly taken place in a 'no hot work' zone. The welding was discovered during pre-sail departure checks of the main deck. The Chief Officer noticed dogging plate welds securing a half-height container had been welded on to a 'no hot work' zone on the deck.

The above figure shows Welds on 'no hot-work' zones

Our members' initial finding was that the task was not properly planned or supervised, allowing sea-fastenings to be welded on to a 'no hot-work' zone.
