## IMCA Safety Flash 24/18

2018

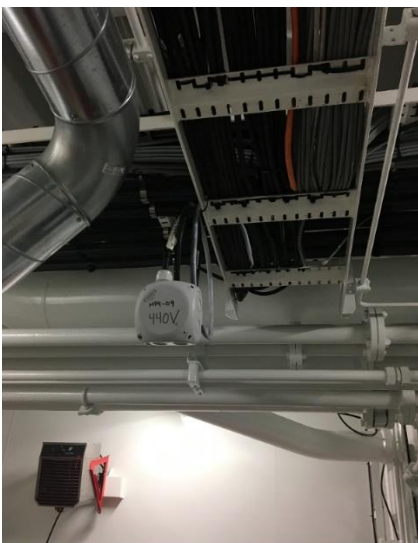
*Showing inappropriately labelled live cable*

- ◆ The cable had apparently been installed and secured at the time of vessel construction and was found coiled and secured in the cable tray with plastic cable ties;
- ◆ The wire end of the cable was not covered; it was cut flush with cable jacket and was labelled 'spare'.

- ◆ A live or energised wire installed during the build phase was hidden from view in a cable tray;
- ◆ The wire was incorrectly labelled;
- ◆ The energised wire was installed and labelled as a heater in the electrical panel with the breaker engaged in the on or closed position, but the end of the wire marked as a 'spare'.

- ◆ Our member conducted an onsite 'Cable Verification Campaign' – all accessible cable trays were checked. All spare cables and wires were tagged and identified;
- ◆ Ensure relevant checks are performed during the new build phase;
- ◆ Have a thorough pre-inspection of a work area where cables are present, and notify relevant personnel of any anomalies;
- ◆ Ensure relevant permit to work (PTW)/isolations are in place.

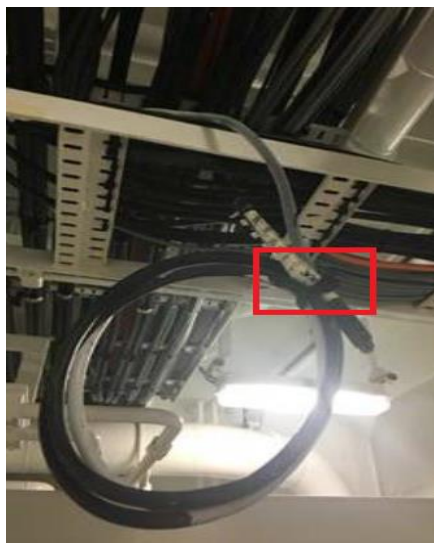
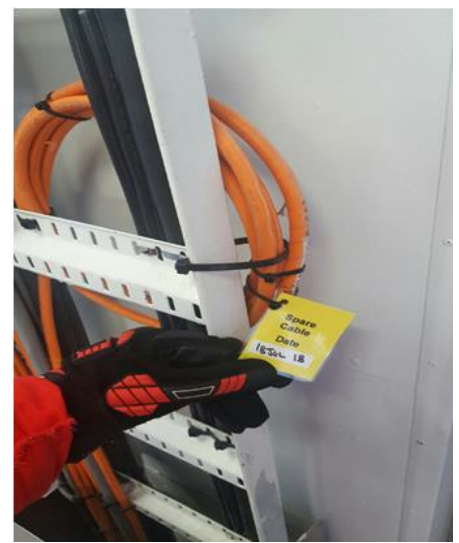
*Properly tagged cable*

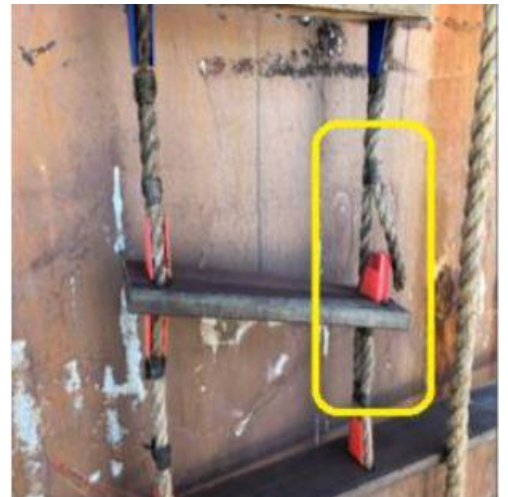
During the disembarkation of two pilots from a condensate tanker, the right anterior side rope of a pilot ladder failed. The structural durability of the ladder was visually assessed by the first pilot and determined to be satisfactory; the second pilot managed to disembark without incident. Further inspection of the ladder revealed a parted side rope, which affected the overall stability of the ladder.

- ◆ The pilot ladder side rope had been weakened due to mould;
- ◆ Inspections that were in place were ineffective.

- ◆ A close visual inspection by trained personnel could have noticed the damage;
- ◆ Improvement needs to be made to the ladder inspection processes;
- ◆ Update knowledge on finding faults with pilot ladders and rope damage;
- ◆ Change the pilot transfer procedure and review alternative methods.

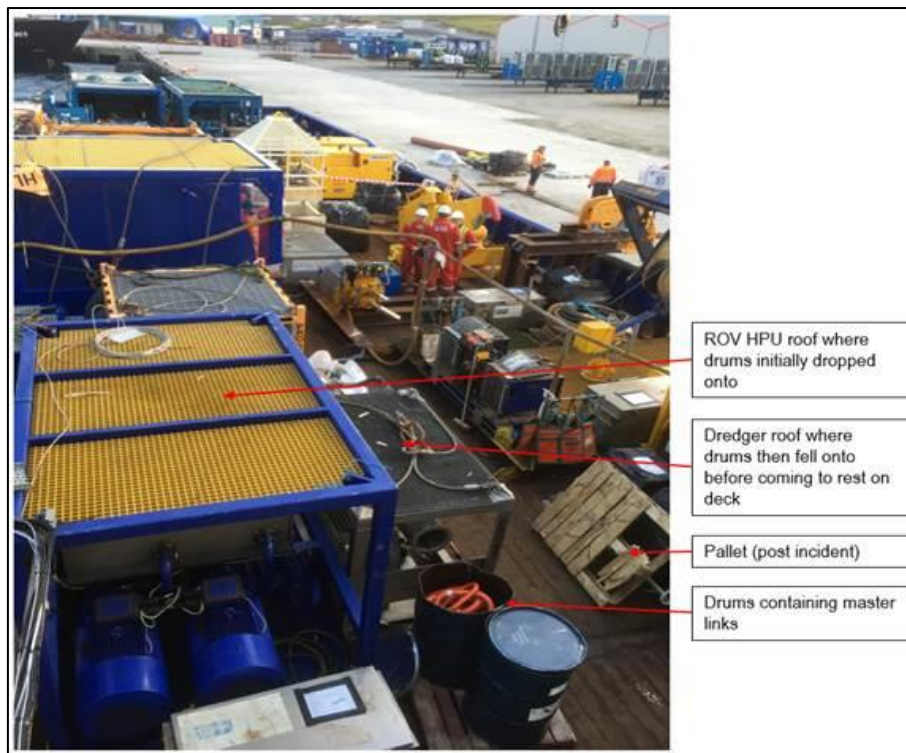
A wooden pallet broke whilst it was being lifted during mobilisation, causing its load to fall to deck. There was no injury to personnel nor was there any damage to equipment. The pallet load consisted of two drums containing lifting master links and was lifted onboard from the quay using basket slung arrangements. When the load was approaching its final laydown area, part of the pallet broke, causing the load to invert and the drums to drop onto the ROV hydraulic power unit (HPU) equipment on deck and then onto the deck itself. Part of the contents of one of the drums was also released.

- ◆ The practice to basket sling a pallet had become the 'norm' following the pallet lifter being sent away for repair 5 weeks earlier; a replacement was not sourced;
- ◆ Personnel failed to comply with lifting guidelines, best practice, lift plans and task risk assessments;
- ◆ Personnel involved in the lifting operations did not intervene or challenge this unsafe lifting practice;
- ◆ There was ineffective and inadequate supervision and control of lifting operations;
- ◆ The drums containing the master links were not decanted into dedicated lift baskets prior to arrival at quayside.

- ◆ Further discussion of 'stop work authority' and the importance of feeling able to intervene or challenge when faced with unsafe practices;
- ◆ Ensure that there is a pallet lifter onboard, fit for purpose and certified for use;
- ◆ Consider decanting lifting equipment and accessories into dedicated lift baskets prior to transportation to the quayside/vessel (this is also relevant to all other equipment too);
- ◆ Ensure and verify all personnel involved in, supporting and controlling lifting operations fully understand lifting operations processes, procedures and good practice compliance requirements;

- ◆ Ensure and verify all personnel involved in supporting and controlling lifting operations review and sign off on existing vessel and site-specific lift plans and lifting operations task risk assessments, to verify their compliance and understanding of risk control measures and mitigations.

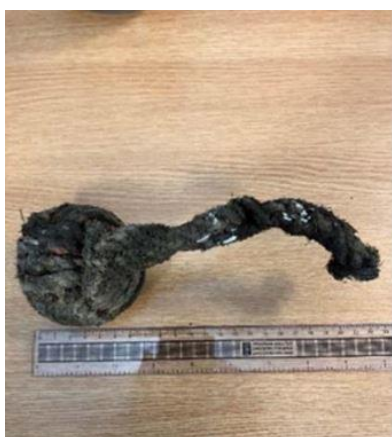
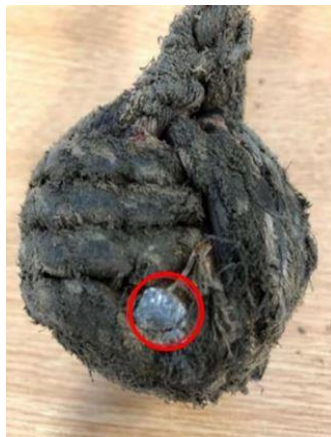
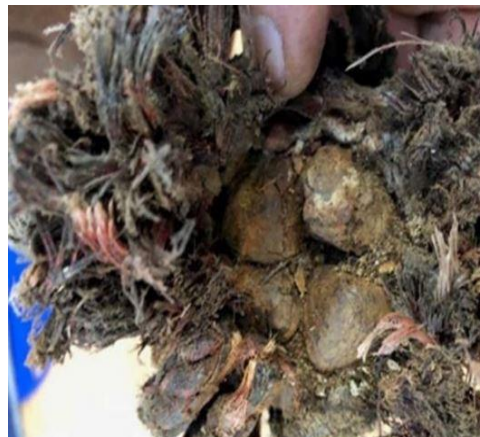
The images show the condition of the 'monkey's fist' when it was thrown ashore, showing an area of protruding concrete. Upon inspection of the monkey's fist, it was noted that it was heavier than normal. The object was cut open and the inside was found to be concrete, together with two layers of rope making up the outer layer. Should the 'monkey's fist' have struck anyone upon thrown overboard, it had the potential to cause serious injury.

- ◆ The dangers and potential for injury was discussed with the vessel;
- ◆ A safety memo was created in order to share the learnings from this incident.

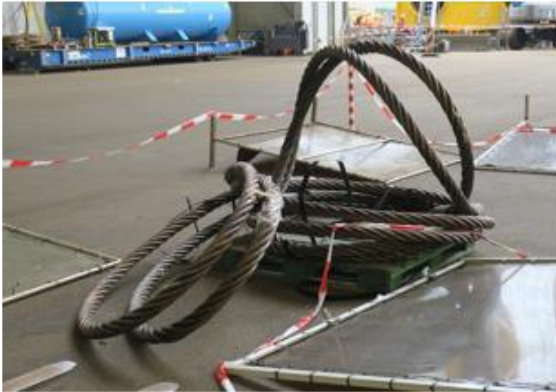
*Incident 1*

In both cases, the injured person was standing in the centre of the coiled superloop releasing fastenings when the sling sprang upwards, striking the person in the face. After the first incident, certain company personnel attended a training course specifically addressing the risk of stored energy in coiled superloops and how to control these risks when uncoiling. It was then the intention that these persons would be present at third-party yards to provide advice when company coiled superloops were being uncoiled.

Company work instructions have been updated to include safety instruction on the uncoiling of superloops. The intention of the safety instruction is to raise the awareness of the risks involved in uncoiling superloops and how to control these risks to third parties receiving coiled superloops.

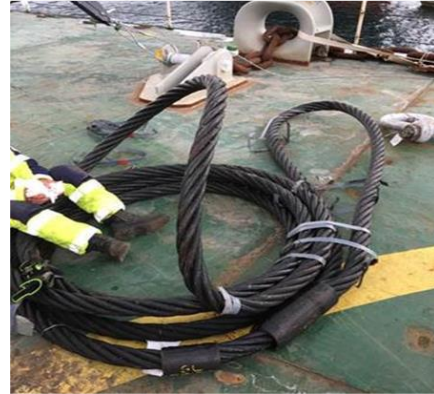
*Incident 2*

However, whilst there was a trained person at the yard at the time of the second incident, uncoiling by untrained yard labour took place without taking his advice.

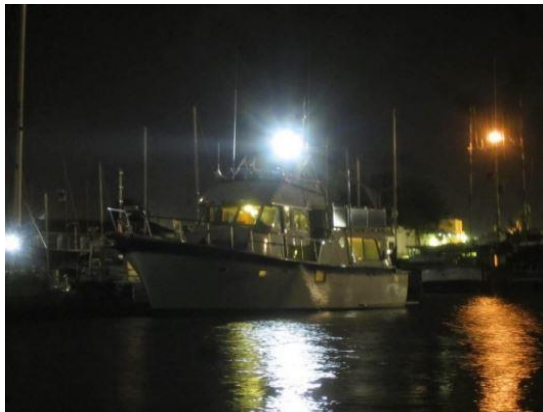
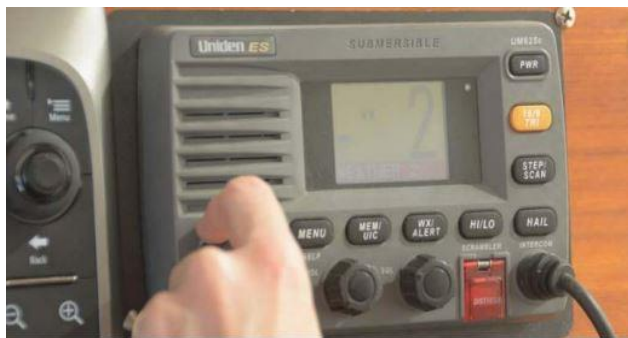
- ◆ Poor reception was noticed when around LED lighting on-board vessels (navigation lights, searchlights and floodlights); interior and exterior lights and adornment lighting are just some of the few lighting systems containing LED lighting;

- ◆ The radio frequency (RF) interference caused was found to create potential safety hazards;
- ◆ A maritime rescue coordination centre was unable to contact a ship involved in a traffic separation scheme incident by VHF radio. The ship had also experienced very poor AIS reception;
- ◆ Other ships in various ports experienced degradation of VHF receivers, including AIS, caused by their LED navigation light. LED lighting installed near VHF antennas has shown to interfere with the reception.

- ◆ RF interference may not be immediately obvious to maritime radio users. However, it may be possible to test for interference caused by LEDs;
  - turn off LED light(s)
  - tune the VHF radio to a quiet channel
  - adjust the VHF radio's squelch control (until the radio outputs audio noise)
  - re-adjust the VHF radio's squelch control until the audio noise is quiet (slightly above the noise threshold)
  - turn on the LED light(s) – if the radio outputs audio noise, then the LED lights have raised the noise floor
  - if the radio does not output audio noise, then the LED lights have not raised the noise floor;
- ◆ If the noise floor is found to have been raised, then it is likely that both shipboard VHF marine radio and AIS reception are being degraded by LED lighting.
