## IMCA Safety Flash 25/16

October 2016

### 1 Fire-Fighting Water Jet Hits Antenna – Failure of Limits, Stops and Safeties

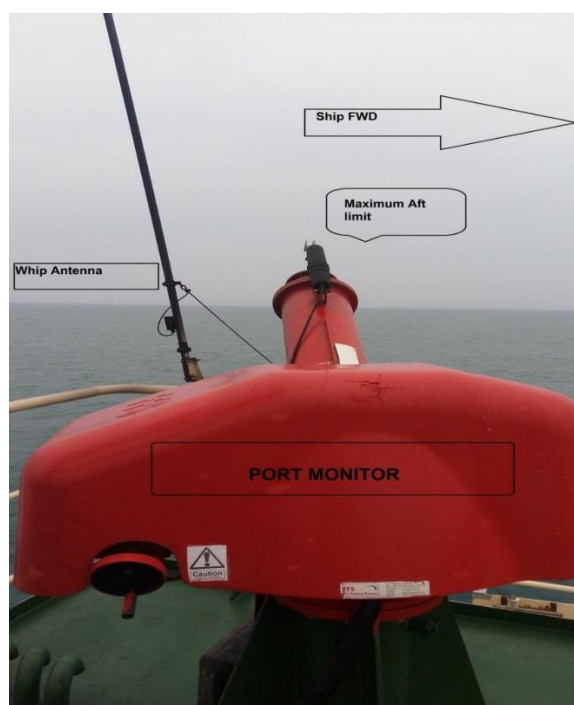
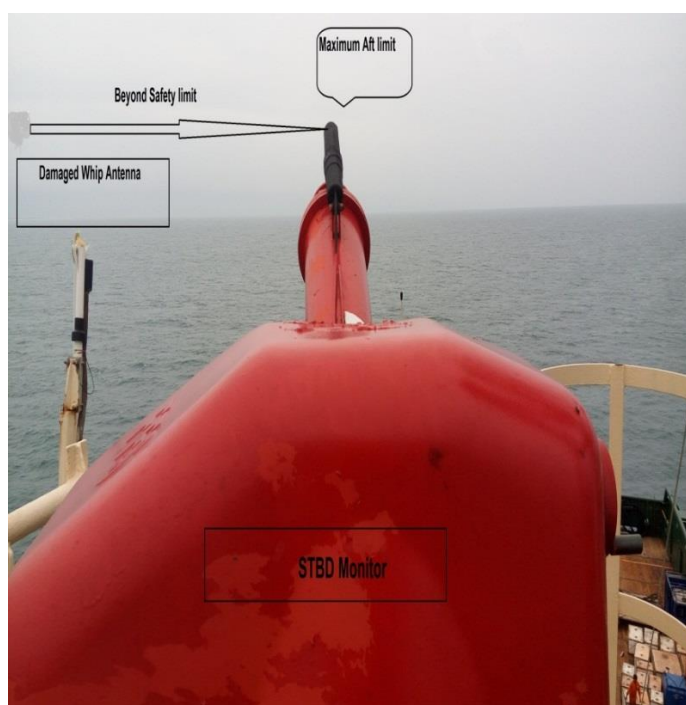
A member has reported an incident in which the water jet from a fire-fighting monitor hit an MF/HF whip antenna and damaged it. The incident happened during monthly testing of fire-fighting equipment. It was discovered that the horizontal travel of the fire-fighting monitor went beyond acceptable limits, allowing the water throw to hit and damage a nearby whip antenna. The testing was immediately stopped and damage was assessed.

- ◆ Maintenance on this fire-fighting monitor had been carried out earlier by third party contractors;
- ◆ The **root cause** was determined to be incorrect adjustment of turning limit switch of the fire-fighting monitor;
- ◆ It was noted that it was important to regularly check the turning and elevation limit switches settings of fire-fighting monitors.

- ◆ The limiting for the monitor was adjusted so that its throw remained in a safe sector of operation with no ship's equipment or structure in line with the water throw;
- ◆ On completion of major maintenance on machinery/equipment, full trial runs and acceptance tests should be conducted to ensure satisfactory operations;
- ◆ Machinery and equipment not used regularly during normal operation of the vessel – such as fire-fighting monitors and pumps – should be tested at regular intervals in accordance with the vessel's planned maintenance schedule. Before such tests it should be confirmed that all safety settings and limits installed in the system are functioning correctly;
- ◆ Our member reiterated the importance of **stopping the job** if work is being done in an unsafe manner.

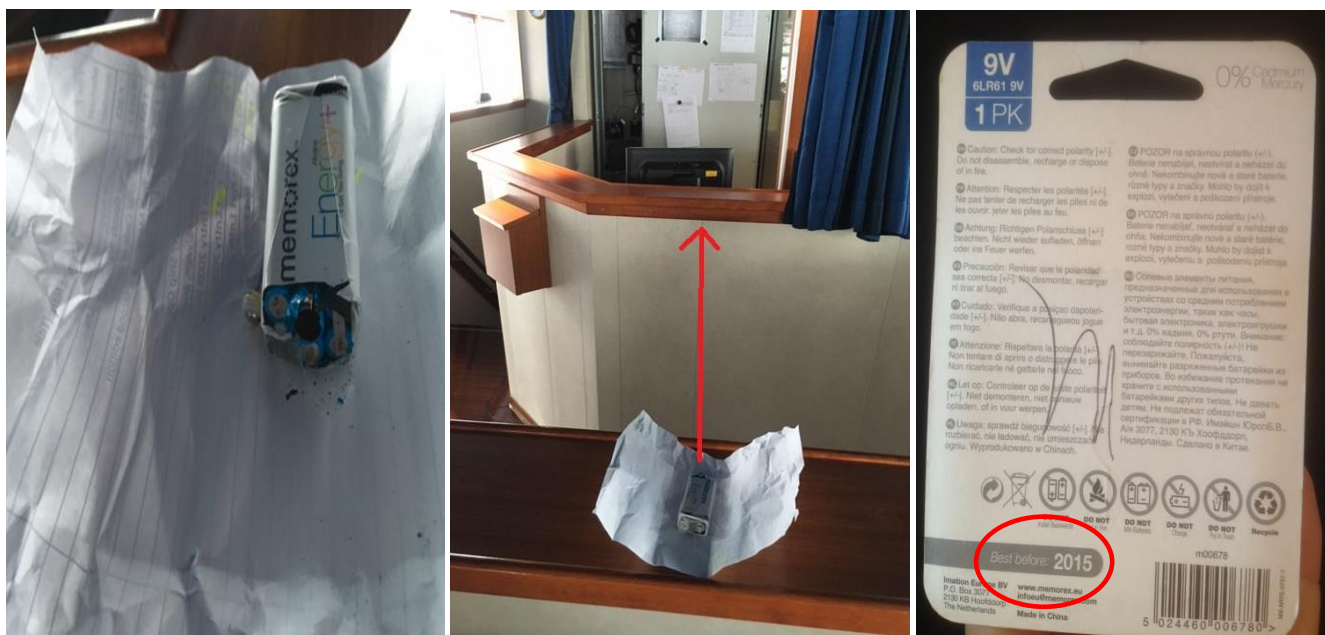
After conducting a thorough search, a PP3 type 9-volt battery was discovered wrapped in a piece of paper with the terminals taped over ready for disposal. The bottom was blown off the battery housing exposing the individual 'AAAA' batteries inside. Fortunately, there were no injuries.

- ◆ The battery was used beyond its recommended expiry date (see 3rd image);
- ◆ As a result of this over-use, one or more internal cells had leaked causing an internal short circuit;
- ◆ The battery overheated causing catastrophic failure.

- ◆ Vessel checked for similar brand or make of battery – two such batteries were found in packaging, both expired. These were disposed of safely;
- ◆ Further checks were made of all other batteries currently in use or in stock to ensure expiry dates were not exceeded;
- ◆ Safety flash was issued to company globally and IMCA.

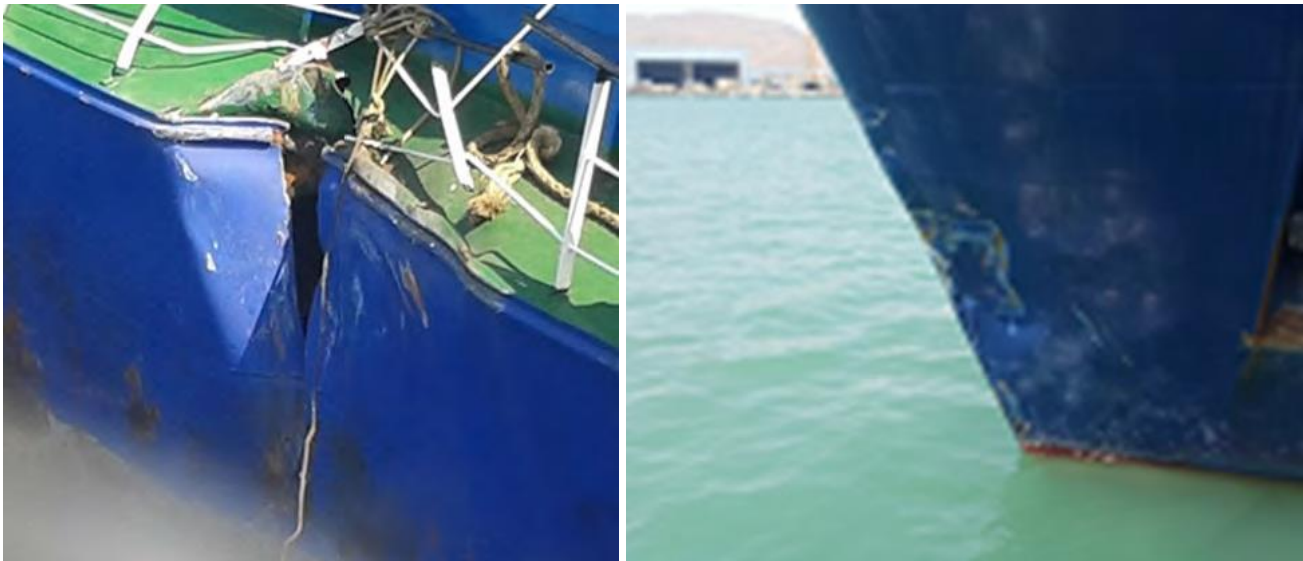
command, attempted to alter the course of the vessel using the bow thrusters but to no effect. The survey vessel subsequently made contact with the pipe-carrying vessel causing some damage.

- ◆ There was a loss of control over both azimuth thrusters:
  - Potentially the autopilot system engaged due to some mechanical failure or to human error

- One single switch controlled both "independent" steering systems
  - Autopilot option overrode both azimuth thrusters, with no automatic disengagement available

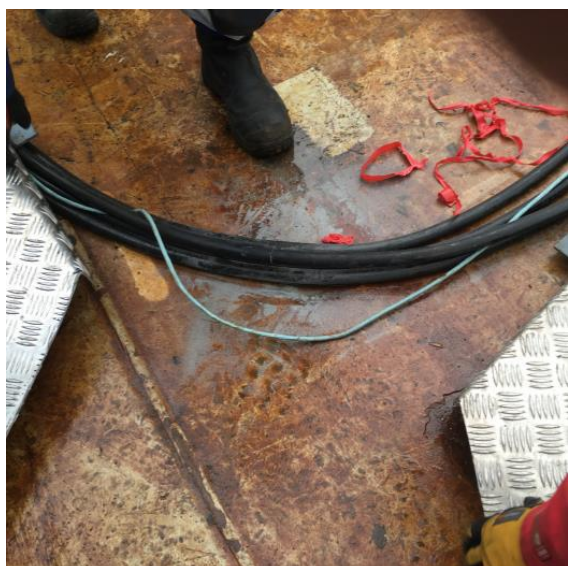
*Cables routed across the deck*

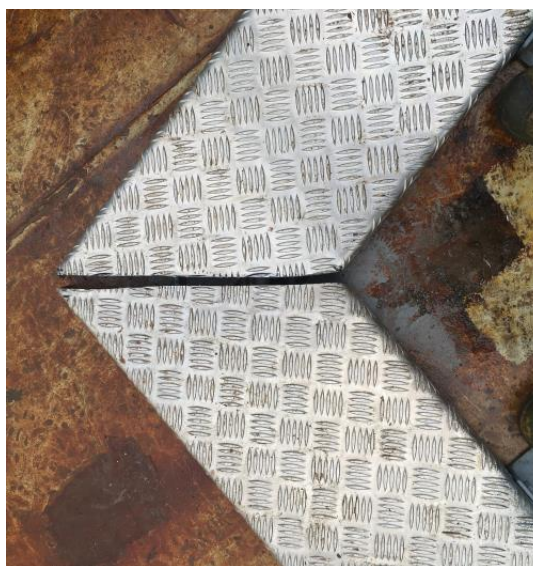
*Prefabricated Aluminium covers*

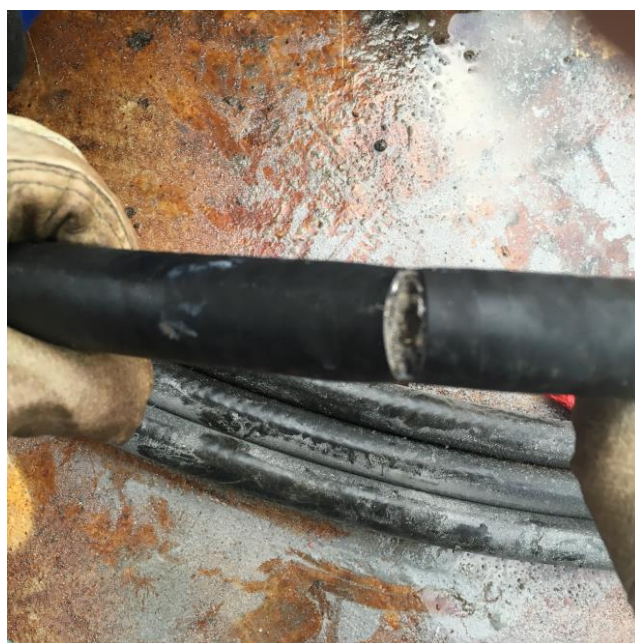
During this time the angle on the covers had to be altered so they would neatly butt up against each other. On several occasions the rigger/welder removed the covers to a more suitable location on deck to modify or improve the fit. On the last modification the cable protection covers were left in place and the rigger/welder proceeded to grind over the bundle of cables, making contact with the live 440v, 250A cable.

*Damaged cable*

- ◆ The task was not properly planned or risk assessed:
  - The Permit to Work did not cover this specific task (it covered Hot Work/Welding/Grinding only)
  - The Job Risk Assessment (JRA) did not cover grinding in vicinity of live electric cables or the requirement for electrical isolations of the cables;
- ◆ The toolbox talk was not specific to the task being undertaken by the rigger/welder;
- ◆ There were no isolations in place whilst working next to live electric cables;
- ◆ Electrical isolation was not applied immediately after the incident, and did not occur until 2.5 hours later, posing further risks to other crew members working on deck/in the vicinity.

When he realised that cable had been damaged, the rigger/welder immediately **stopped the job** and applied insulating tape to the cable, to prevent any ingress from the damp conditions. He was not aware that the cable was live. He then reported the incident. Around two hours later, the power to the damaged cable was isolated at the supplying junction box and a pad-lock put in place as a lock-out mechanism, as per company procedures.
