## IMCA Safety Flash 25/17

October 2017

### 1 Fatality: Crew Member Crushed Between TMS and Snubber Ring

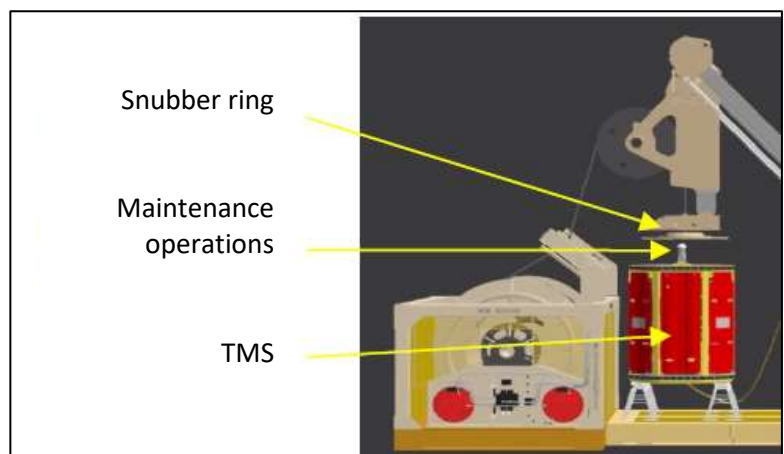
During a maintenance operation, a member of an ROV crew sustained fatal injuries when he was trapped between the top of the tether management system (TMS) and the snubber ring.

It should be noted that this incident remains under investigation. Additional information will be provided in due course.

- ◆ Maintenance activities should be properly risk assessed and undertaken in accordance with company procedures;
- ◆ Maintenance activities often introduce additional hazards into the workplace; these should be fully understood, assessed and managed;
- ◆ There should be a documented safe system of work, for example, a maintenance manual and/or work instruction;
- ◆ If activation of the equipment is necessary to complete the maintenance activity, for example for testing purposes, extreme care needs to be taken which includes removing all personnel from any danger zone;
- ◆ Avoid undertaking a maintenance activity under a load or between a load and fixed point;
- ◆ Equipment must be turned off and isolated when being worked on.

The incident highlights the need for strict compliance with the 'golden' or 'life-saving' rules used by all contractors and clients.
