IMCA Safety Flash 25/18

1 Finger Injury: Diver Caught Finger in Bell Door

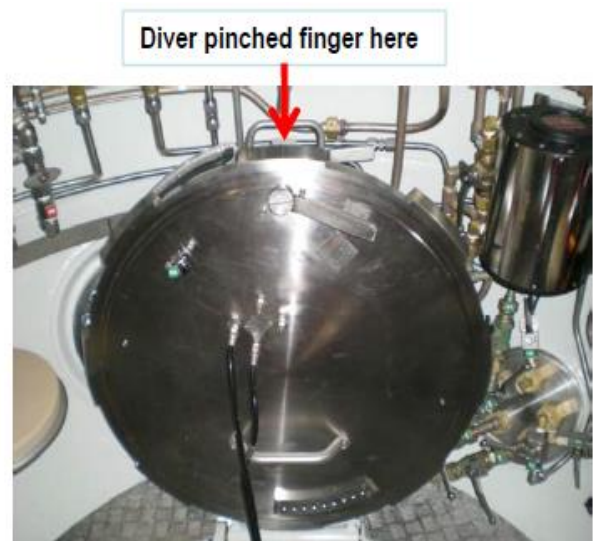
A diver suffered an injury when his finger got caught between the top of the bell door and the retaining latch. The incident occurred at the end of the dive, when both divers had been recovered to the bell and were preparing for return to surface. The dive team were attempting to close the bell door; however, the racked umbilical was stopping the door from fully closing. Diver 1 placed his hand on top of the door and leant onto it to steady himself as he tried to reposition the umbilical. At that point, the door moved back slightly, pinching his finger between the top of the door and the retaining latch. He suffered a deep cut to his finger which led to him being decompressed from the system as a precaution against possible infection.

The investigation for this incident highlighted a number of contributory factors:

- ◆ Incorrectly stored umbilical interfering with the closing of the bell door;
- ◆ Lack of awareness/perception of risk;
- ◆ Lack of hazard markings on the pinch point location.

- ◆ There needs to be a thorough check of work areas for potential pinch points, and where these cannot be removed, ensure that they are physically highlighted and identified in task risk assessments (TRAs), and communicated to all personnel during toolbox talks (TBTs);
- ◆ There was a review of equipment stowage in the bell, which resulted in the repositioning of the bell scrubber, improved stowage of rebreather and repositioning of divers' seats within the bell.

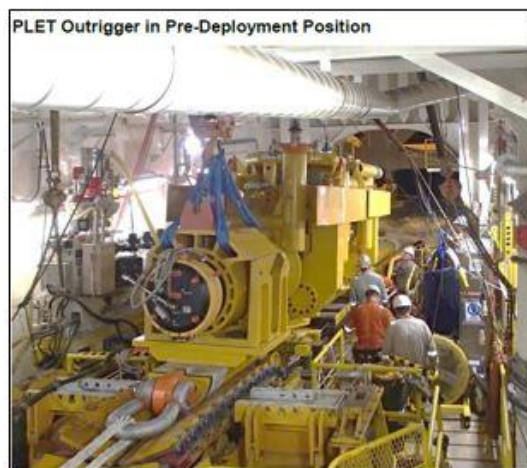
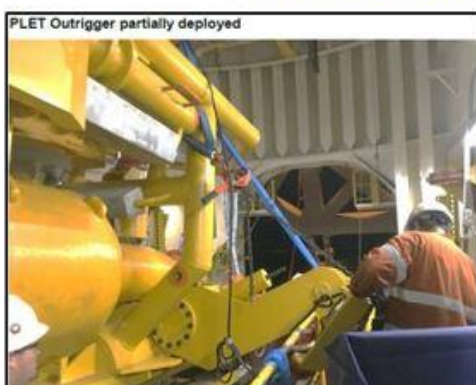
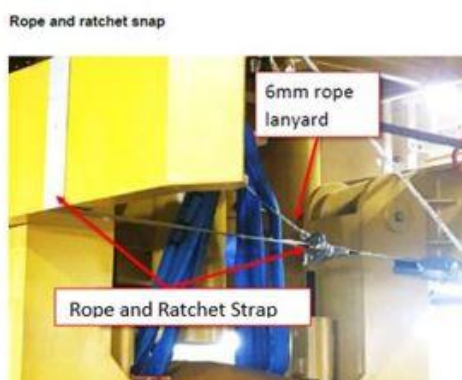
As a pipeline end termination (PLET) passed through the firing line, a rigger incorrectly cut a webbed ratchet strap (instead of a 6mm rope lanyard) which was restraining the aft PLET outriggers/stabilizer legs in the upright position. After cutting the ratchet strap, the starboard stabilizer leg deployed to approximately 35 degrees from vertical, coming to rest on the pipeline induction heat (PIH), injection moulded poly propylene (IMPP) unit. The port side outrigger released (approximately 60 degrees from vertical) until it came to rest on a nearby handrail.

- ♦ Engineering design: there was no integral mechanical means to lock or hold the outriggers in the vertical position;
- ♦ Management of change (MoC): original drawings indicated a wire rope sling arrangement which was later changed to a flat ratchet strap;
- ♦ A risk assessment did not identify the potential stored energy hazard posed by the outriggers;
- ♦ Communication: a decision was made to introduce 6mm rope to the ratchet strap to allow for easy retrieval subsea with an ROV. This decision was made informally and intermittently conveyed between teams (field engineers and rigging), which introduced a new risk.

- ♦ Reviewed risk management process for the design of subsea structures to make the process more robust and to allow the project team to analyse structure designs and address all failure points during the design phase;
- ♦ Ensure changes to designs as supplied by a customer are managed robustly with justification documented for any engineered changes in rigging arrangements – a more robust MoC;
- ♦ Thorough review of risk management processes, particularly between teams and in the 'interface' between teams; in this case, between the fabrication and project teams;
- ♦ Reinforced the importance of clear communication during critical operations, to ensure the message/work scope is delivered in a clear manner and that any risks are fully understood by the crews.

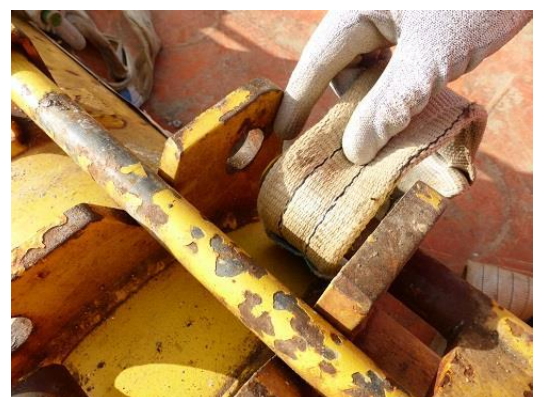
A crewman suffered a serious hand injury whilst working on subsea mattress recovery using a quick release mattress handling beam. The lifting webbing slings and ROV hooks were disconnected from the mattress and then, whilst reconnecting the beam, two of the pins failed to fully engage due to the slings being caught by the pins. The crewman was in the process of freeing the sling, when another deck crew member operated the quick release bar, which re-engaged the pin, resulting in trapping the injured person's finger.

- ◆ The task plans and task risk assessments clearly define the roles and responsibilities of the deck team involved in the operation, and that mitigation for entrapment hazards is fully understood, including nominating a person to control and operate the handling beam quick release bar;

- ◆ Consideration is given to attaching rope grommets or tie wraps to the end of the slings to help keep the sling in place when engaging the pins and to keep fingers out of line of fire;

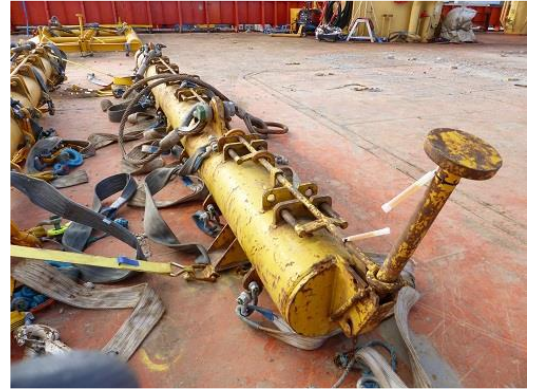
Our member notes that this incident took place during the hours of darkness, and records the following reasons for occurrence:

- ◆ The design of the pin engagement mechanism and the width of the slings;
- ◆ On this occasion there was a breakdown in communication between the deck crew members; the injured person was not clear of the pins when the mechanism was re-engaged.

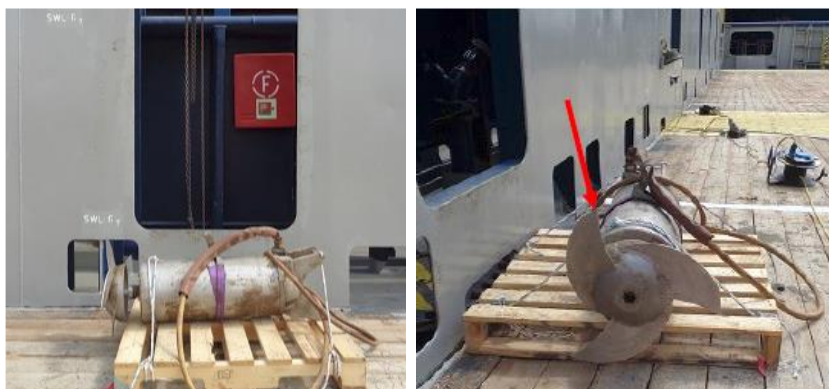
A crew member injured his leg while moving a mud agitator with unprotected blades. At the time of incident, the vessel was proceeding to port. First aid was administered immediately on-board, followed by further examination and treatment of the wound at a clinic onshore. The injured person returned to the vessel on the same day.

- ◆ There was inadequate risk awareness – risks could have been reduced by protecting the blades before lifting/handling the agitator; waiting until the vessel reached port could also have reduced manual handling risks;
- ◆ Manual handling practice could have been improved – while the agitator was suspended by chain blocks during the work, whilst gripping the blades using pieces of rags (rather than wearing gloves), the load slipped from his hands and hit the crew members' leg. A rope or another hands-off approach could have been used to turn/move/stabilise the load.

- ◆ Better risk awareness when moving objects with blades or sharp edges:
 - protect the sharp edges
 - arrange lifting and moving of load without actual manual handling – ropes, tag lines etc
 - wait until more personnel are available and/or vessel is in port (as appropriate)
 - use proper personal protective equipment (PPE) – gloves.
